Coal-Mac, Inc. TDS Reduction from Valley Fills

**Terry Potter, P.E.
Engineering Manager**

**2013 West Virginia Mine Drainage Task Force Symposium
March 26 - 27, 2013**

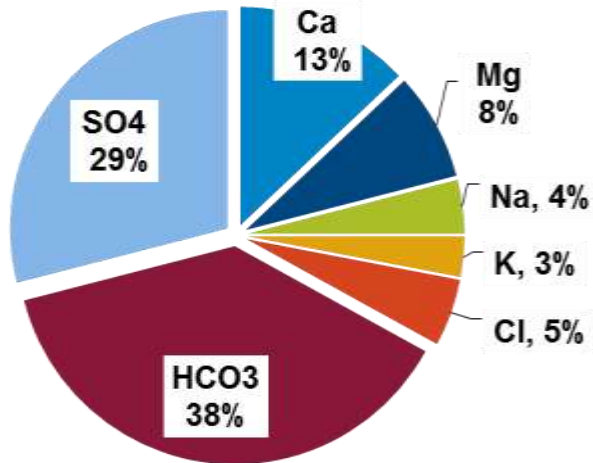
Pond et al. 2008
Un-mined Sites (7)
Mean SC: 62 μ S/cm
Mean ion sum - 56 mg/L

Sulfates contribute the greatest increase to TDS – from 16 mg/l to 700 mg/l

Bicarbonates are next – from 21 mg/l to 186 mg/l

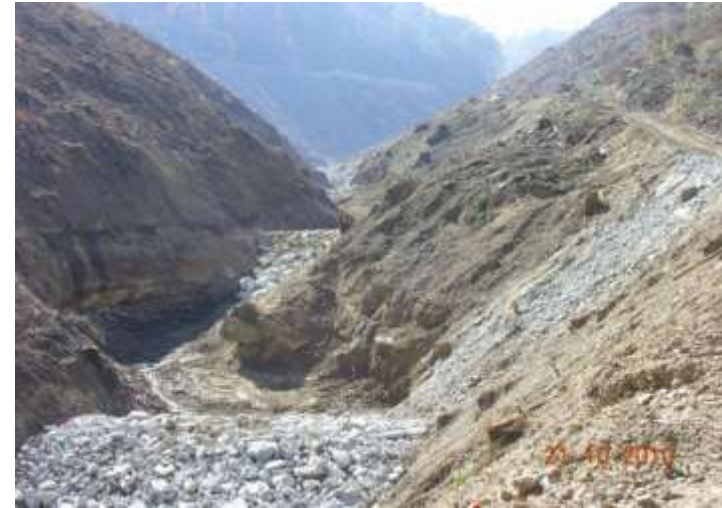
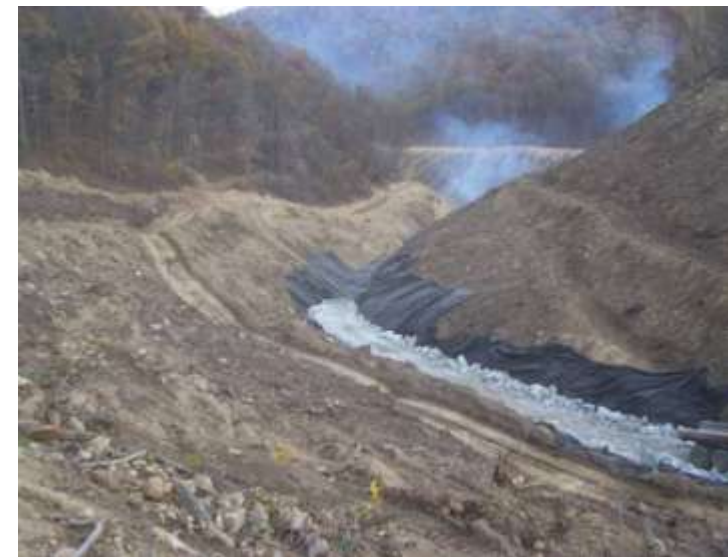
Check dams and wrapped underdrain

- *Nine (9) check dams*
- *Wrap 4,200' of underdrain with filter fabric*

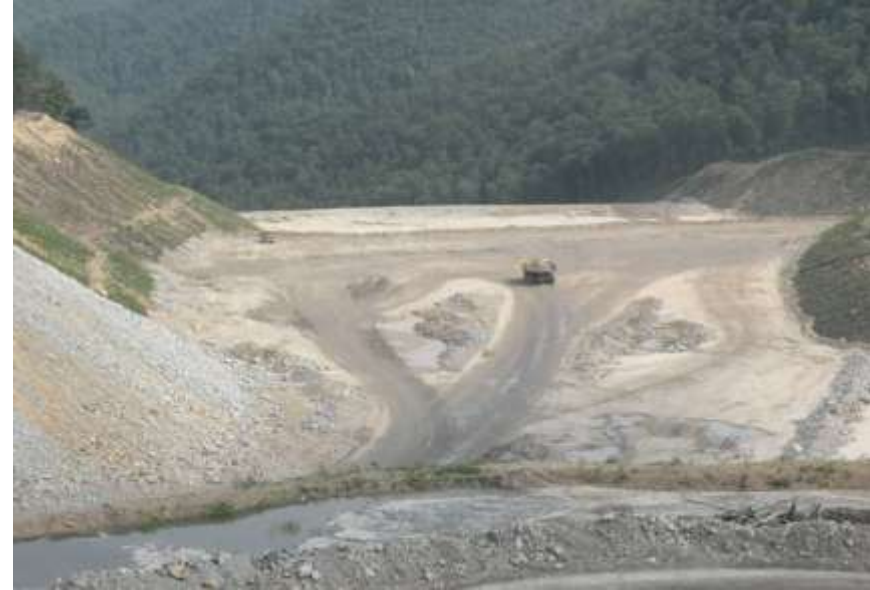
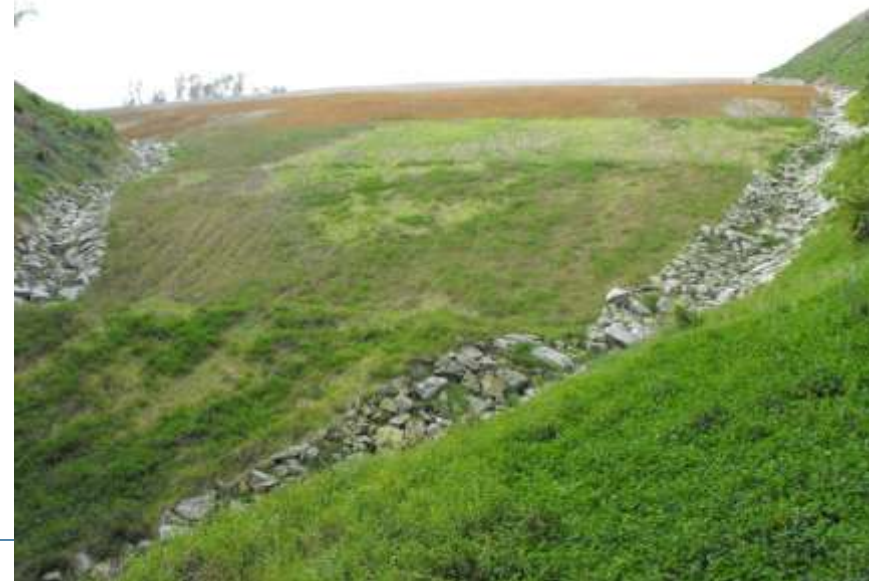
Fifth Bench Level Elev. - 1375'

- Compact and slope 5% to west side
- 1,900' underdrain daylights on 5th bench

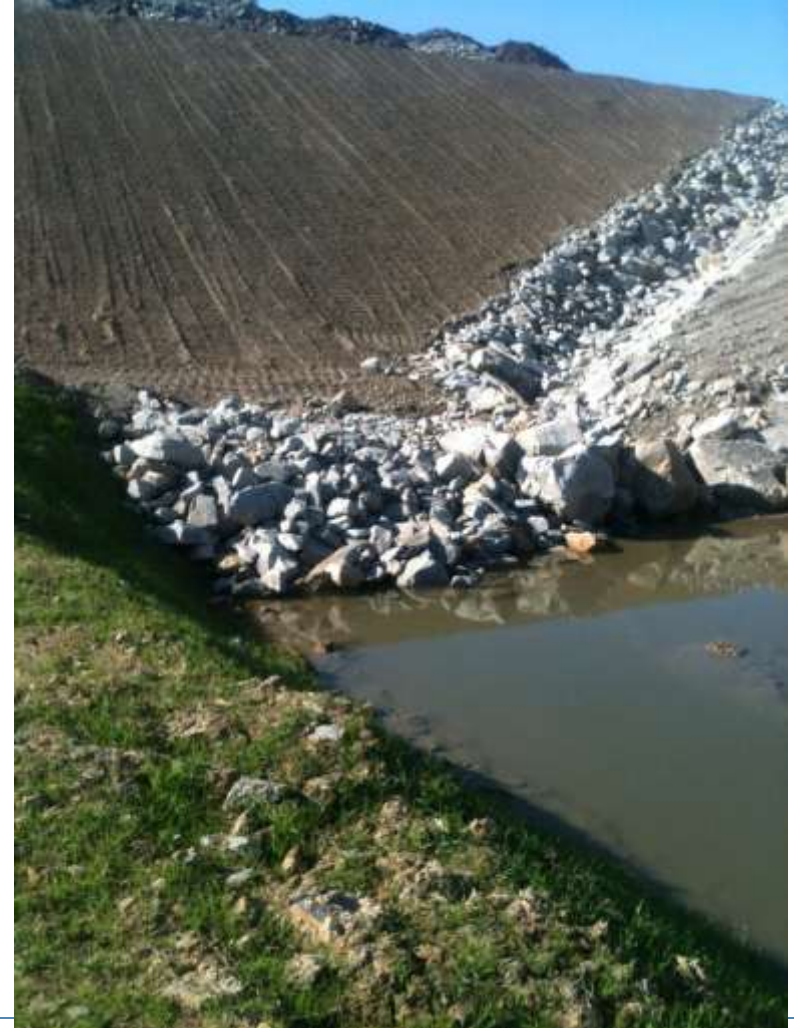
Coalburg level - 1595'

6,500' pavement underdrain daylights into sediment ditch

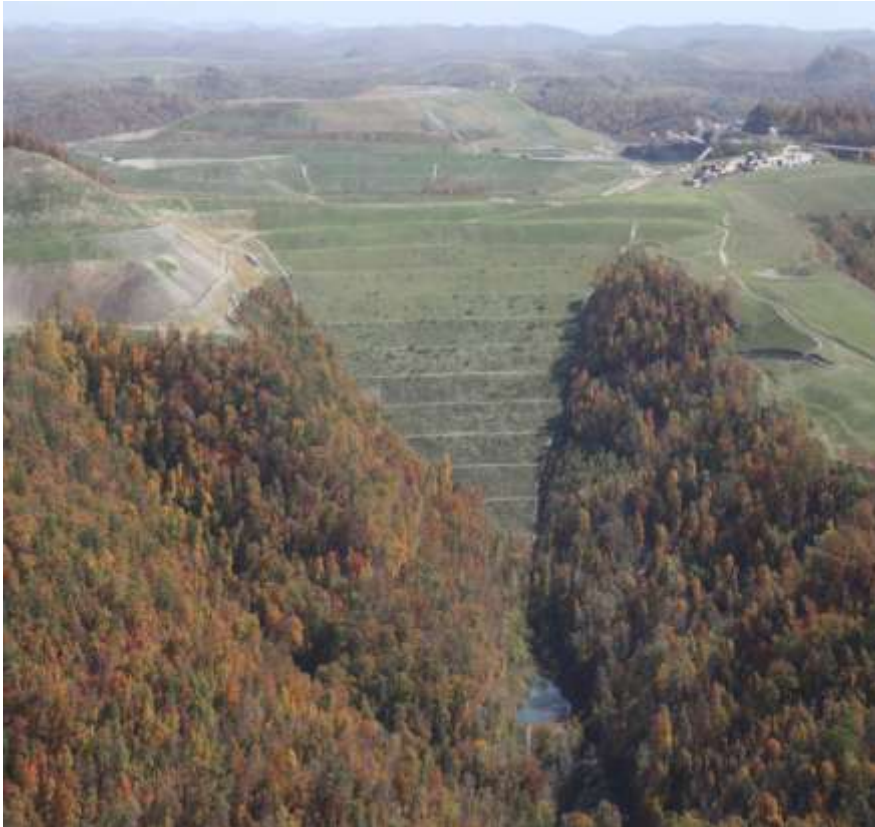
- Nearby Valley Fill 4
 - Approx. 9 MM cu yds

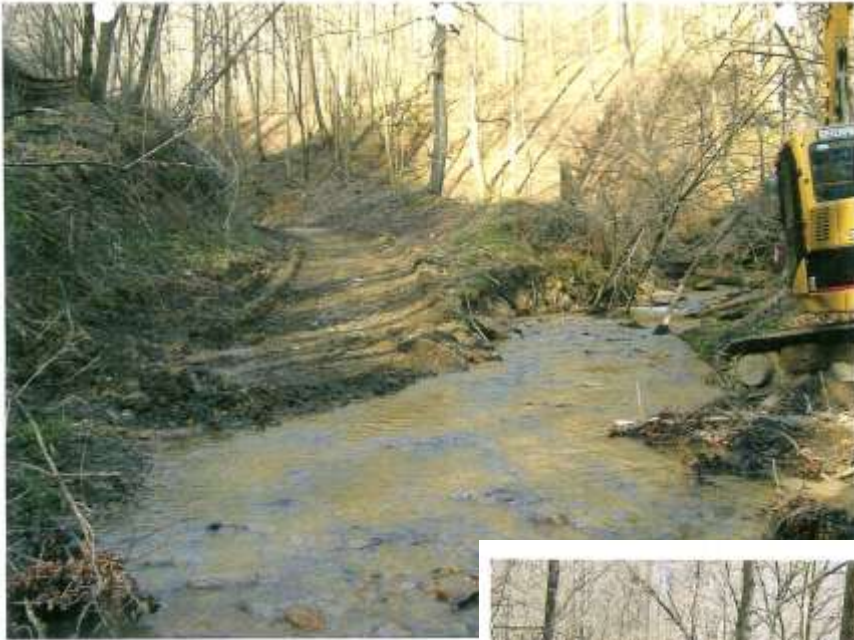
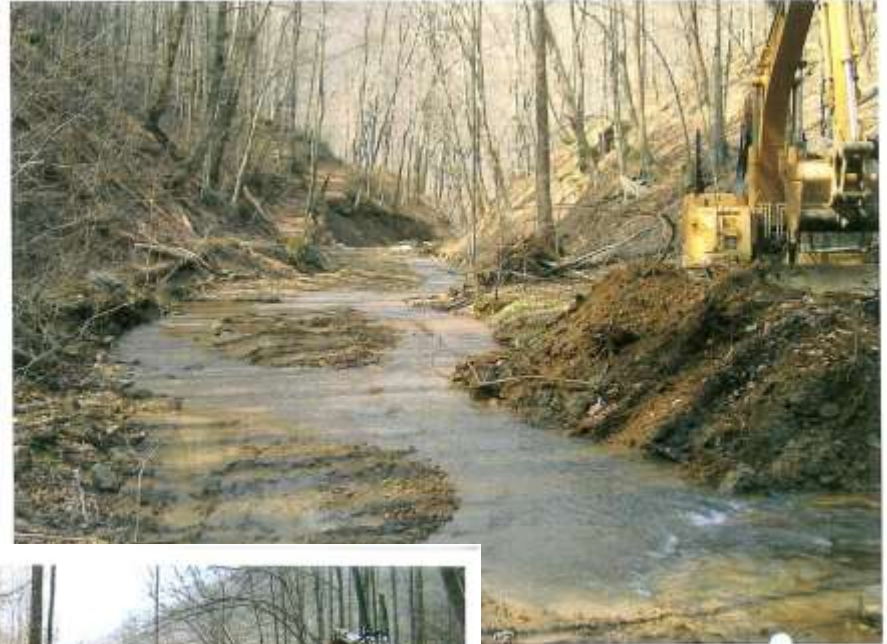
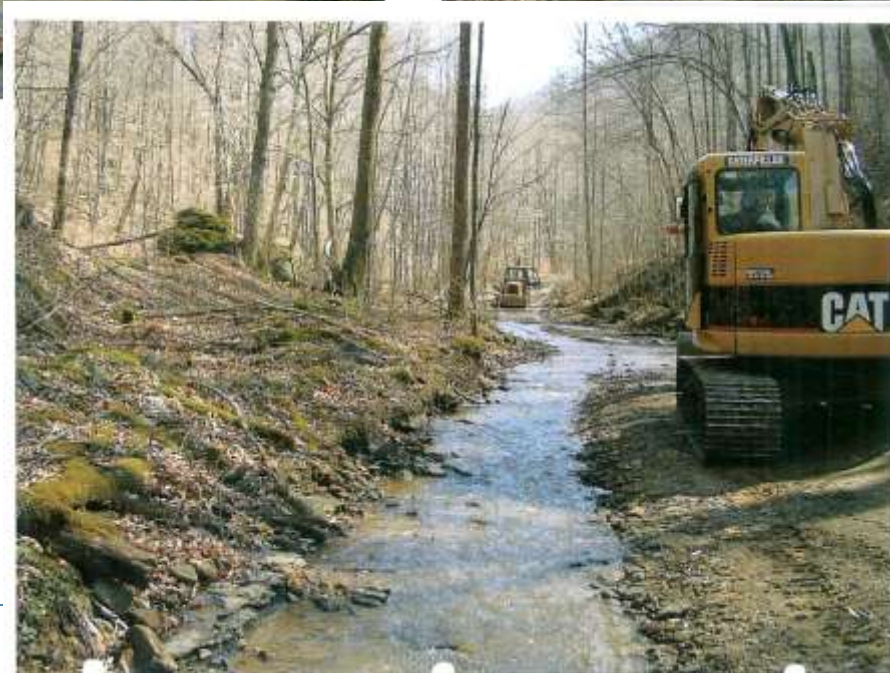
Existing Gas well access road through stream

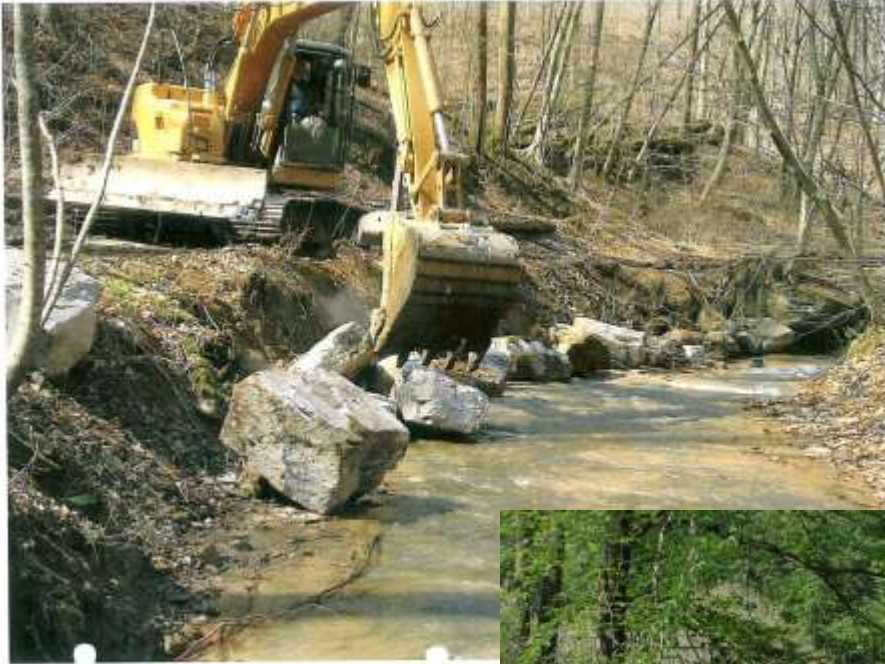
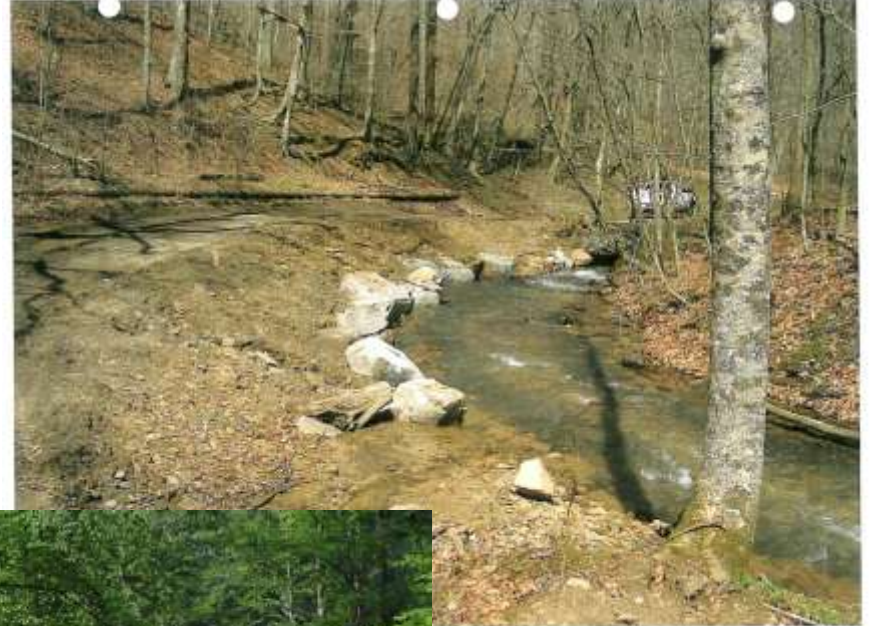
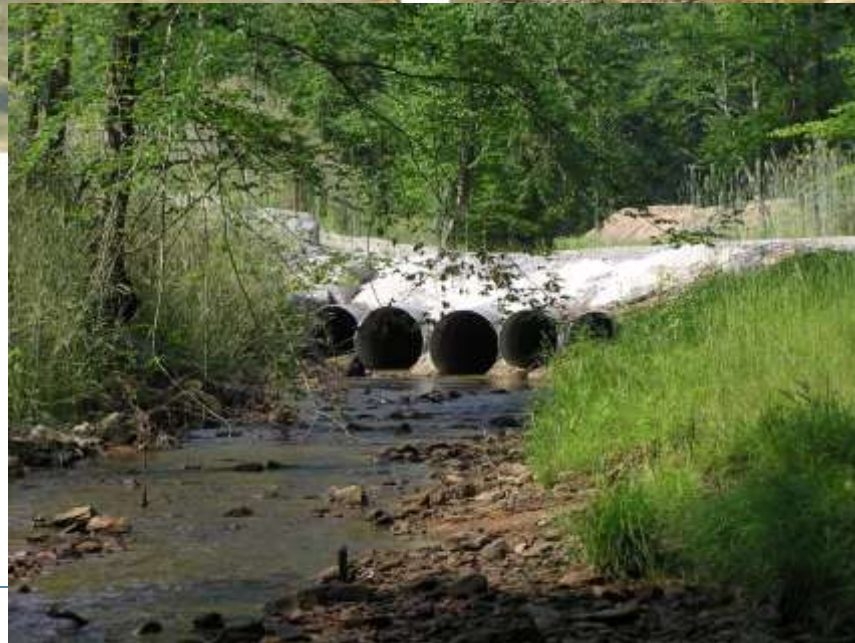
Road construction and stream crossing

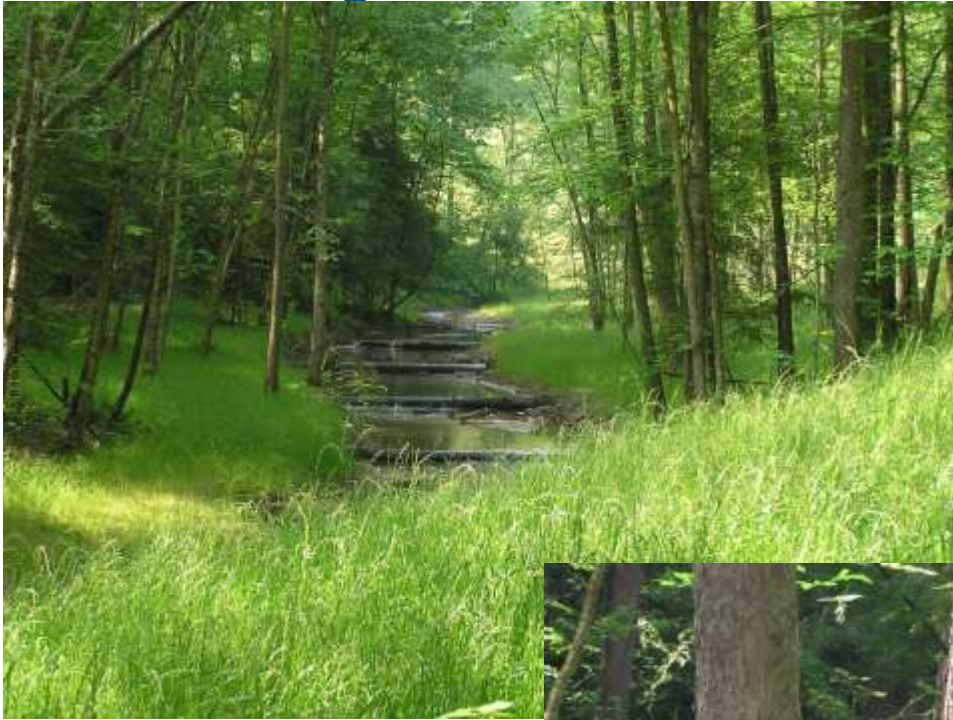
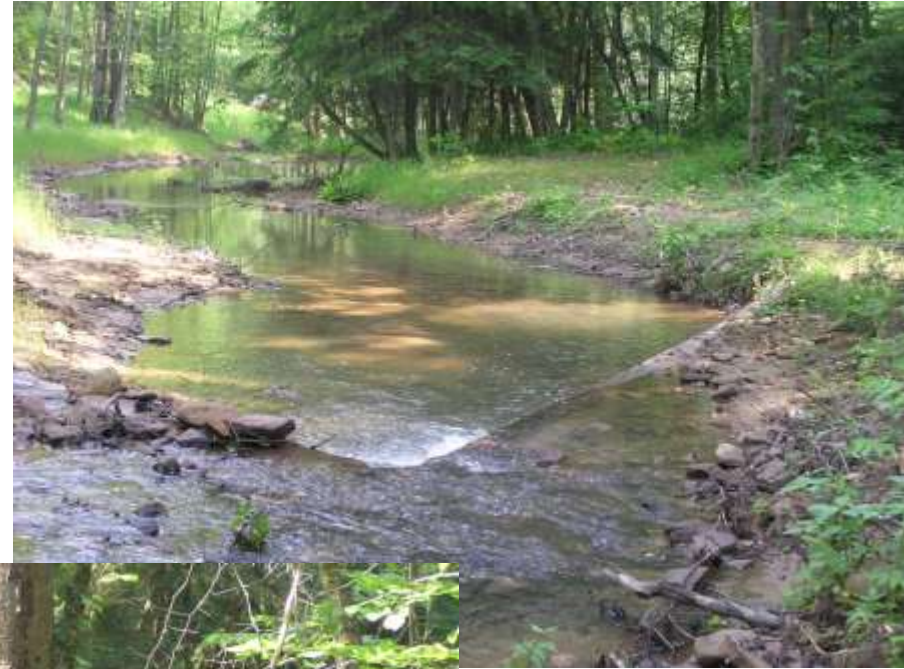
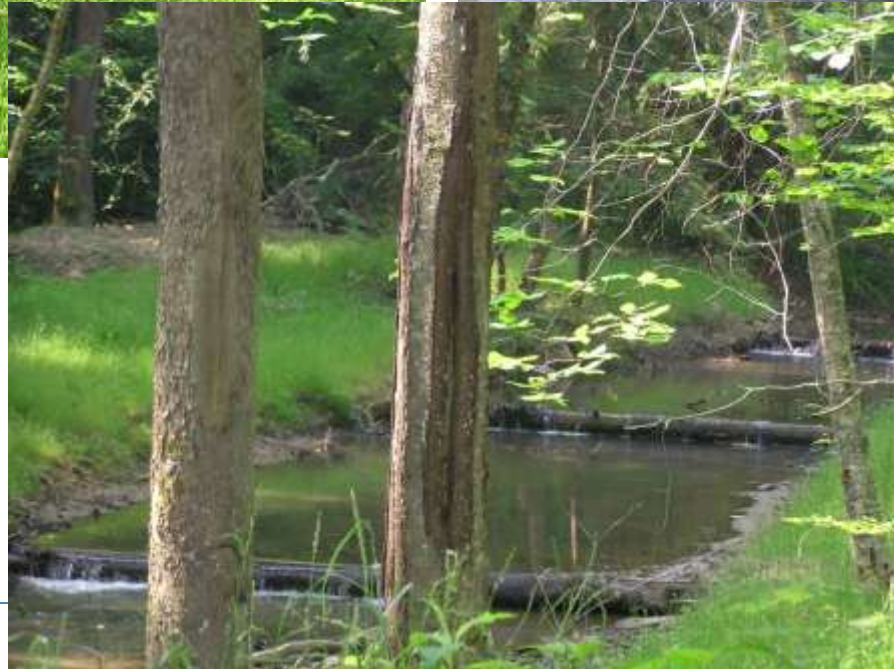
Mitigated Stream – Left Fork of Pine Creek

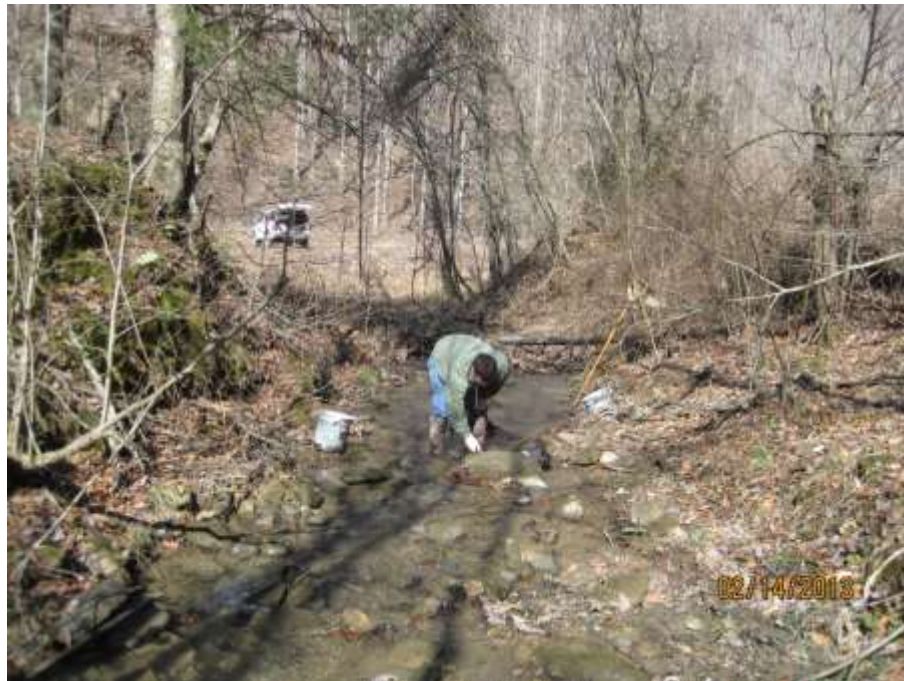
Site BF 1&2

TDS range 32 mg/l – 211 mg/l
WVSCI range 66.92 – 89.63

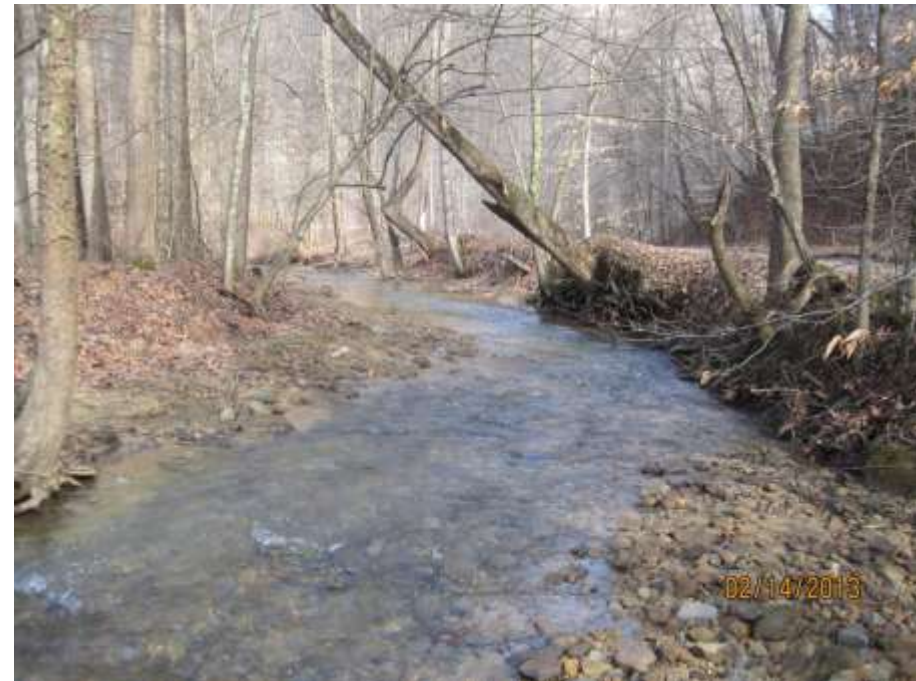
Site CMDLFPC

TDS range 244 mg/l – 587 mg/l
WVSCI range 55.95 – 83.10

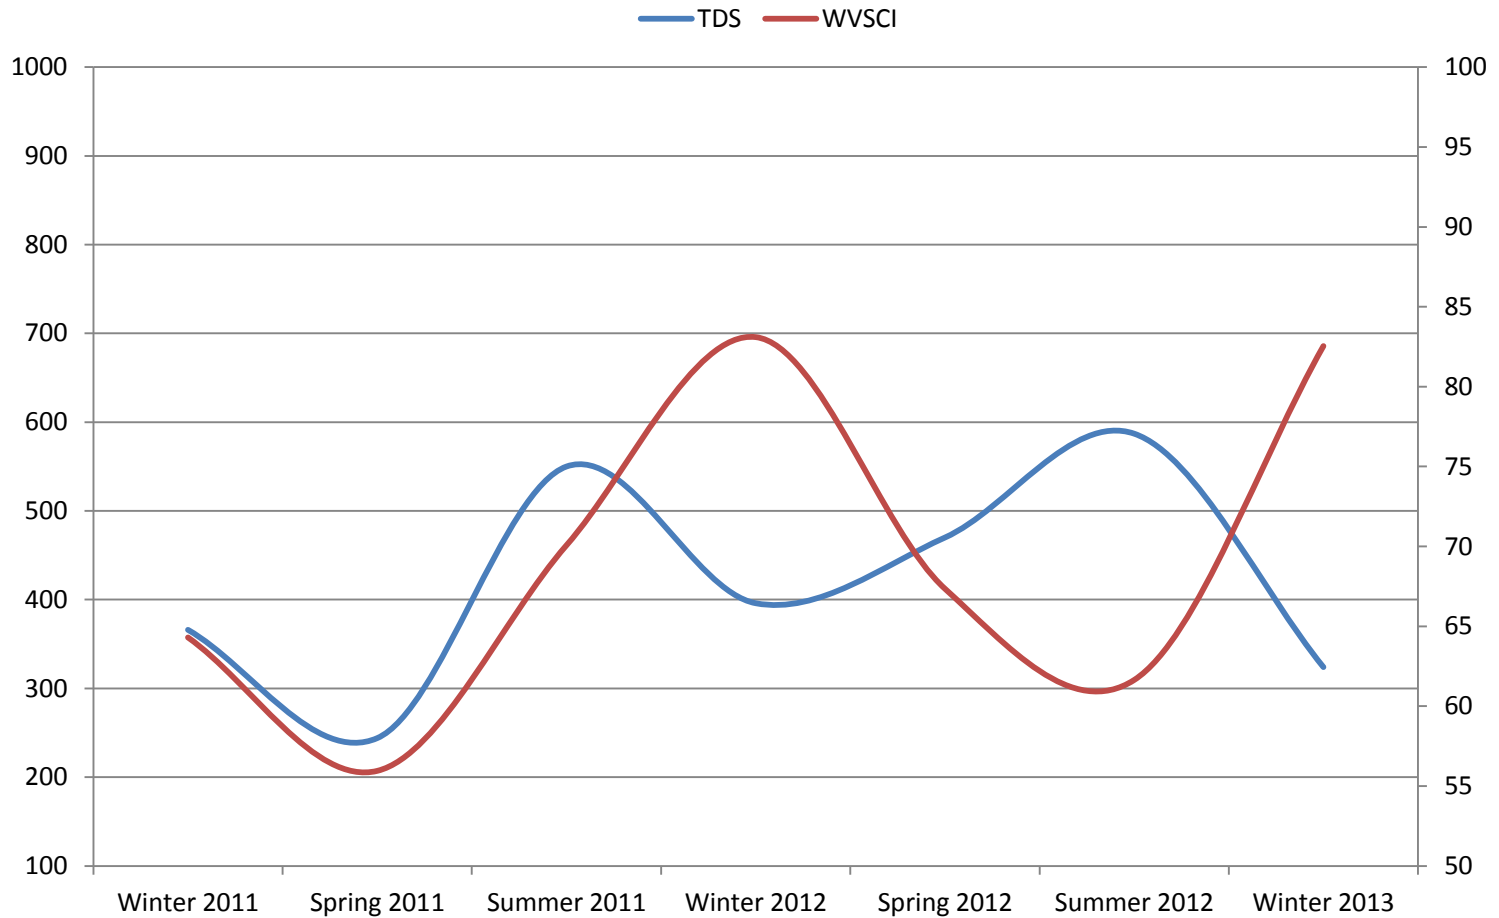
Site WVDLFPC Graph of TDS vs. WVSCI

- Conductivity has remained below required levels during construction of Fill 1 for past two (2) years.
- Based on this success, US COE, in co-operation with US EPA, has authorized construction of second valley fill.
- The work performed in this watershed has not resulted in a change in the WVSCI. No real correlation between Conductivity and WVSCI can be determined.
