Influences on Mine Water Quality that are not Related to Acid Mine Drainage

Robel Gebrekristos and Graham Trusler

Digby Wells Environmental

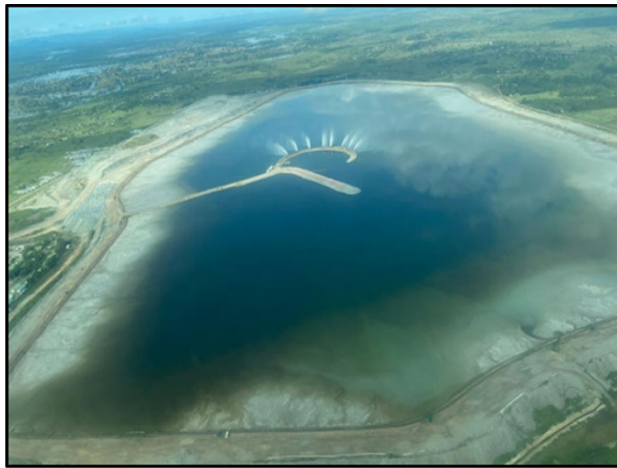
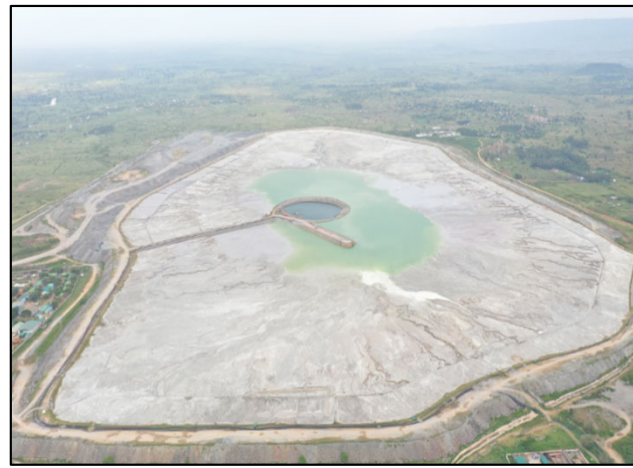
TSF before (left) and after (right) pool reduction

- Biological sampling was instituted to monitor the influence of discharges, and chemical sampling was systematised for the same reasons
- The highly concentrated brine was stored in double lined ponds for evaporation, further treatment, and blending to reduce volumes
- The mine is now operating in a controlled and safe manner with respect to water storage, provision and discharge
- The water in the TSF pool is now at 50 000 m³, which is below its design capacity of 800 000 m³ and way below the 7 000 000 m³ it used to store 3 years earlier.
