Evaluation and Redesign of Wetland/ALD Passive System in North Fork of the Blackwater River, WV

Robert Hedin¹, Katherine Linnell², George Watzlaf¹, Naomi Anderson¹

WALD Passive Treatment Redesign

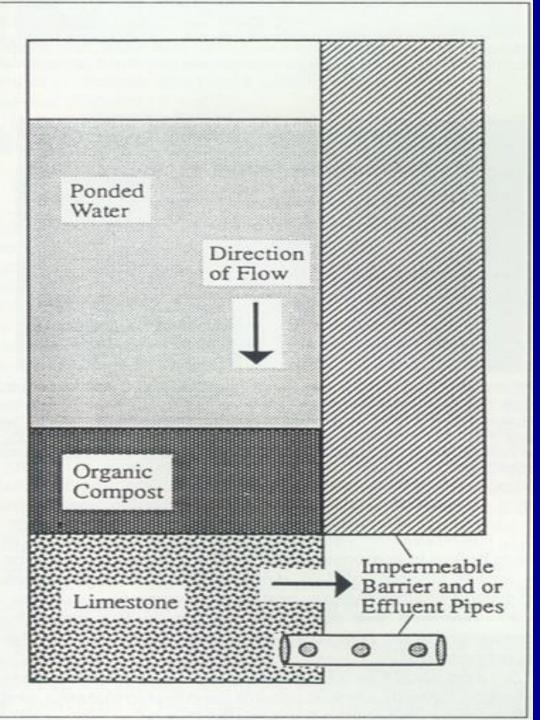
Side View

WALD –
Alkalinity-Producing
System

Idea to push the Water down through Organic compost then into Limestone.

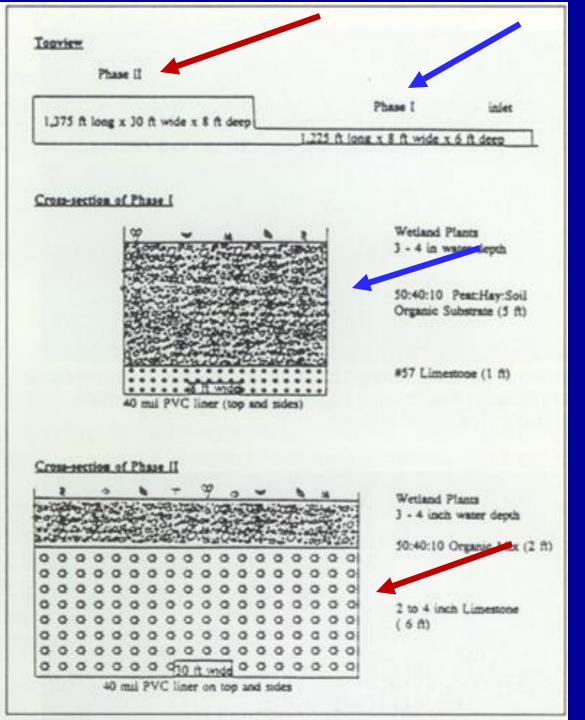
Construction Specs

Topview shows overall dimensions.

Cross-section of

Phase I (8-ft wide) (Organic)

Phase II (30-ft wide) Limestone

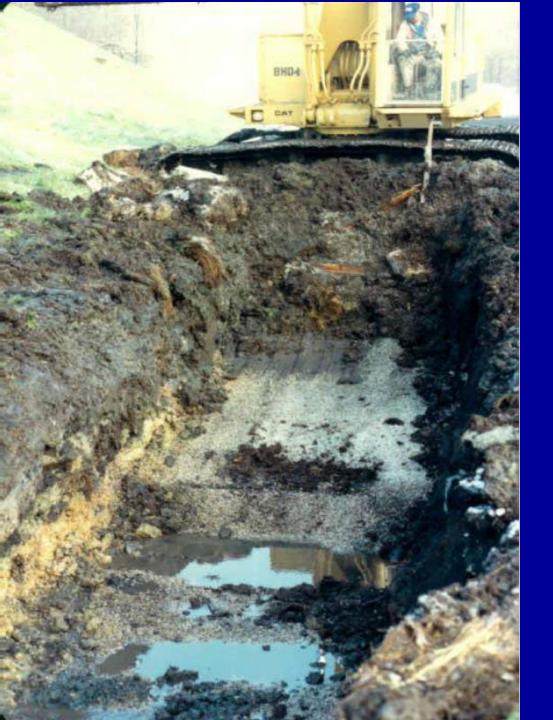
Phase I
8-ft Section

1,225 ft long

5 ft OM 1 ft LS

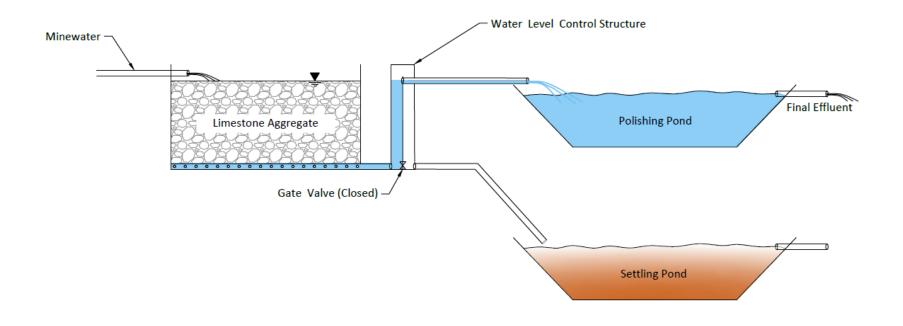
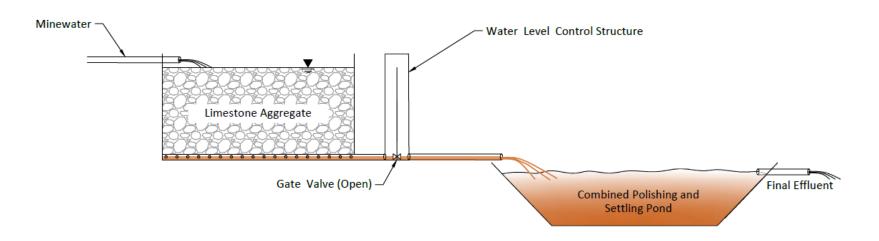
Drainable Limestone Bed Passive System

- Bed of limestone aggregate, open to atmosphere
- Formation of Al, Fe, and Mn oxyhydroxides is encouraged
- Bed is regularly drained empty which removes portion of solids
- Draining eliminates permeabilty issues and prolongs the reactivity of the limestone by years
- Eventually the limestone must be cleaned

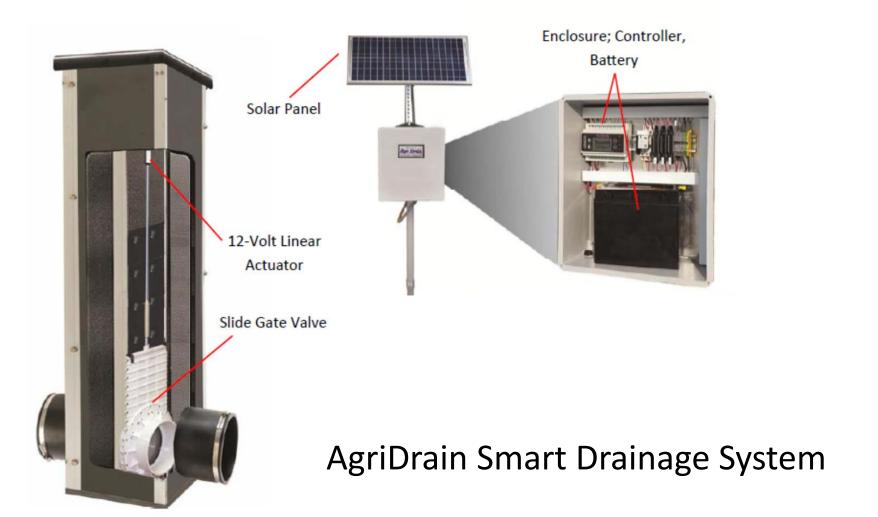
Agri Drain Smart Drainage System (solar powered computer controlled gate valve)

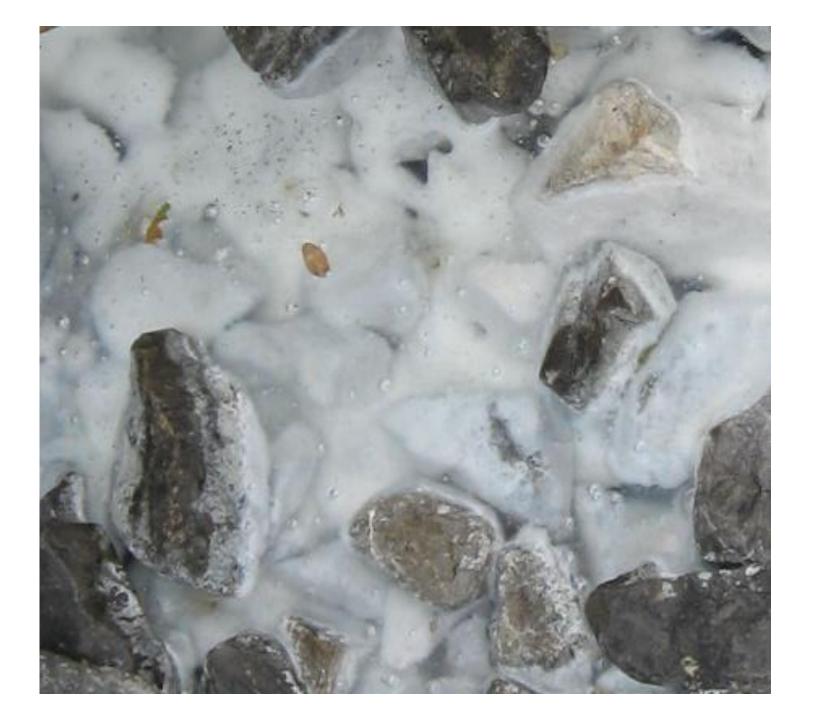
Pittsburgh Botanic Garden DLB solids basin

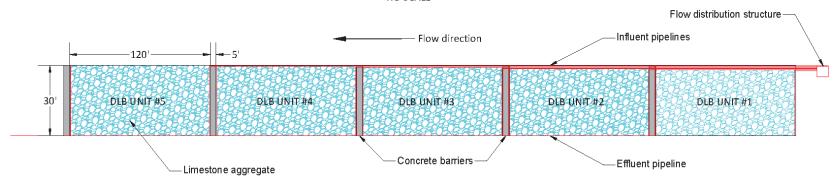
DLB Unit Profile

No Scale

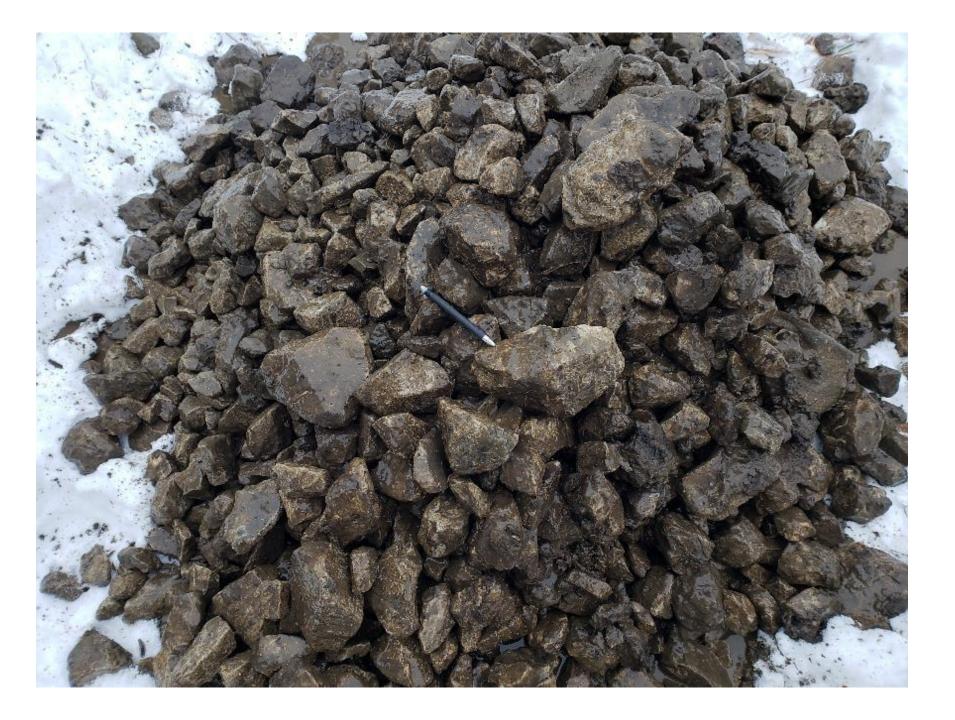
Limestone collected from WALD (Jan 2019)

CaCO ₃	90.5%
MgCO ₃	3.2%
Fe ₂ O ₃	0.3%
MnO ₂	<0.1%
SiO ₂	0.4%
Al ₂ O ₃	0.1%

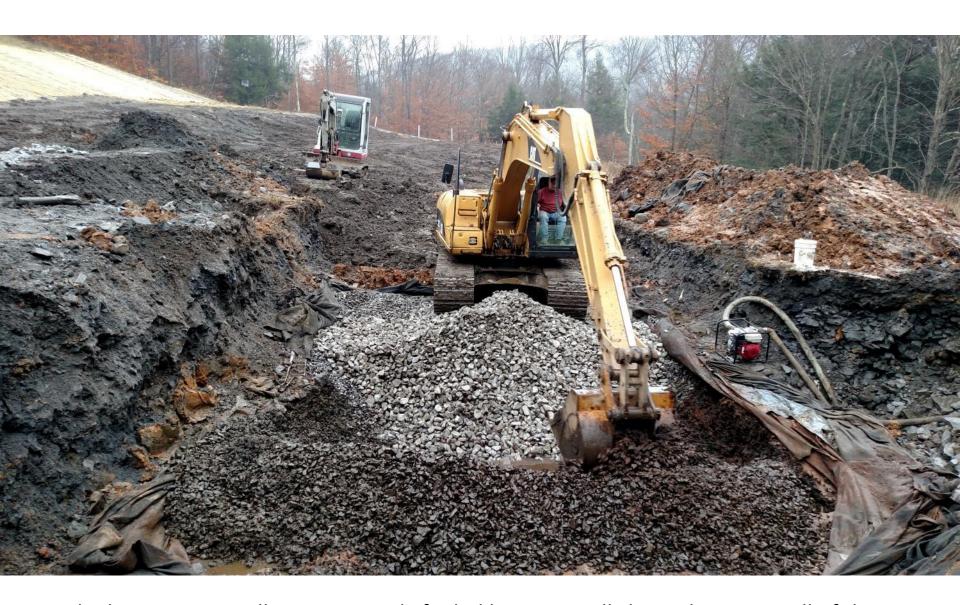
The limestone in Cell C was severely fouled but it was all cleaned. Moving all of the solids out of the bed was a challenge.

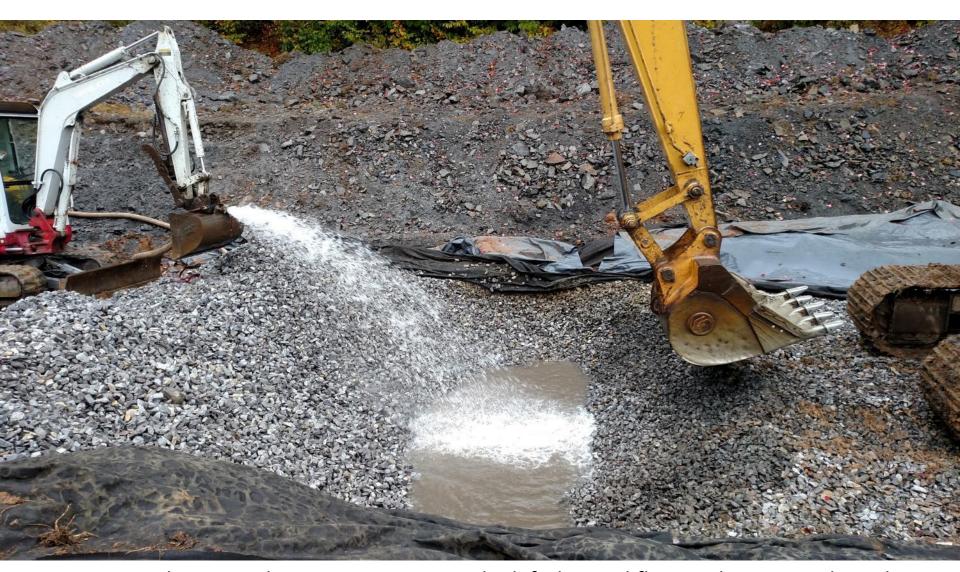
Limestone cleaning. The mini excavator on the left directed flow as the 315 on the right mixed the stone. Water flowed out of the bed through the flush pipes on the bottom.

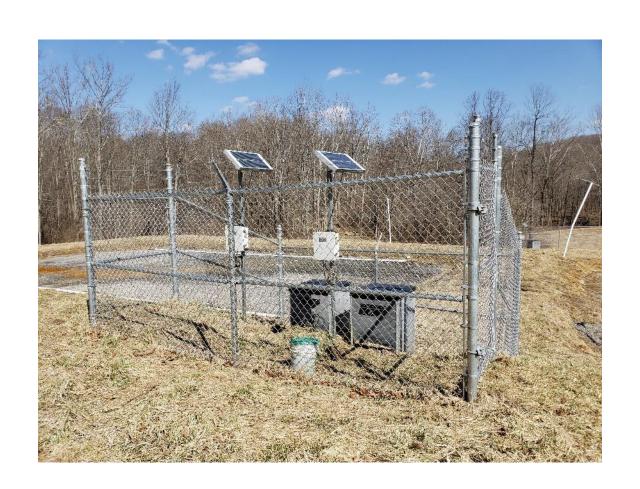
Flow distribution structure

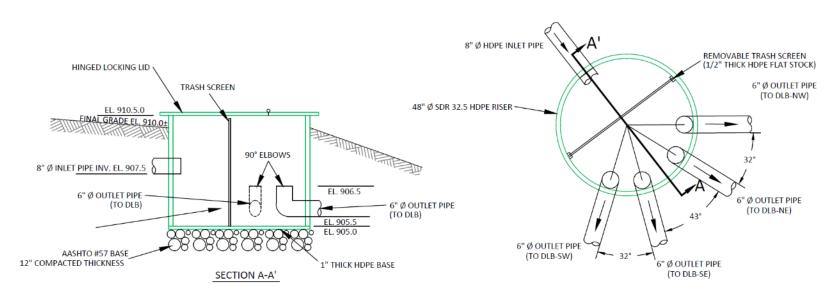
Inlet Distribution Structure

NOT TO SCALE
