Evaluation and Refurbishing Passive Treatment Systems

Presented by Tim Danehy, QEP & Ryan
Mahony

West Virginia Mine Drainage Task Force
40th Annual Meeting
May 26-27, 2019
Morgantown, WV

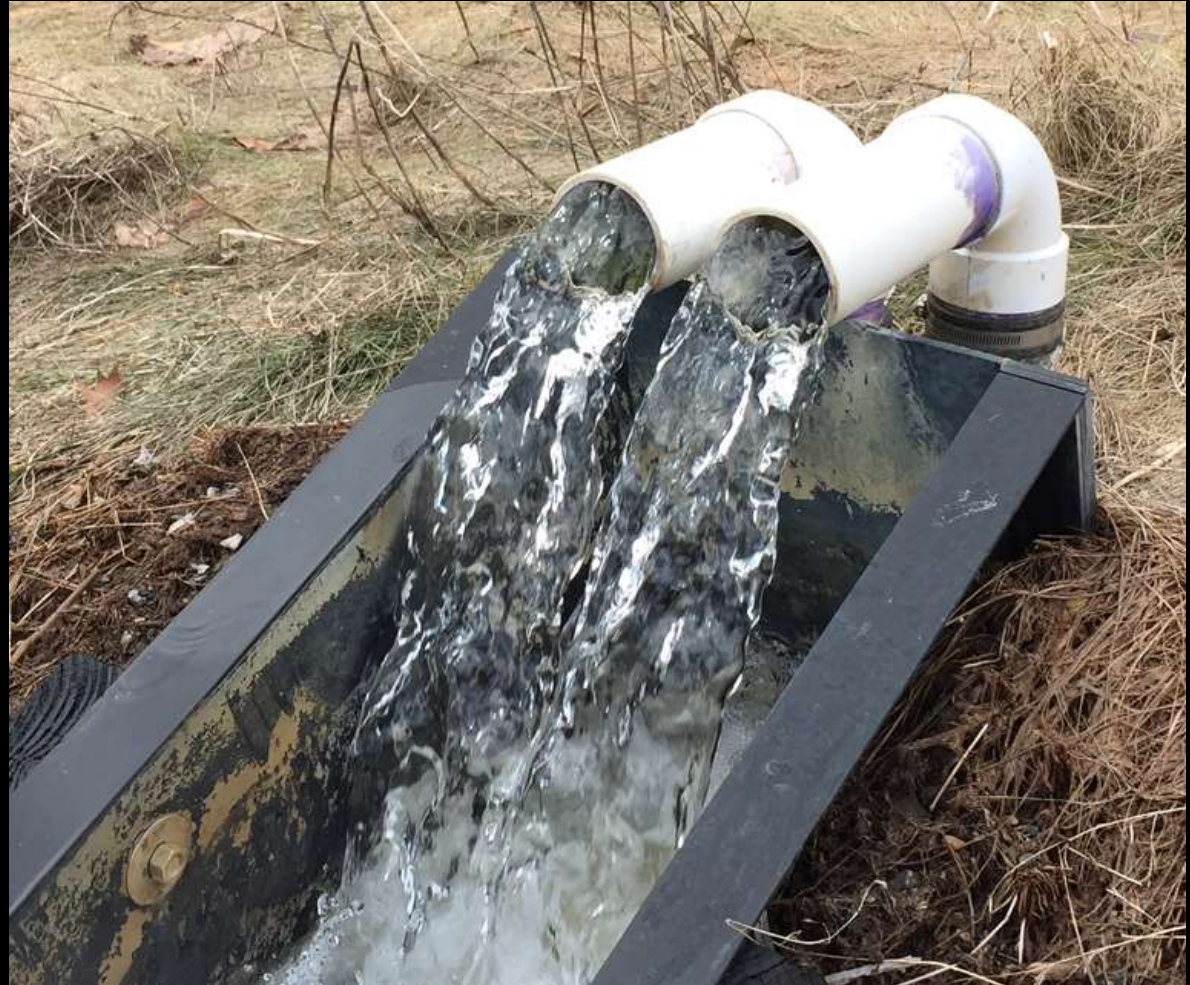
Why isn't my 30 gpm System Removing Mn?

- Design Flow: 30
- Design Mn Load: 14 lb/day
- Actual flow ~200 gpm
 - (Two 3" pipes flowing full)
- Mn in: 15.4 mg/L
- Mn Out: 8.4 mg/L
- Mn Load Removed: 17 lb/d
- System “over performing” 20%
- “Normal” Mn out: ~2 mg/L

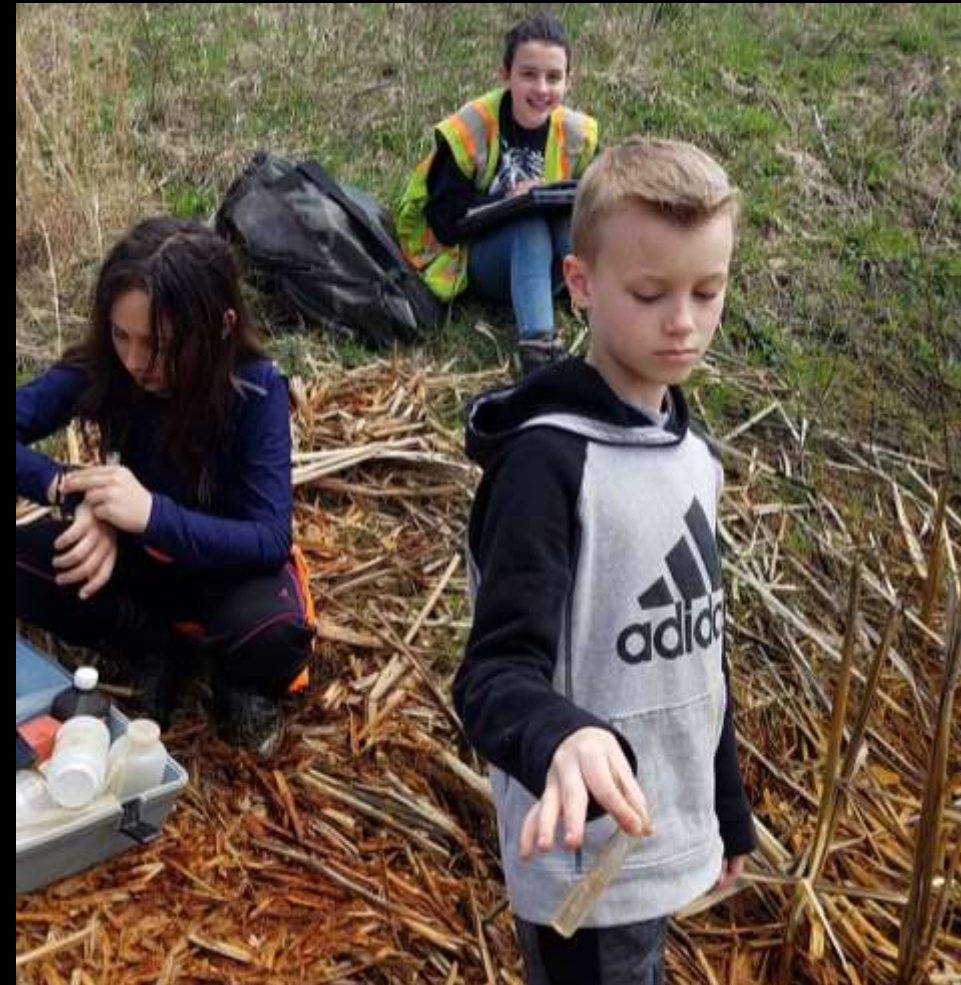
But What is it Supposed to Do?

- Design Flow: 110 gpm
- Actual Flow: 196 gpm (178%)
 - (Previous measurement >400 gpm)
- Design Acid: 309 lb/day (max)
- Design Acid: 123 lb/day (avg)
- Actual Acid In: 669 lb/day (217%)
- Actual Acid Out: 226 lb/day
- Acid Removed: 443 lb/day
- OVER PERFORMING BY 43%

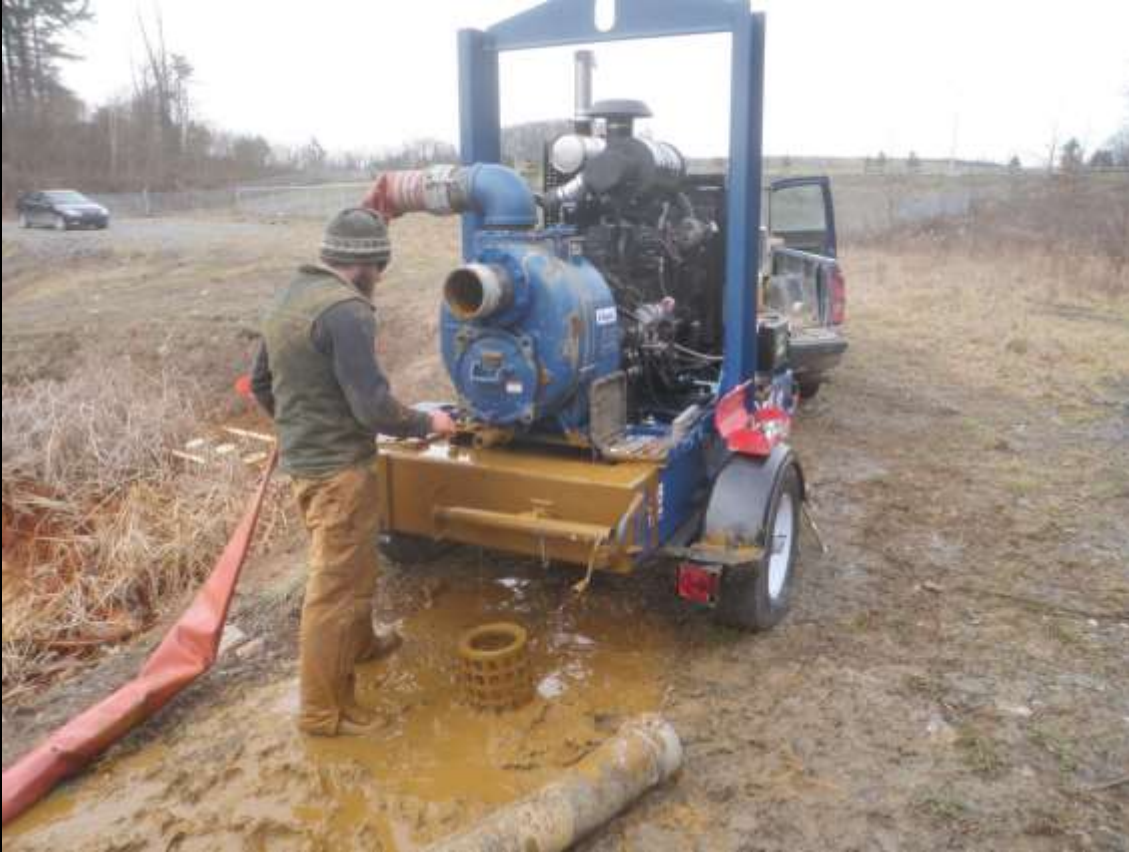
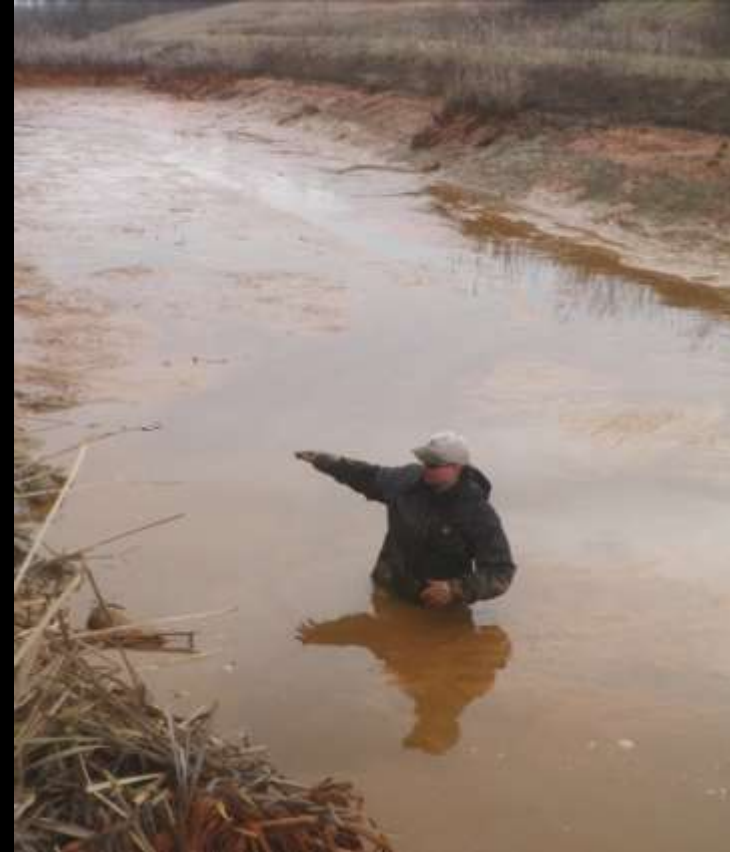
North Fork Montour Run 2013

Diesel powered 6 inch trash pump with intake hose

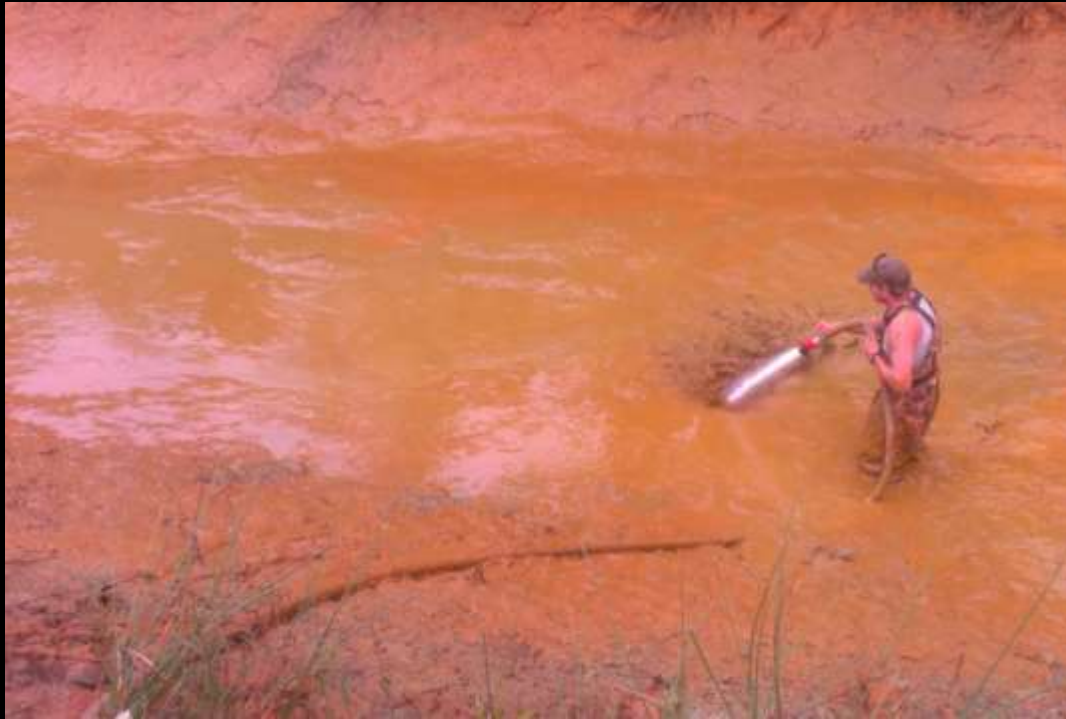
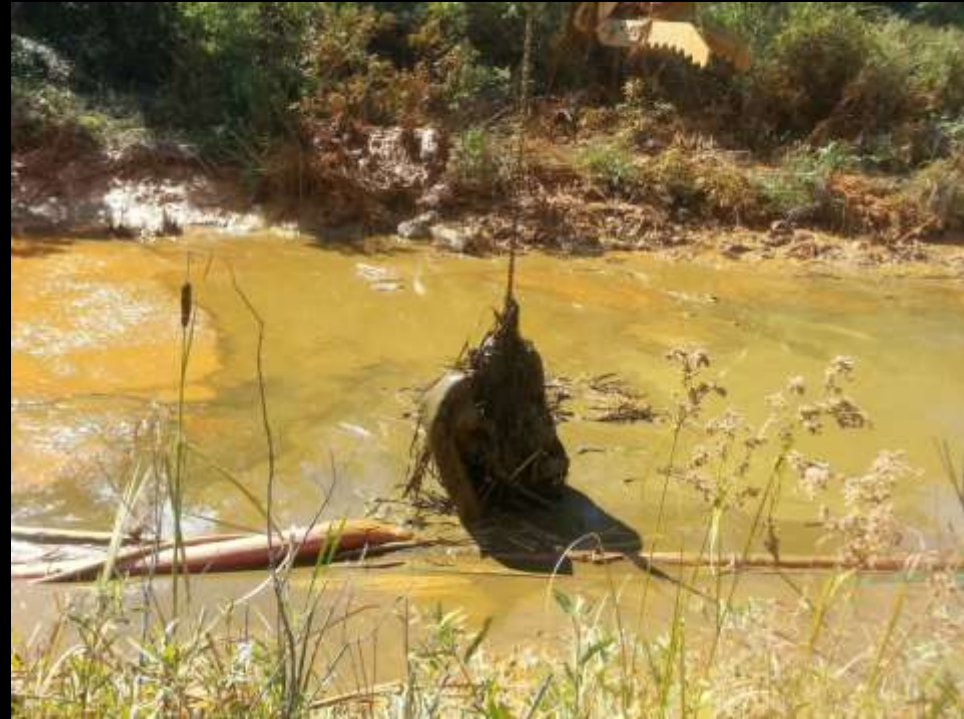
North Fork Montour Run 2013 Sludge Pump

Upgrade to 6" hydraulically driven shredder pump

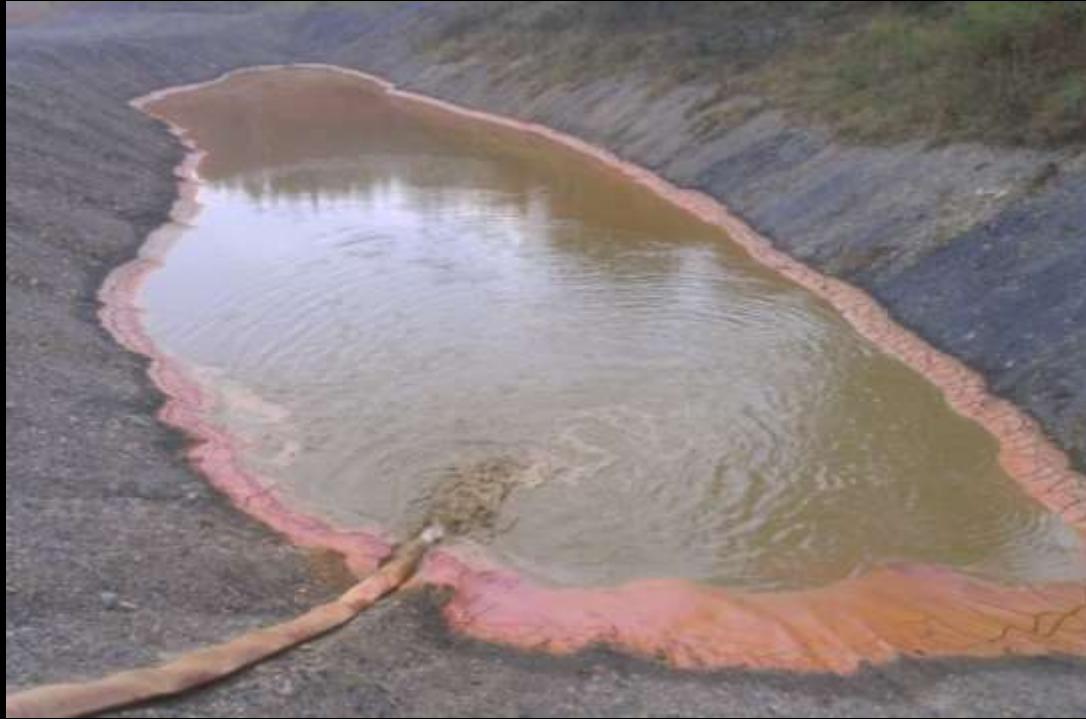
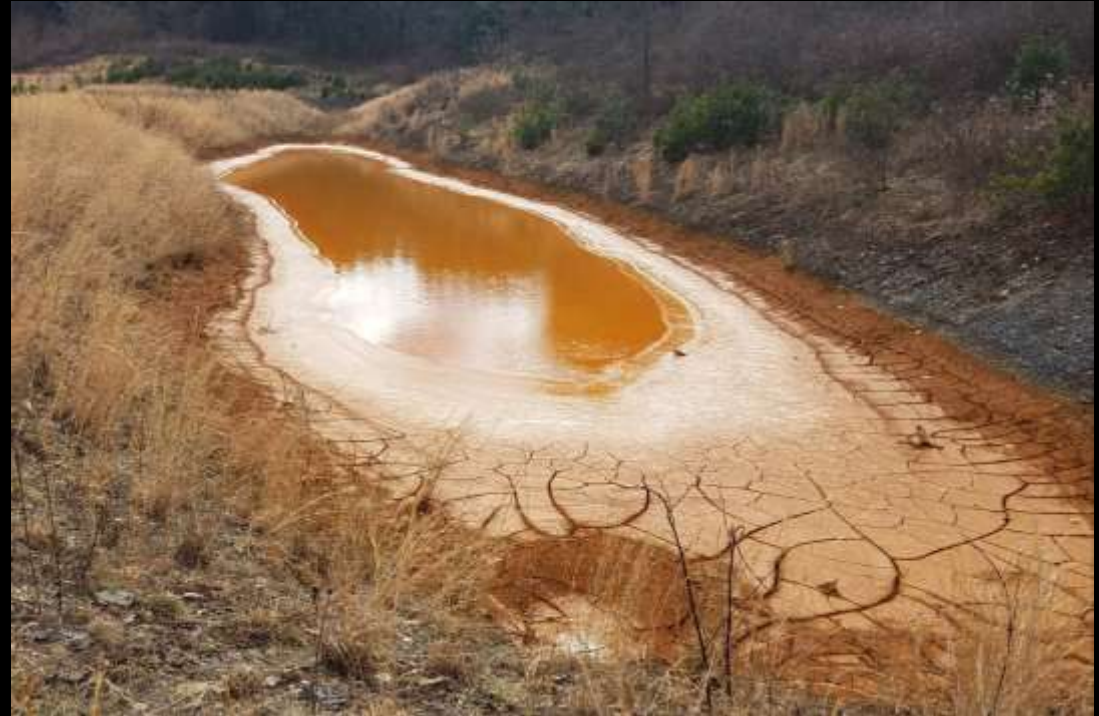
North Fork Montour Run 2013/2018 Sludge Pump

System design improvement- sludge drying pond

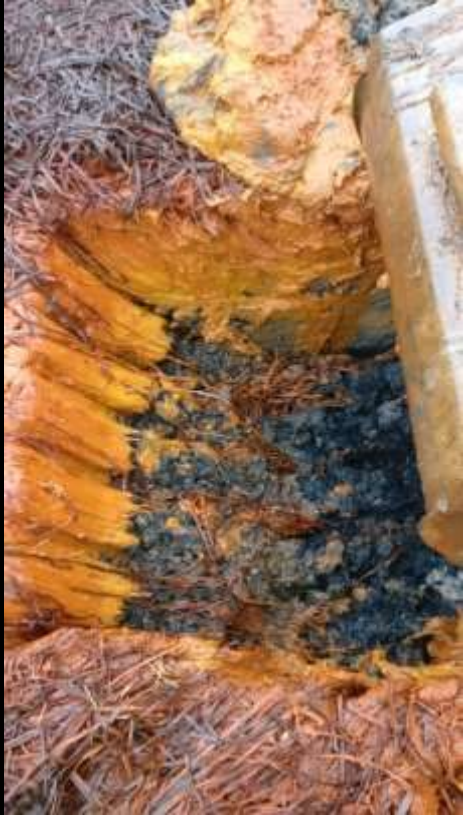
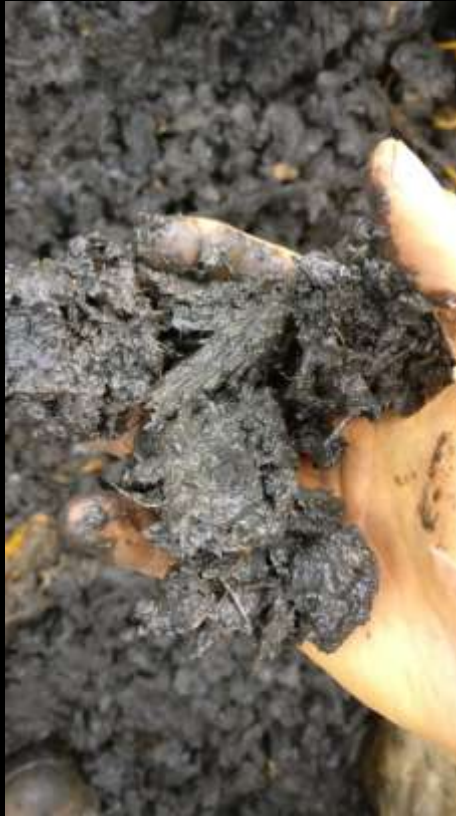
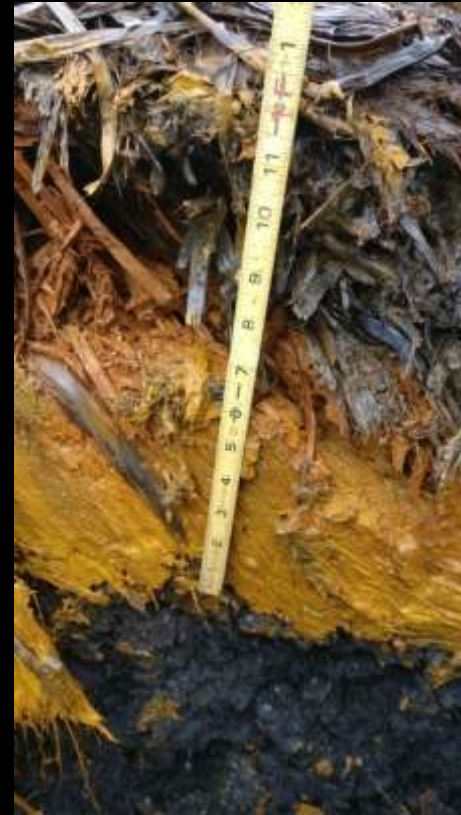
North Fork Montour Run 2018 Test Pits

Jennings-type vertical flow pond test pits

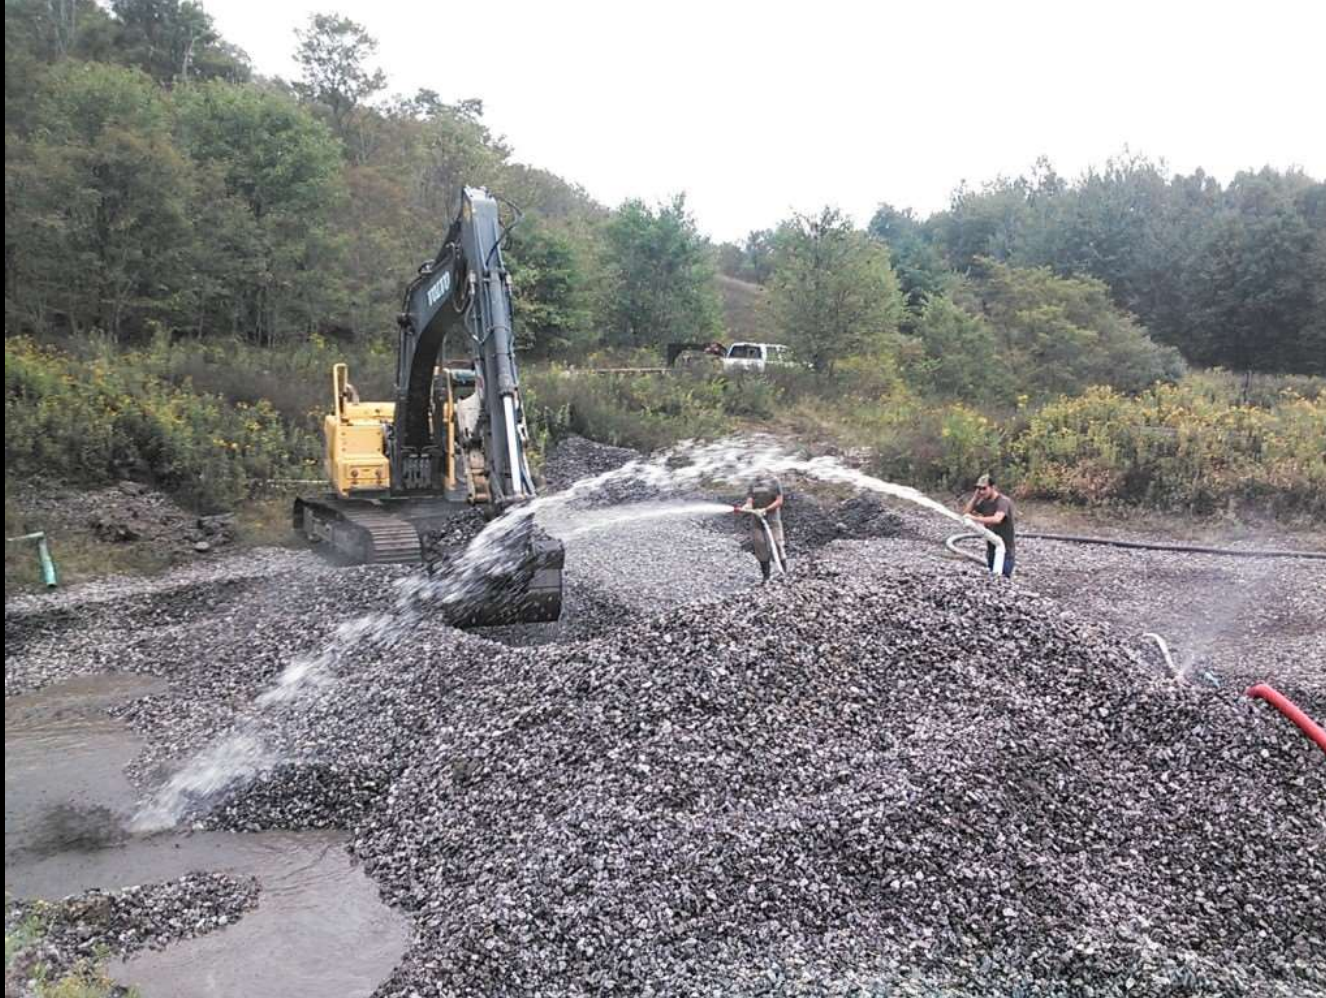
Bear Hill PTS 2013 Maintenance & Improvements

Auto-flushing (siphon) limestone pond with underdrain, stirred and washed

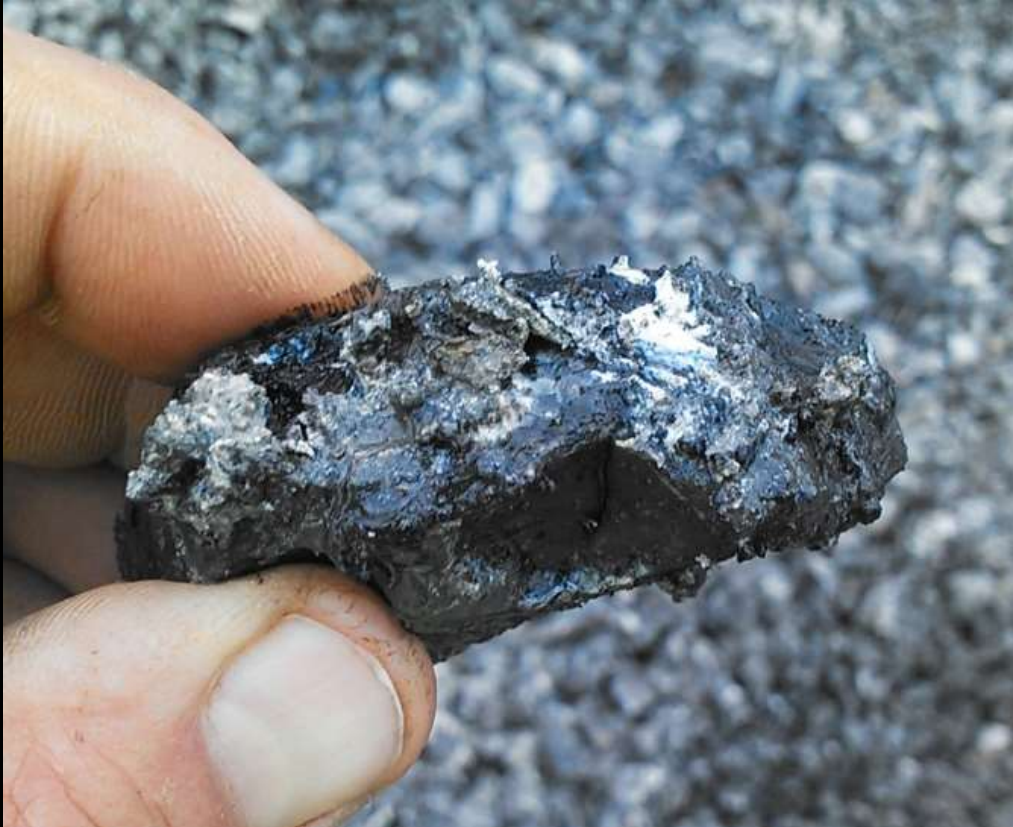
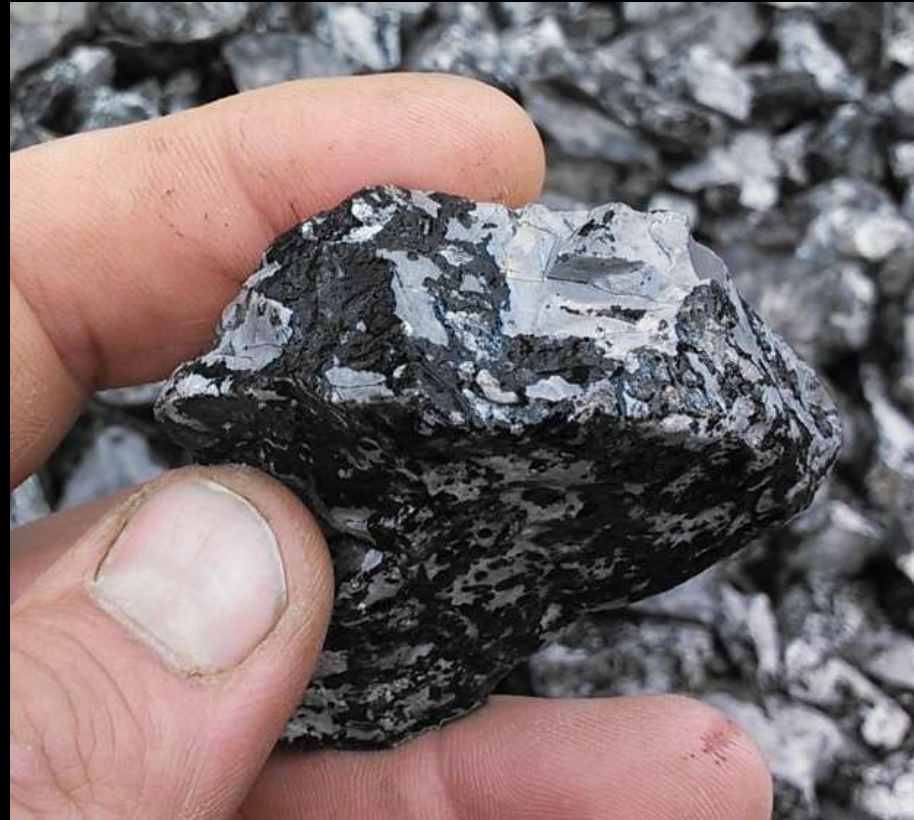
Bear Hill PTS 2013 Limestone

Wash or replace the media?

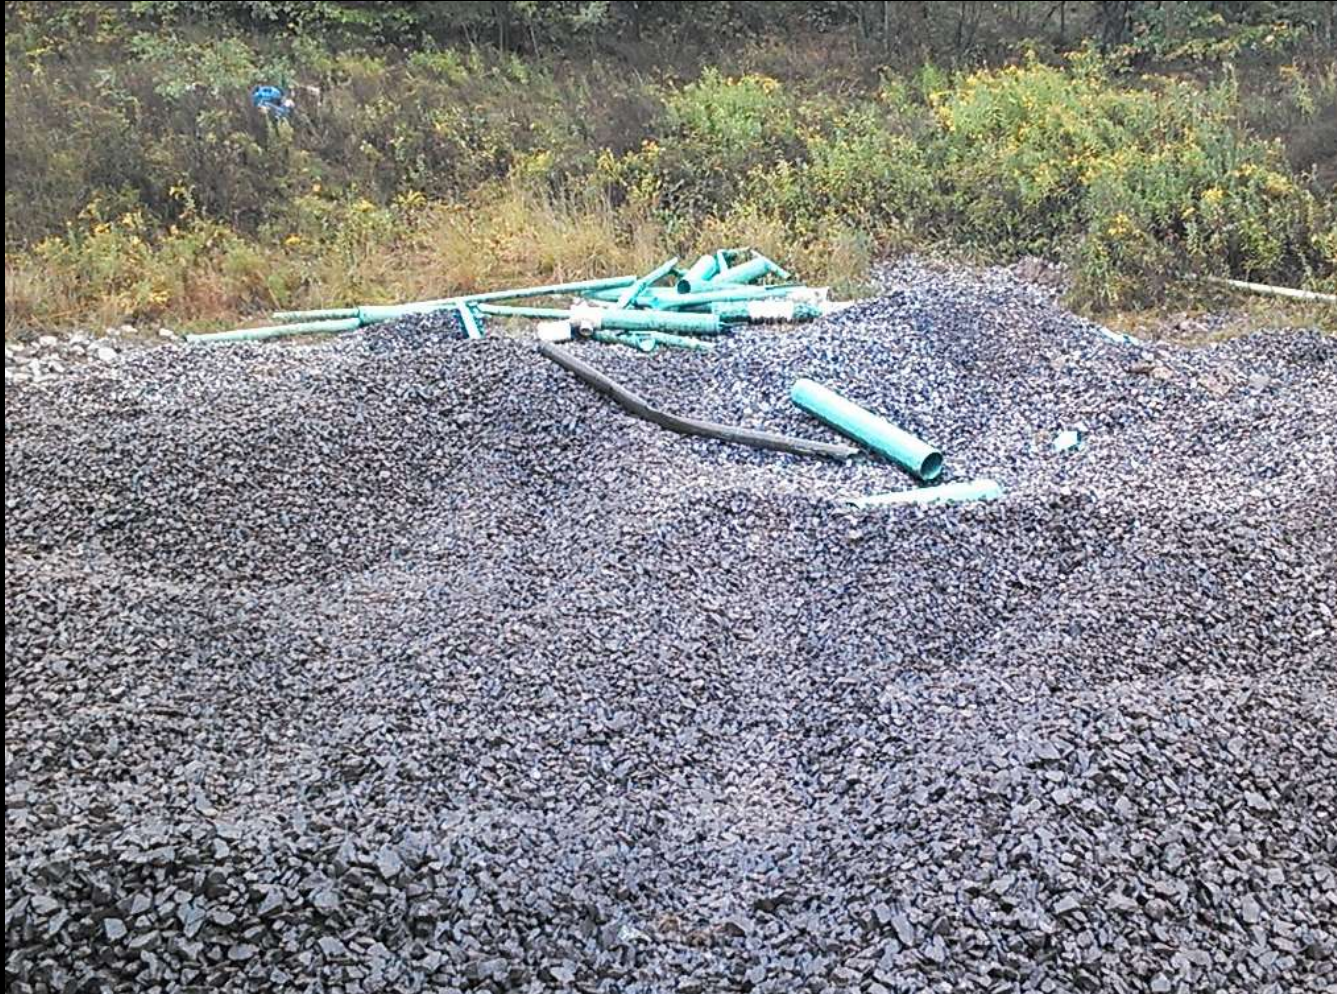
Bear Hill PTS 2013 Broken Underdrain

PVC pipe is a challenge to work around during maintenance

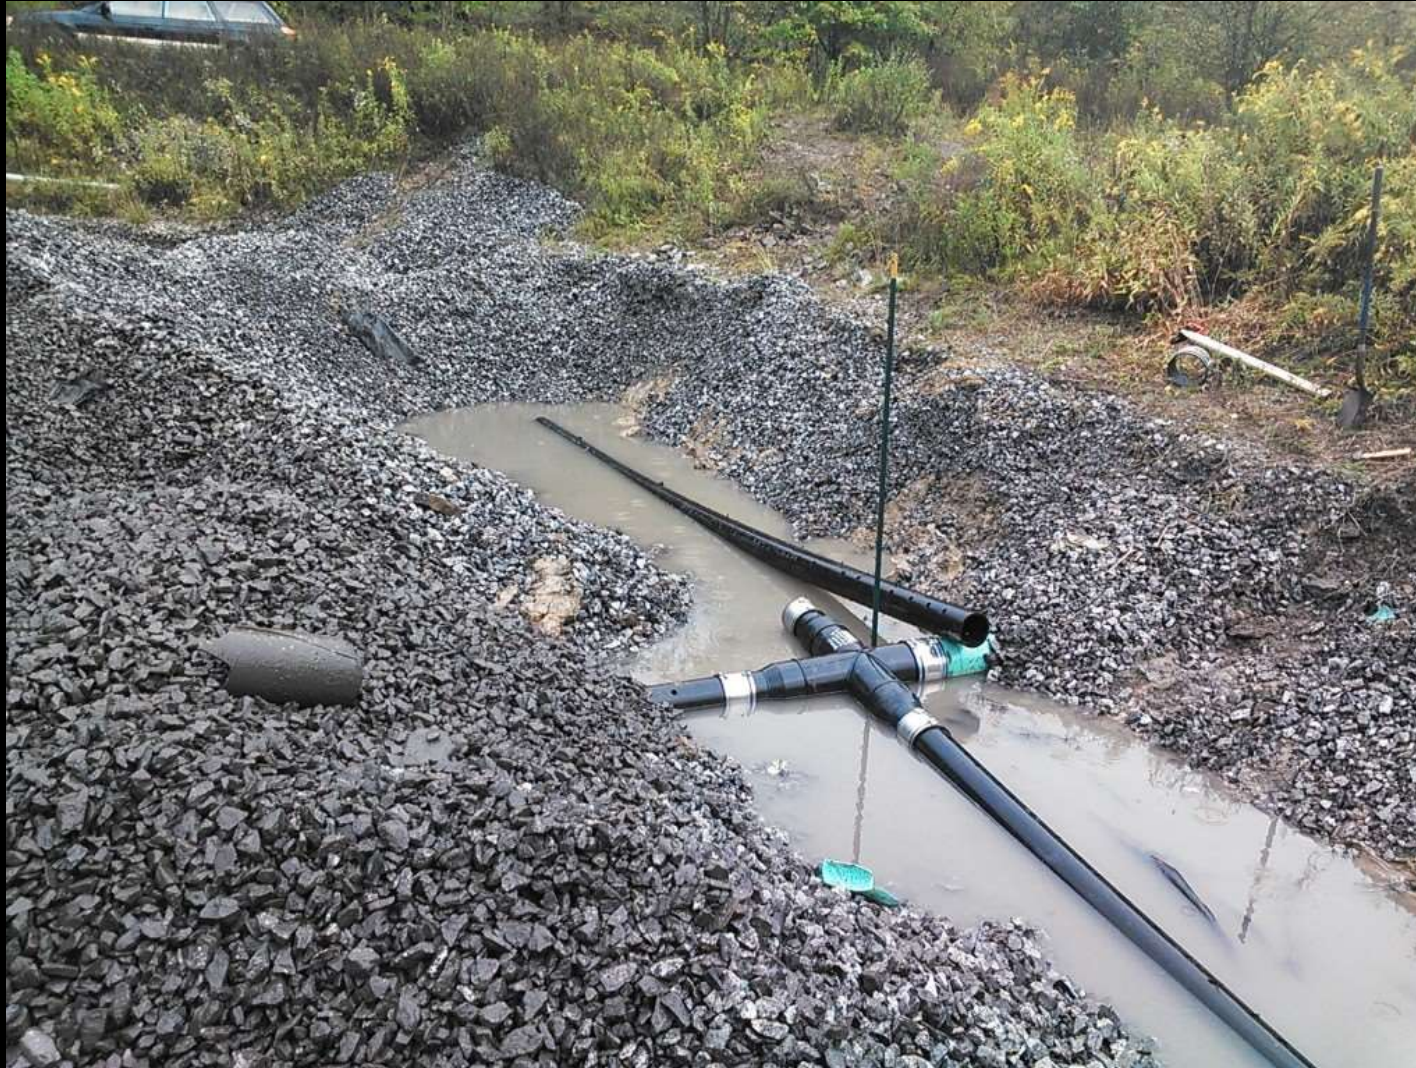
Bear Hill PTS 2013 Replaced Underdrain

Replaced SDR35 underdrain with perforated HDPE DR-17 (shielded ferncos)

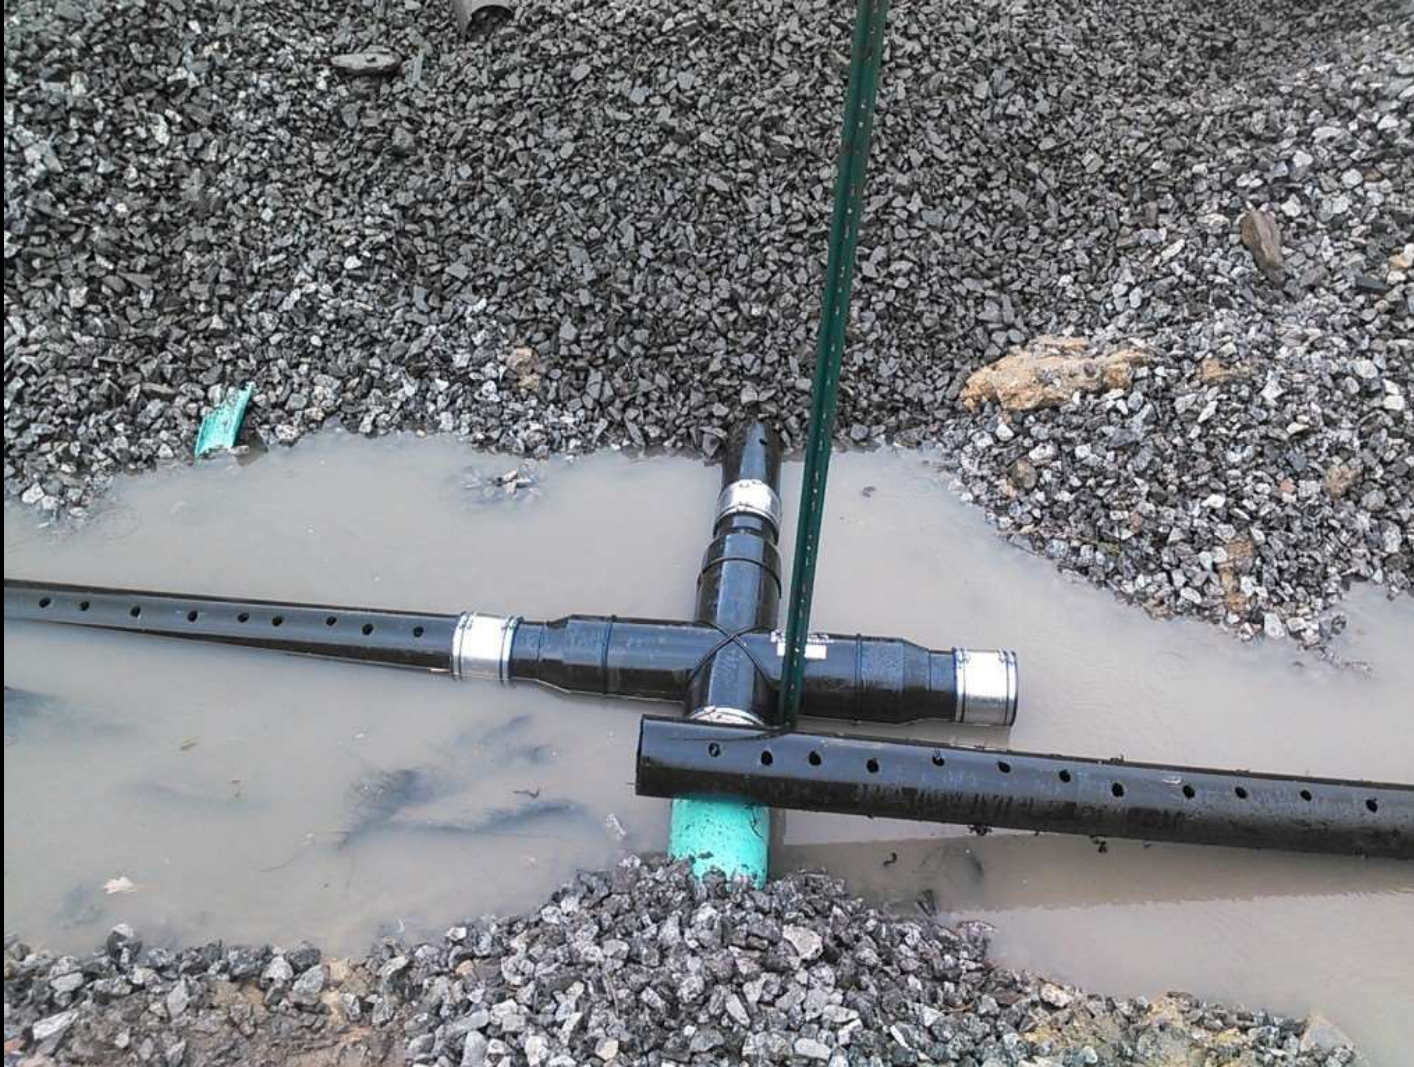
Bear Hill PTS 2013 New Underdrain- HDPE

T-posts to mark pipe junctions

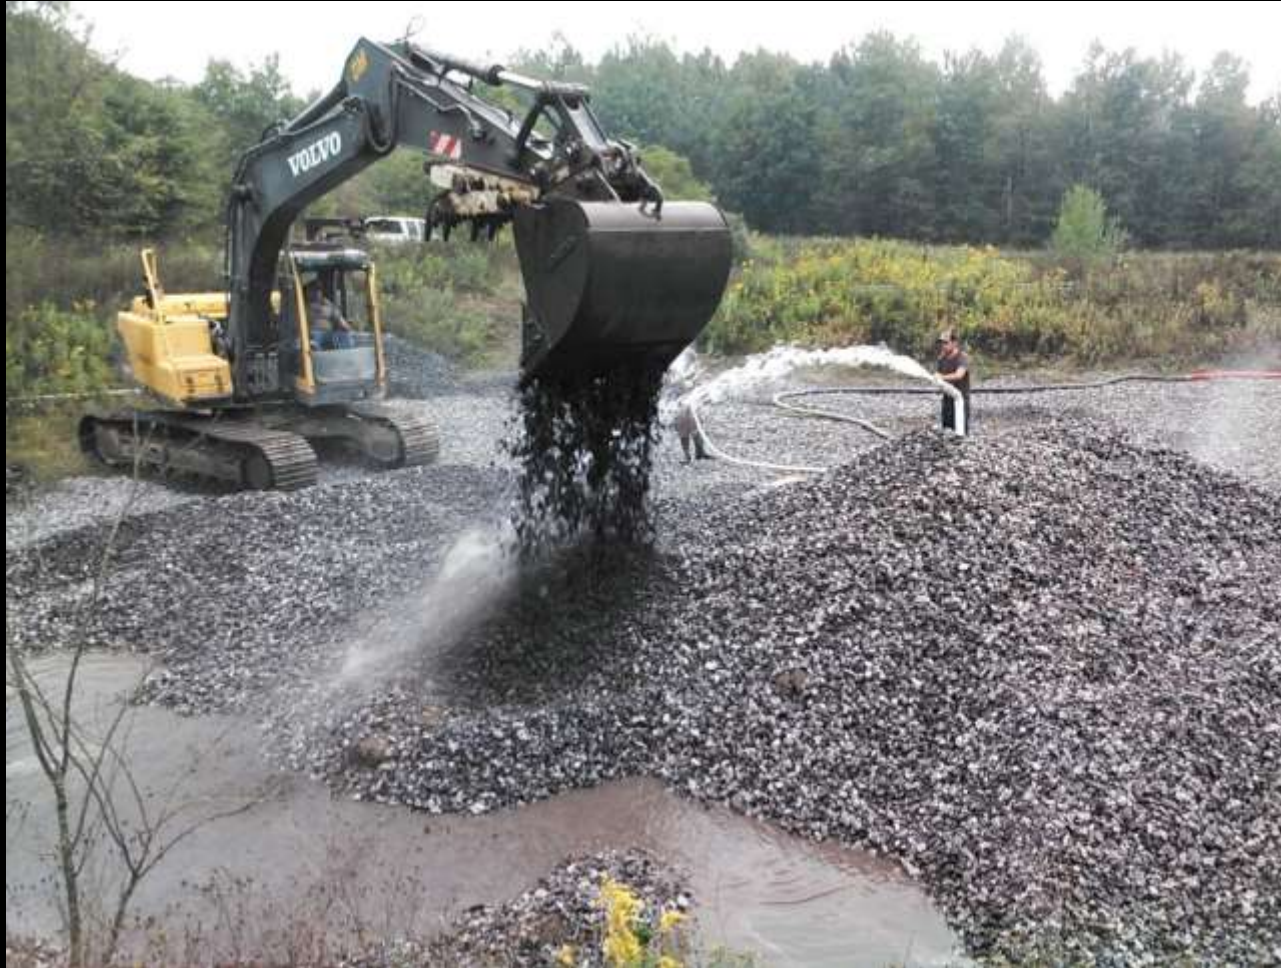
Bear Hill PTS 2013 Stir/Wash Limestone

Stirring stone with equipment versus washing with pumps?

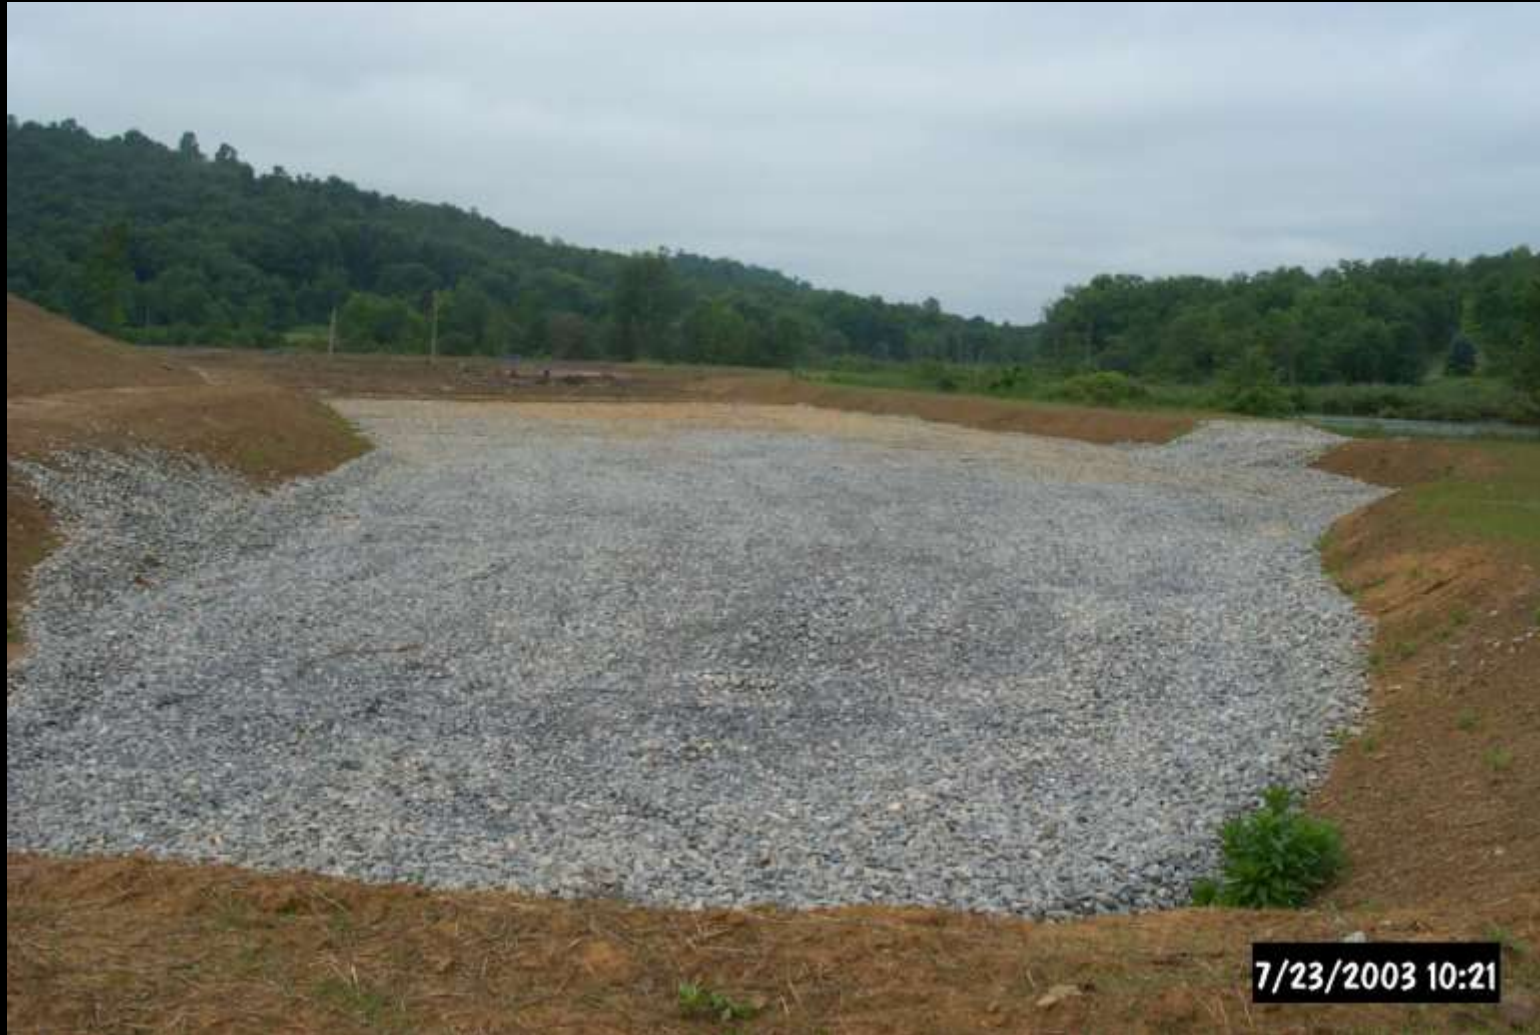
Erico Bridge HFLB installed 2003

HFLB bed with perforated outlet header

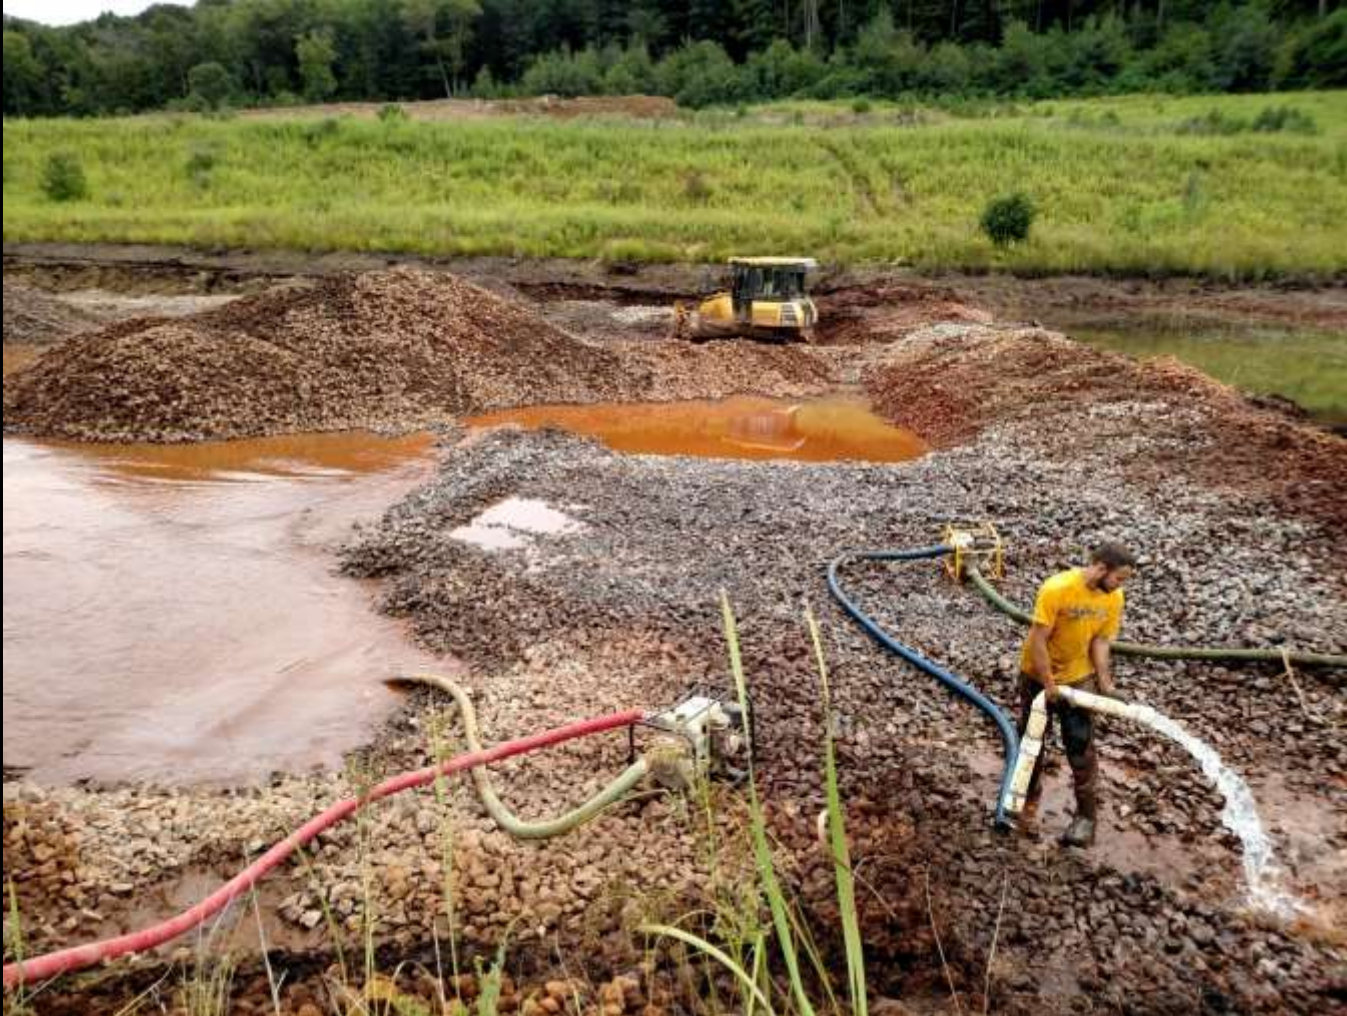
Erico Bridge HFLB Rehab 2015

Pumping clean water to flush clogged limestone

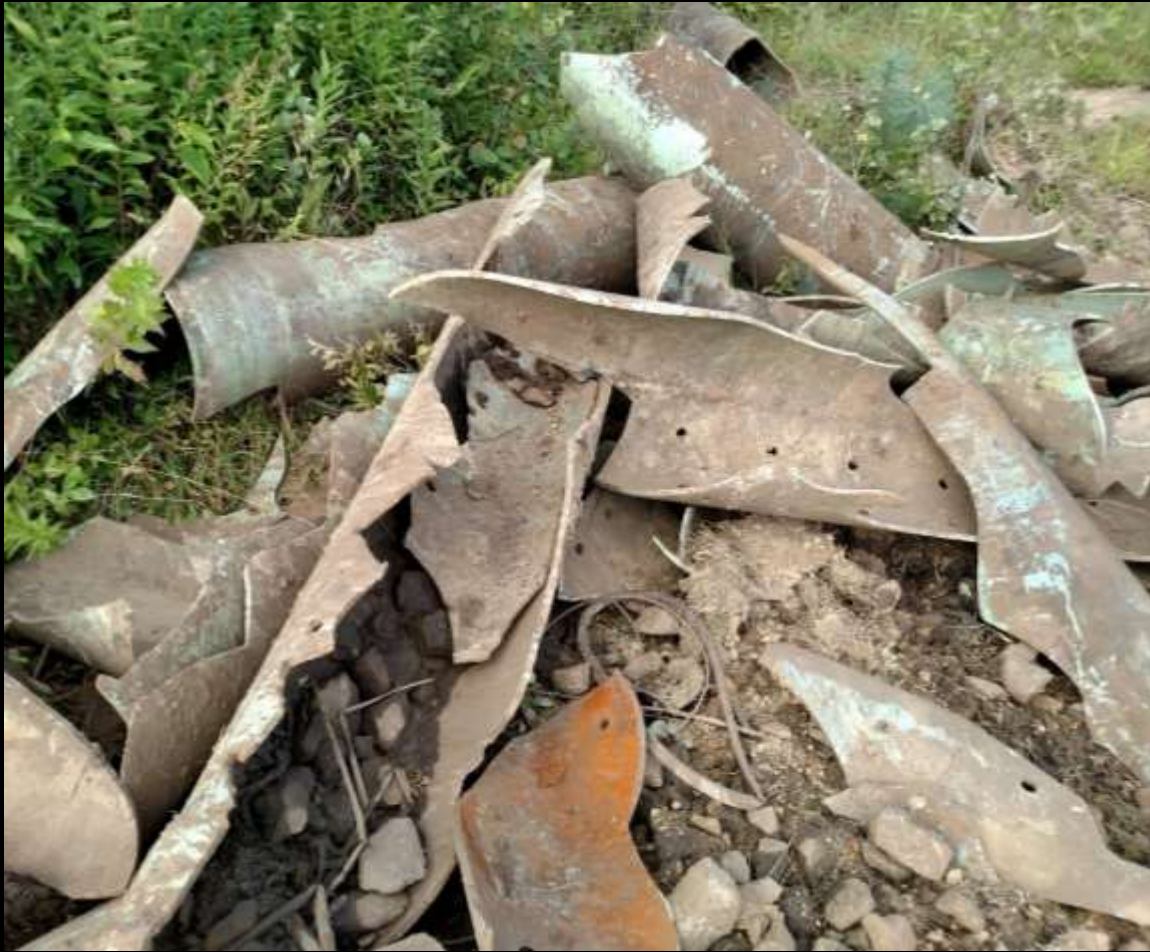
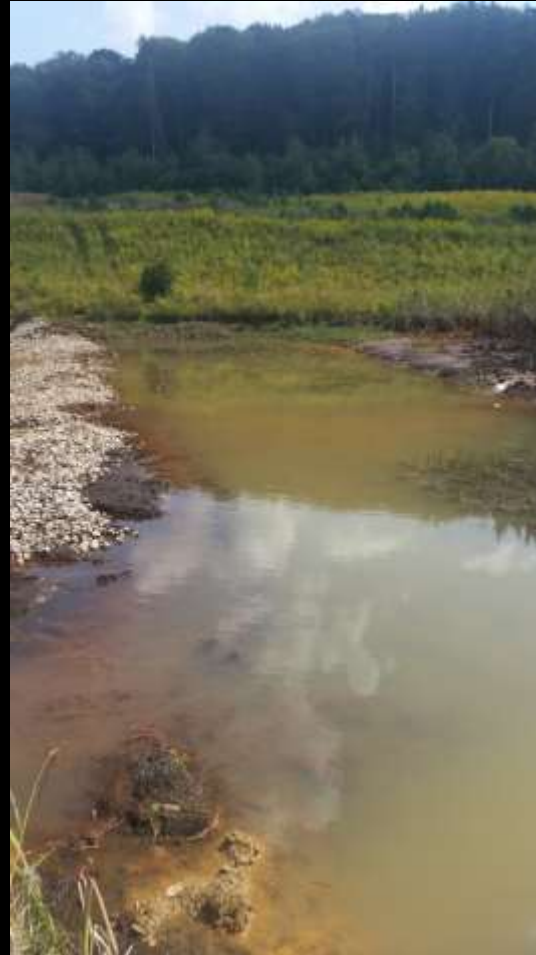
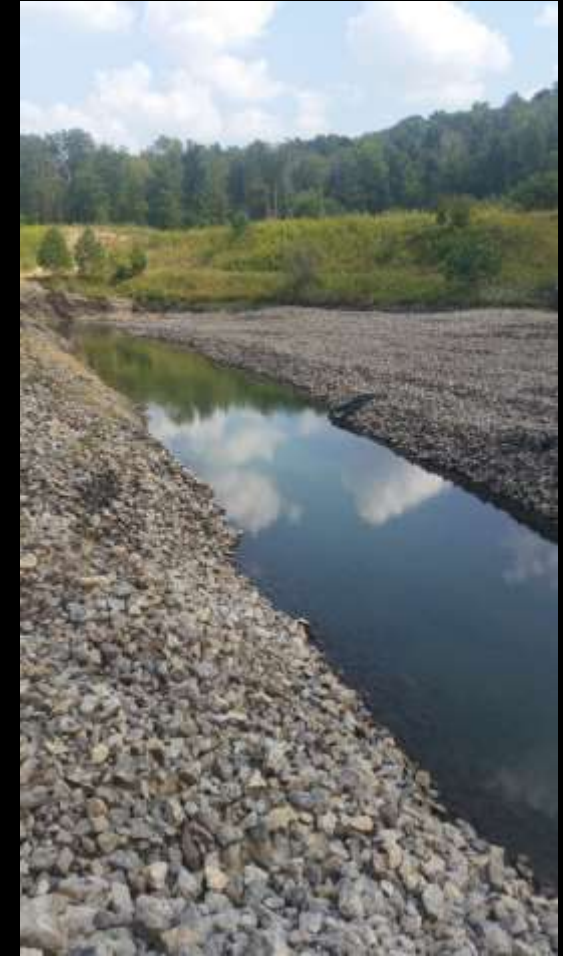
Erico Bridge HFLB Rehab 2015

Manganese plugged ½" perforations, pipe eliminated as much as possible
