Evaluation and Refurbishing Passive Treatment Systems

Presented by Tim Danehy, QEP & Ryan
Mahony

West Virginia Mine Drainage Task Force
40th Annual Meeting
May 26-27, 2019
Morgantown, WV

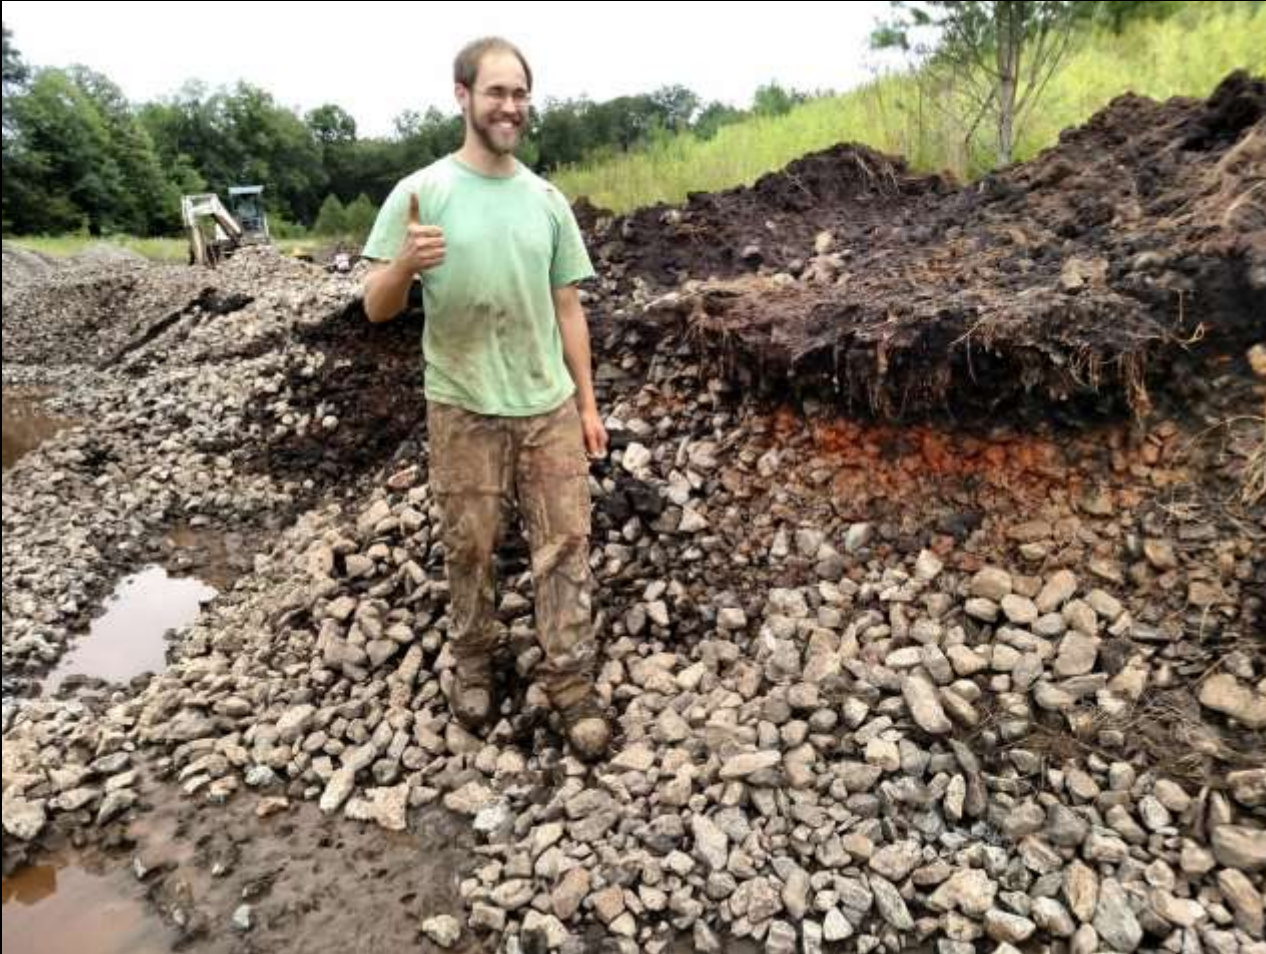
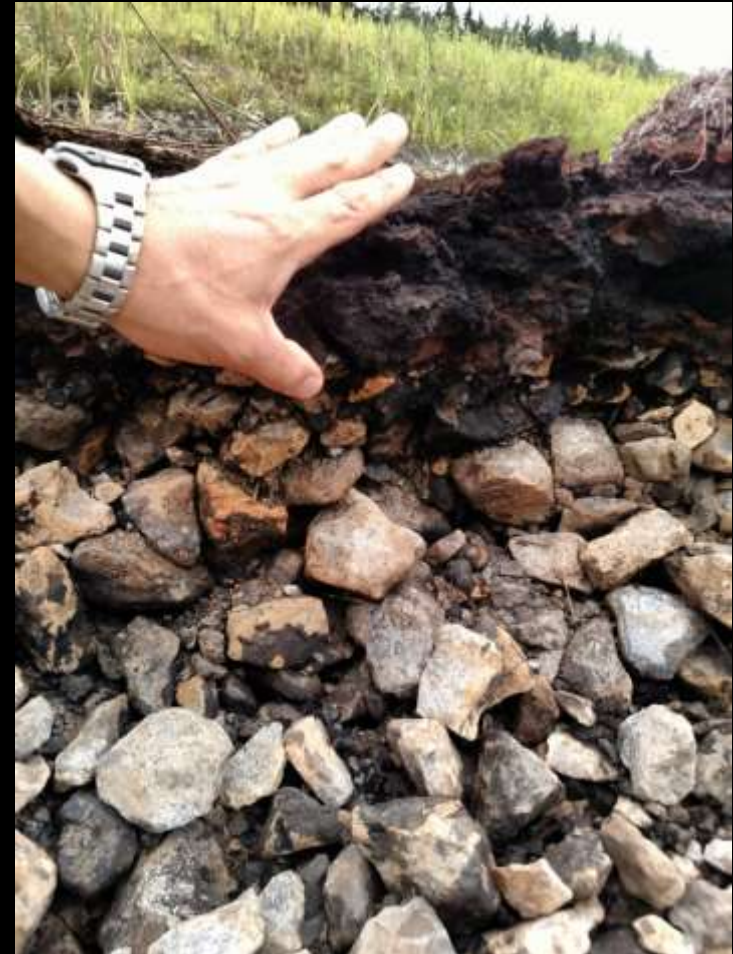
Erico Bridge HFLB Rehab 2015

Limestone was “clean” under the first 6-8”

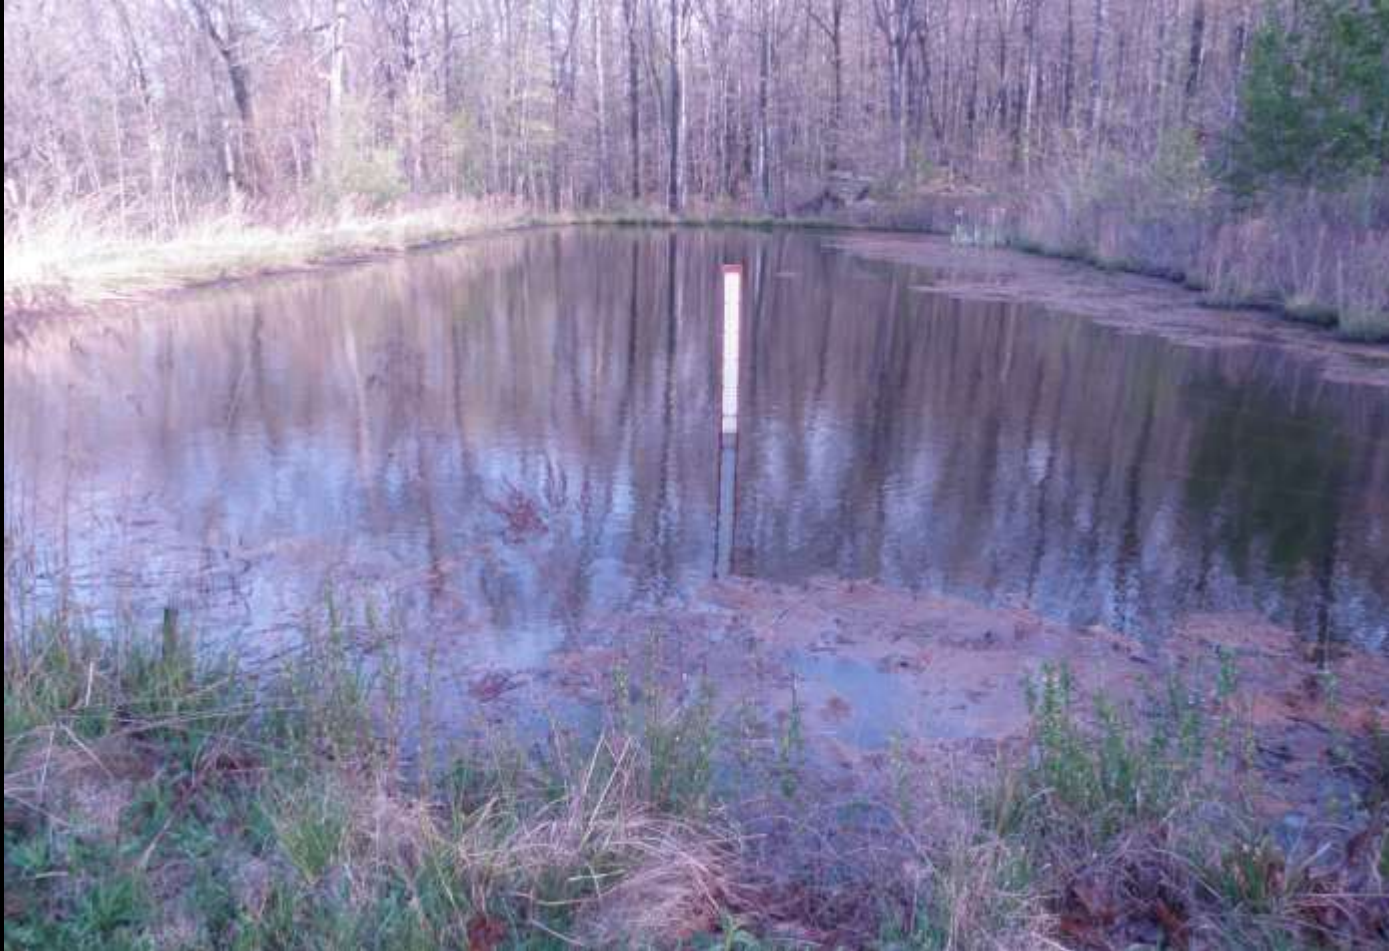
Jennings 2011 Rehab- Old Media Plugged

System put online September 1997
