Complete River & Stream Corridor Assessment

High Definition Stream Survey Greens Run Watershed, WV

Stream Corridor Assessment

For Impact Assessment & Project Prioritization

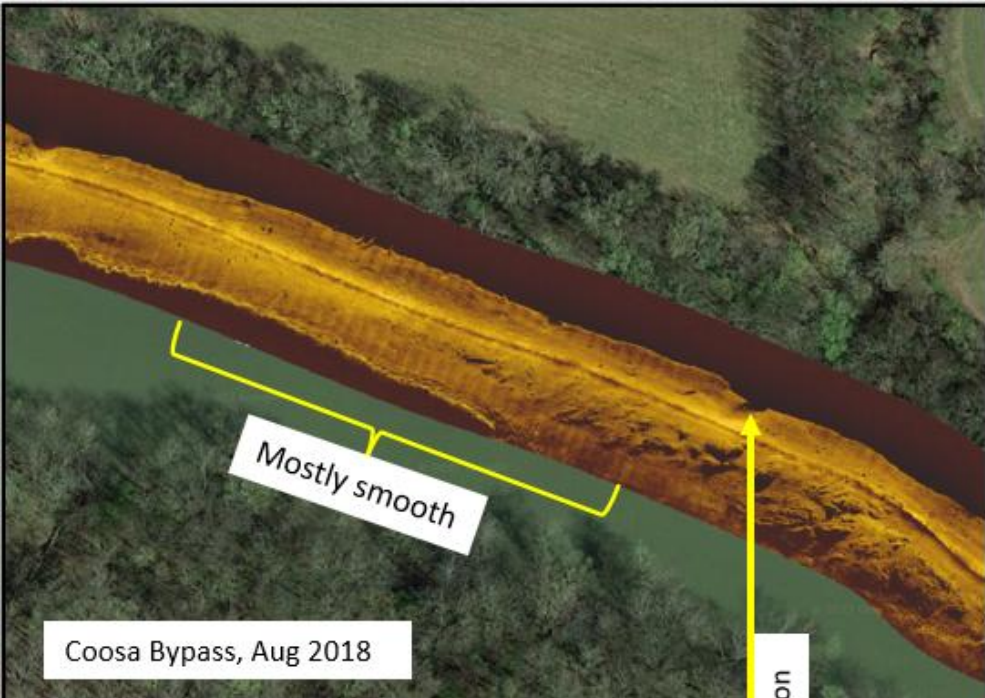
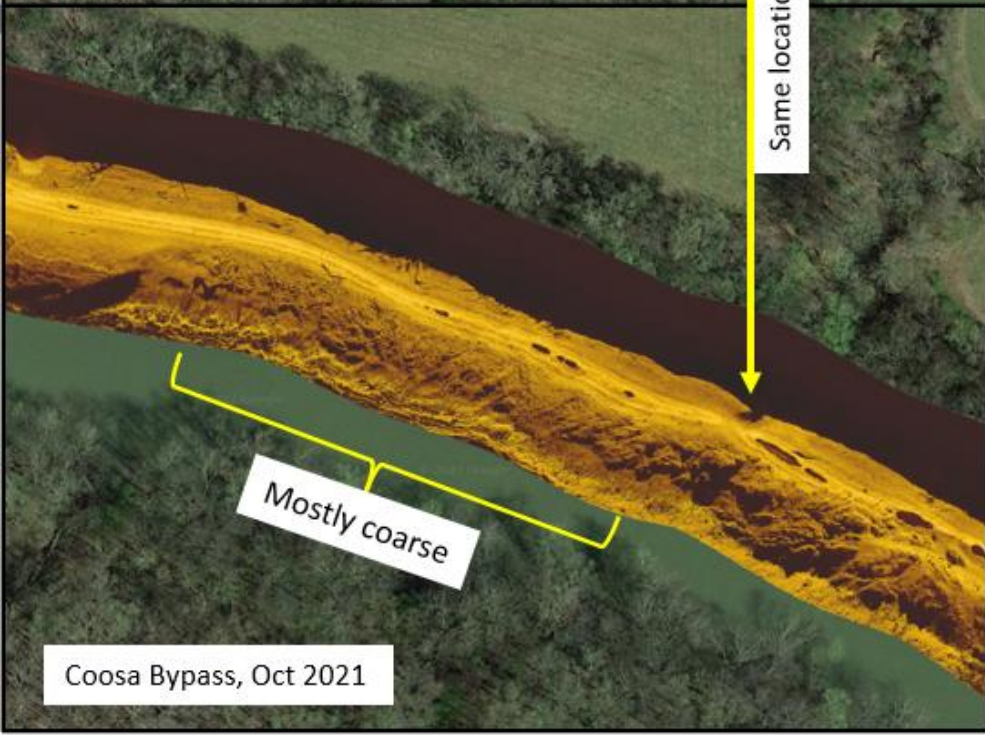
Side-scan Sonar & Video

Same location

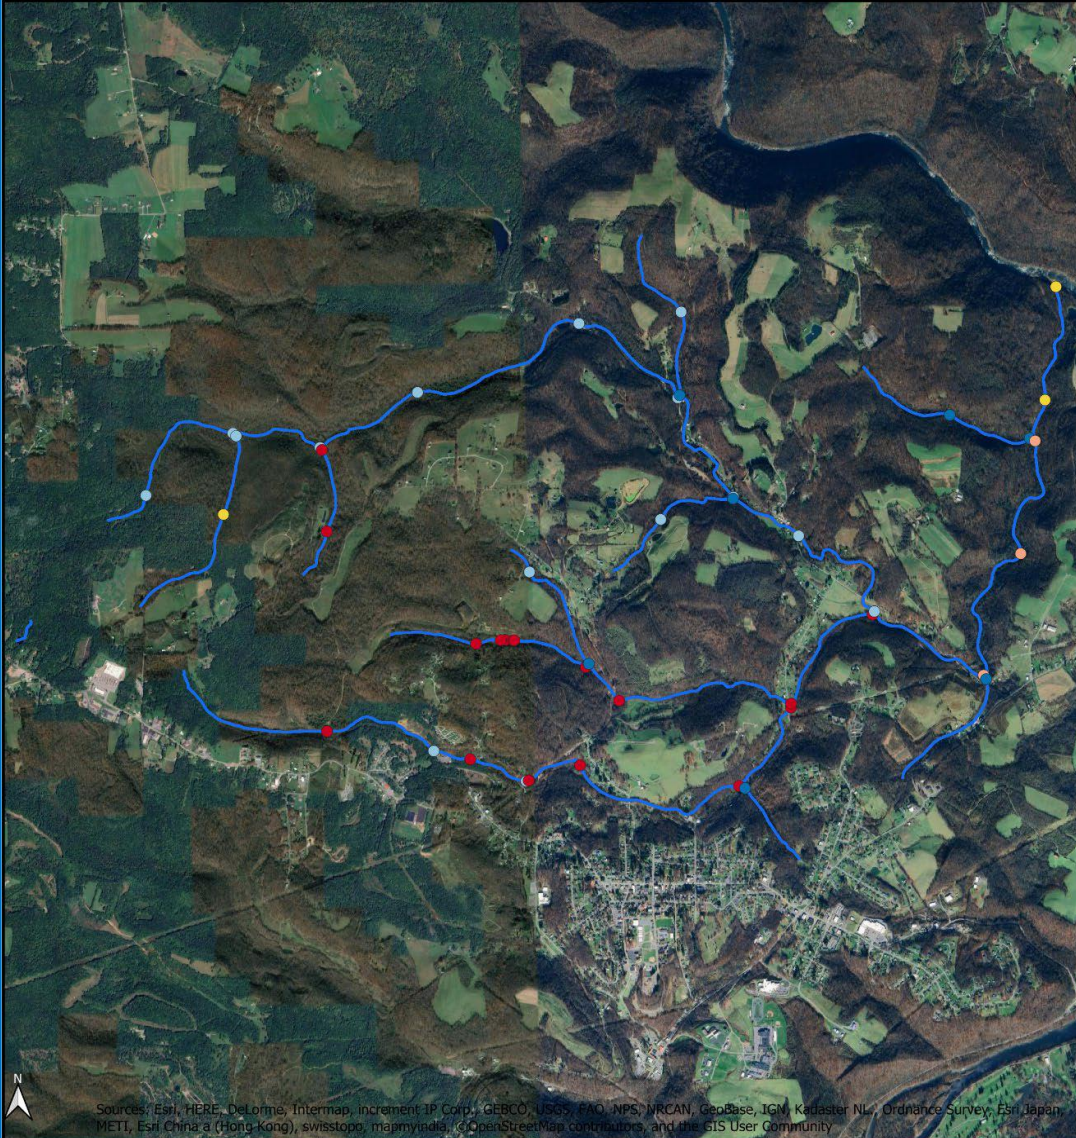
Mean pH Among Sites for the Greens Run Project Area, North of Kingwood, WV.

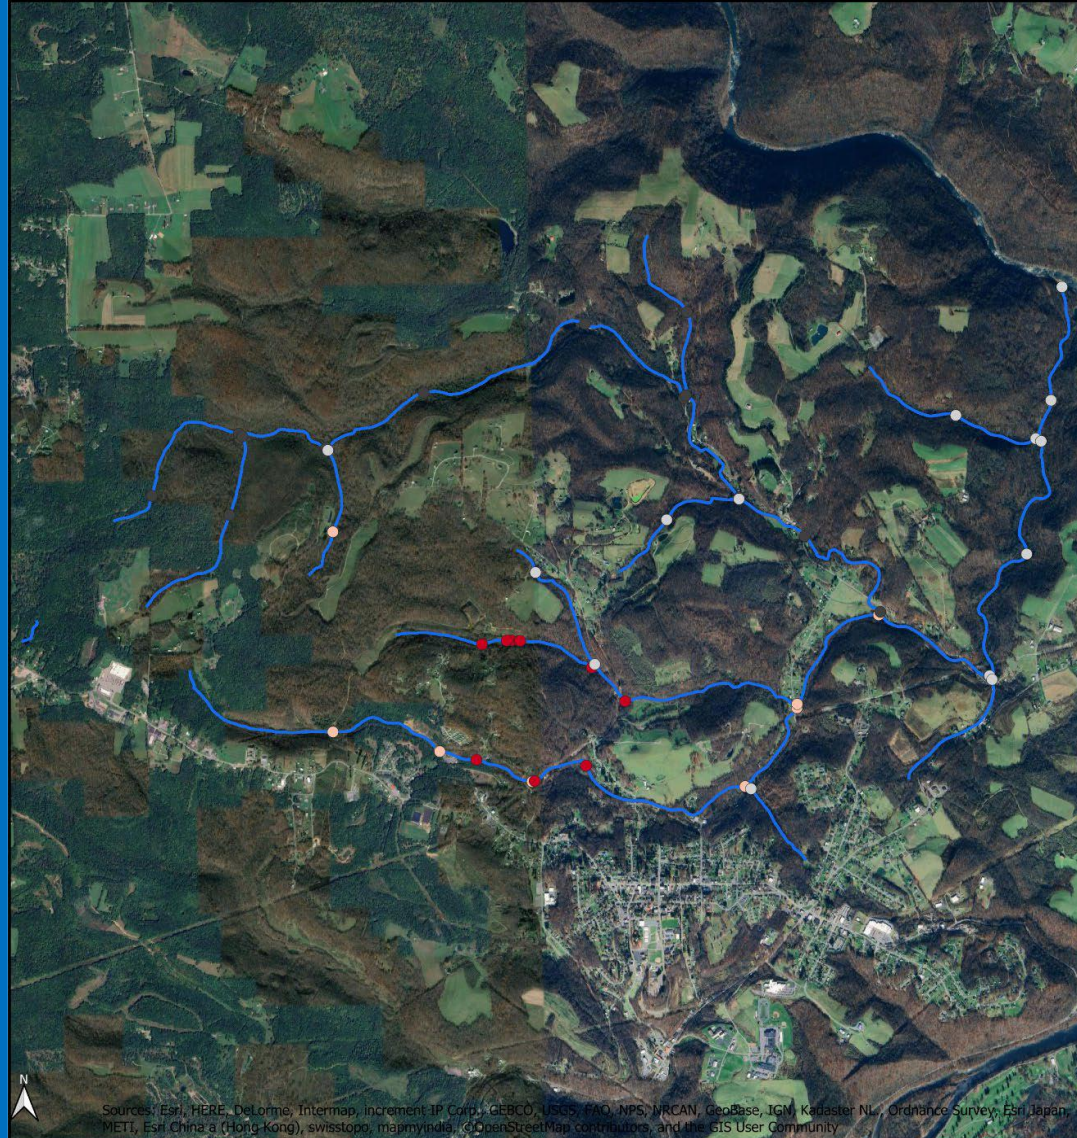
Mean Specific Conductivity Among Sites for the Greens Run Project Area, North of Kingwood, WV.

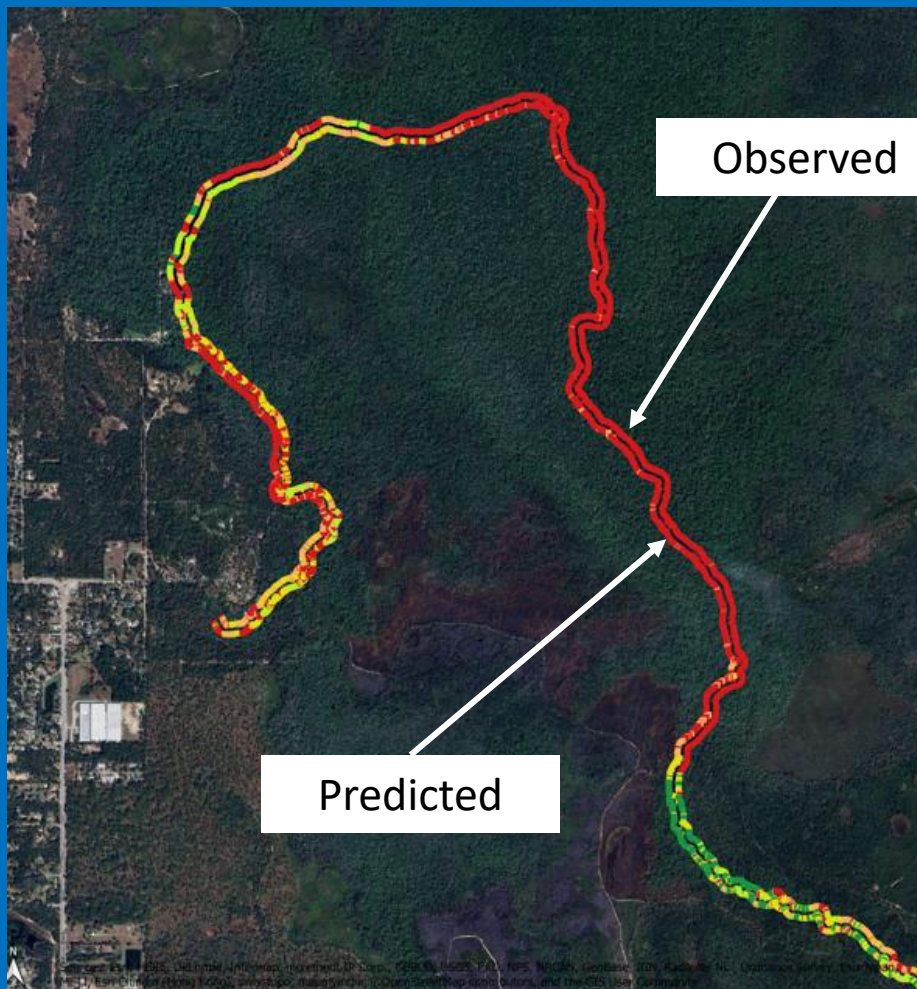
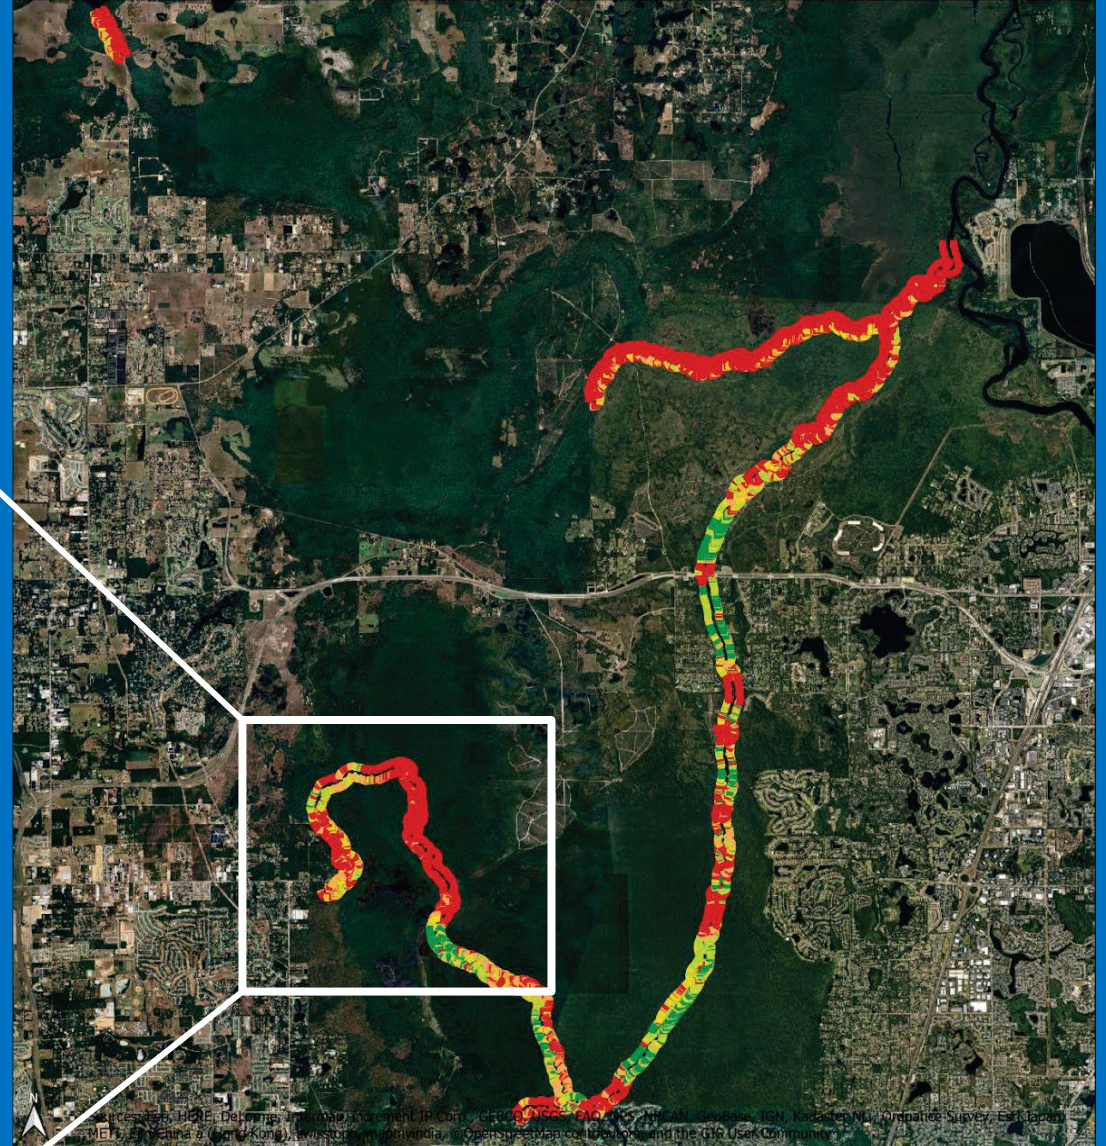
Model	Observed
Least Suitable (Red)	Not Observed (Red)
Rare (Orange)	Rare (Orange)
Common (Yellow)	Common (Yellow)
Dominant (Light Green)	Dominant (Light Green)
Most Suitable (Dark Green)	Complete (Dark Green)

Eelgrass Suitability Model Prediction vs Observed
 Model prediction on right and observed on left looking downstream

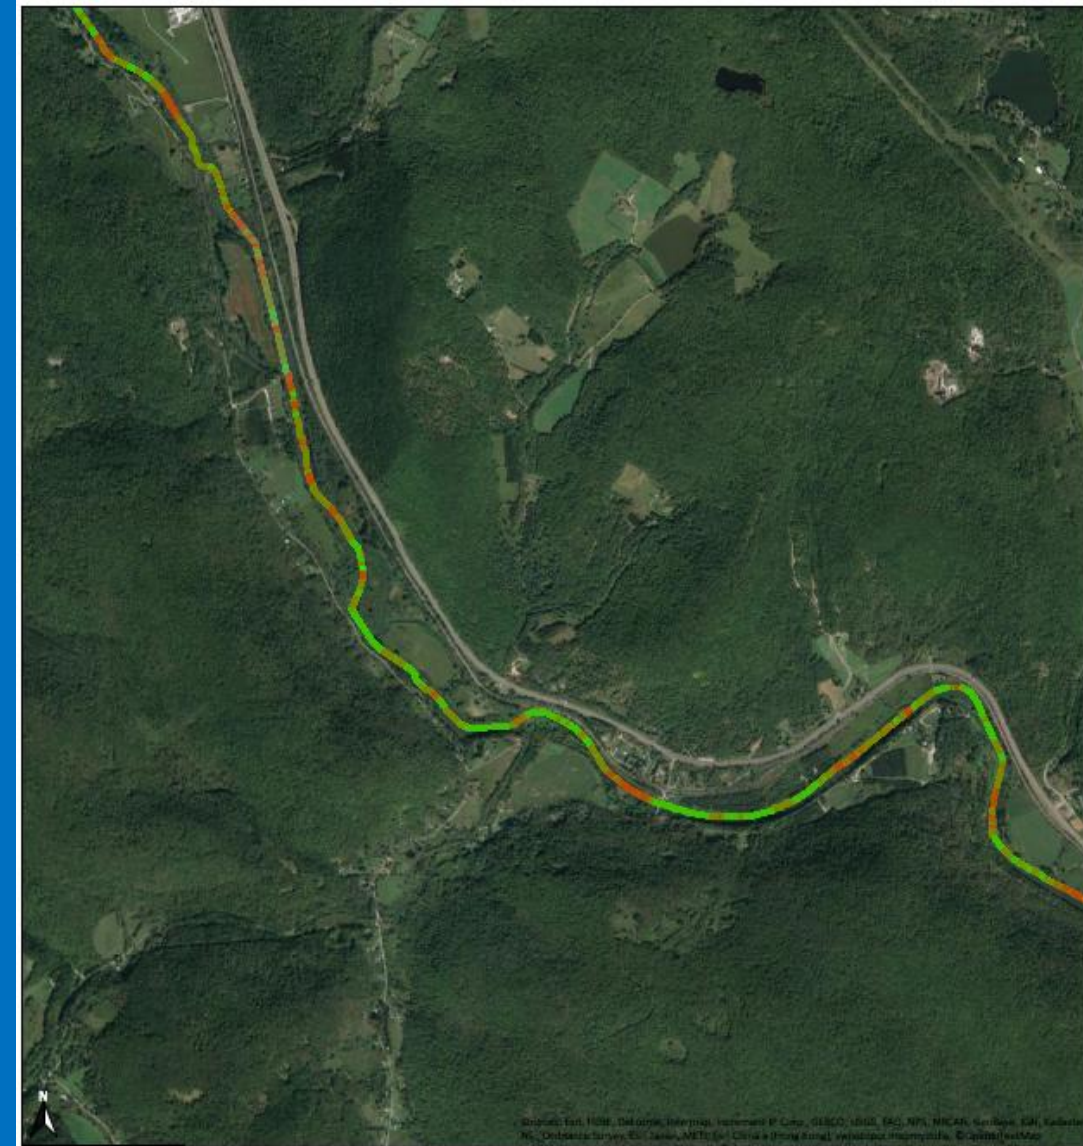
- 0 - 0.2
- 0.2 - 0.4
- 0.4 - 0.6
- 0.6 - 0.8
- 0.8 - 1

HDSS Adult Brown Trout (*Salmo trutta*) Habitat Suitability Along the West Branch: Map WB2

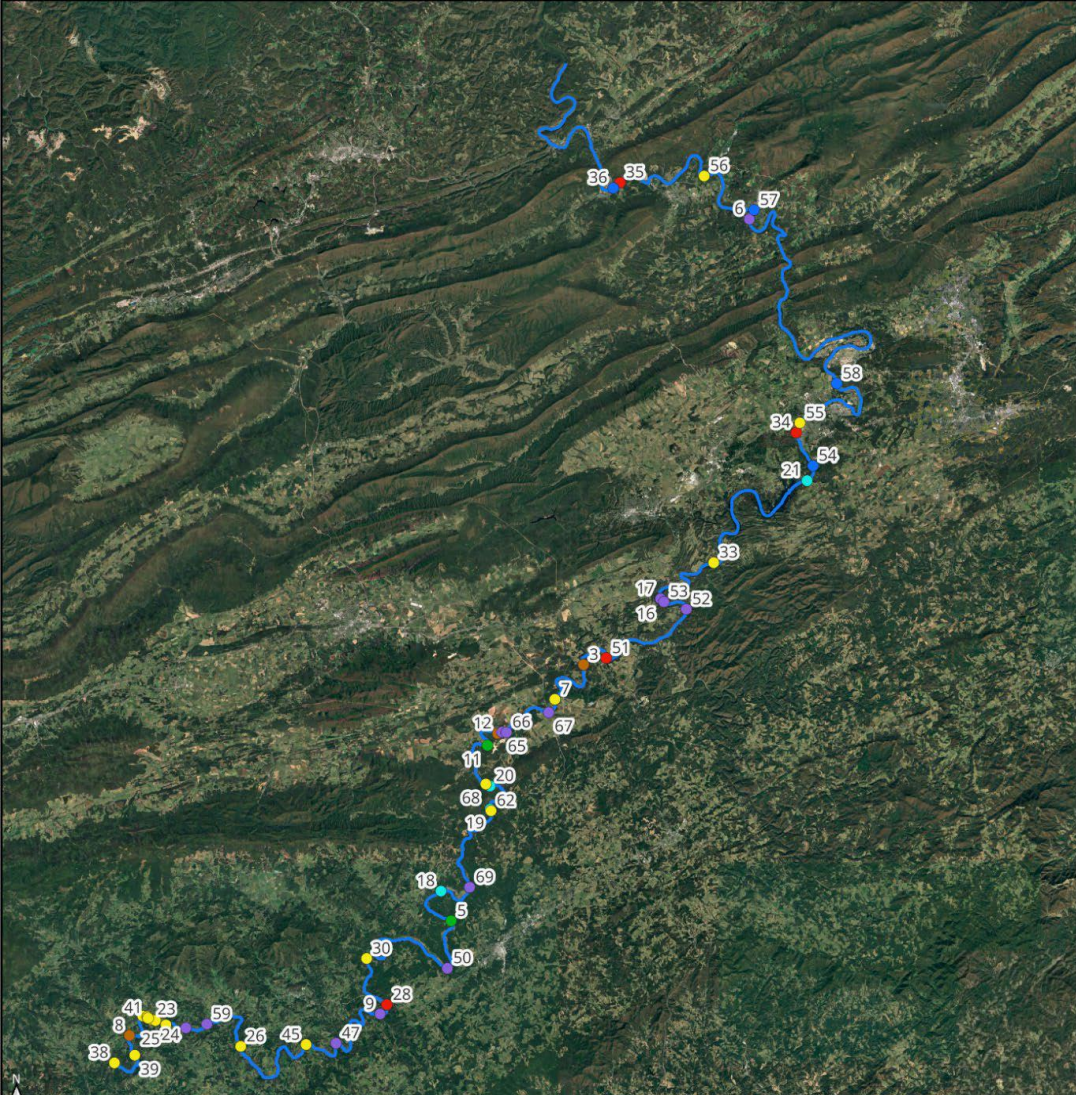
- Dam
- Excess_Fines
- Livestock
- Log_Debris_Jam
- Powerline
- Ramp_Launch
- Trash

Locations of Concern by Type along the New River, VA.
