Truettown

Acid Mine Treatment Plant
and Pigment Production

May 05 - 06, 2026

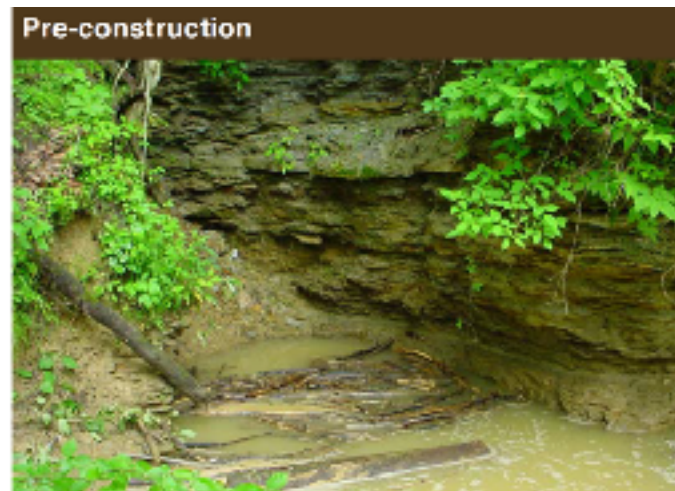
One of Rodger's Hollow primary stream captures during wet conditions, Photo by Sunday Creek Watershed Group

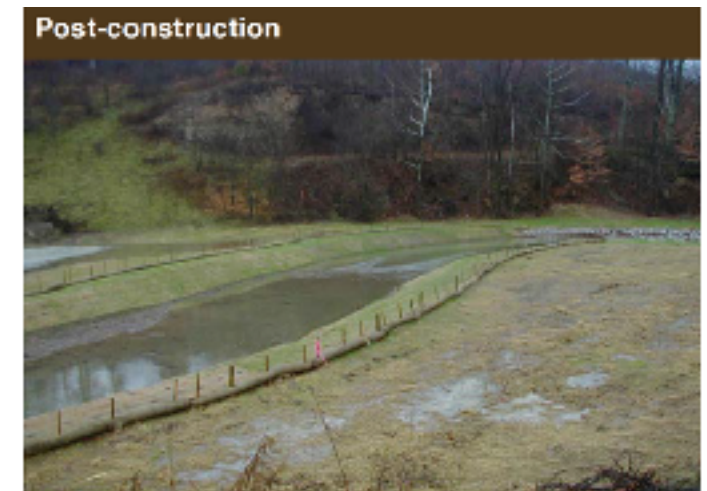
Completed natural channel stream Photo by Kaabe Shaw

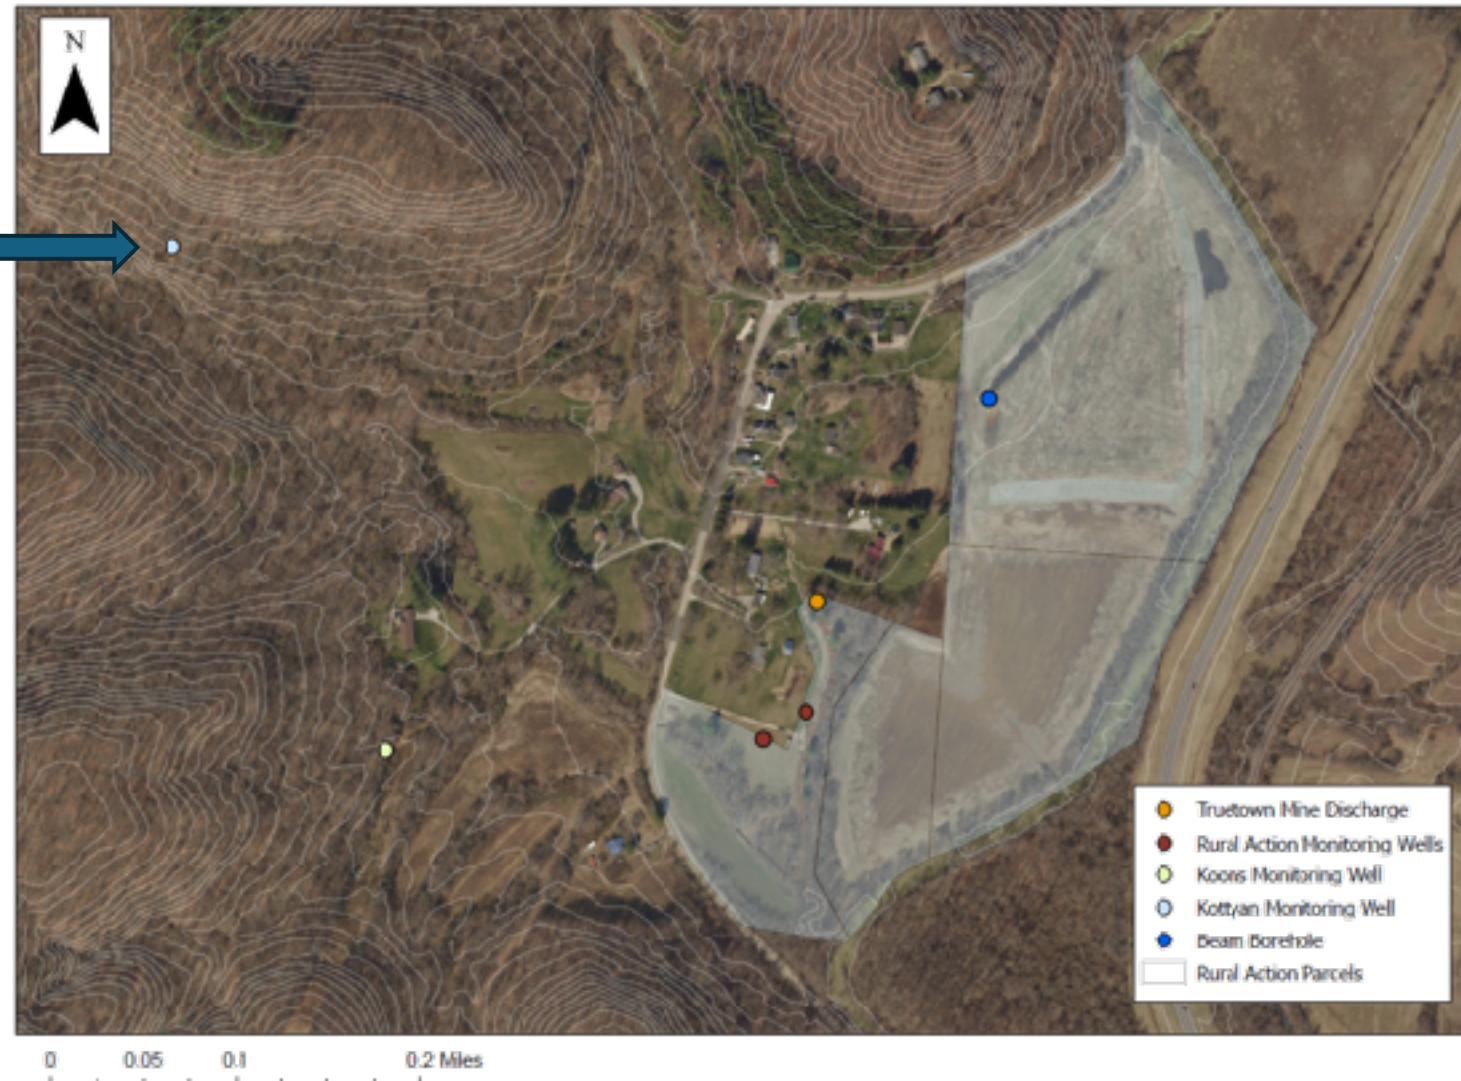
Beam Bore Hole Routed to the Wetland

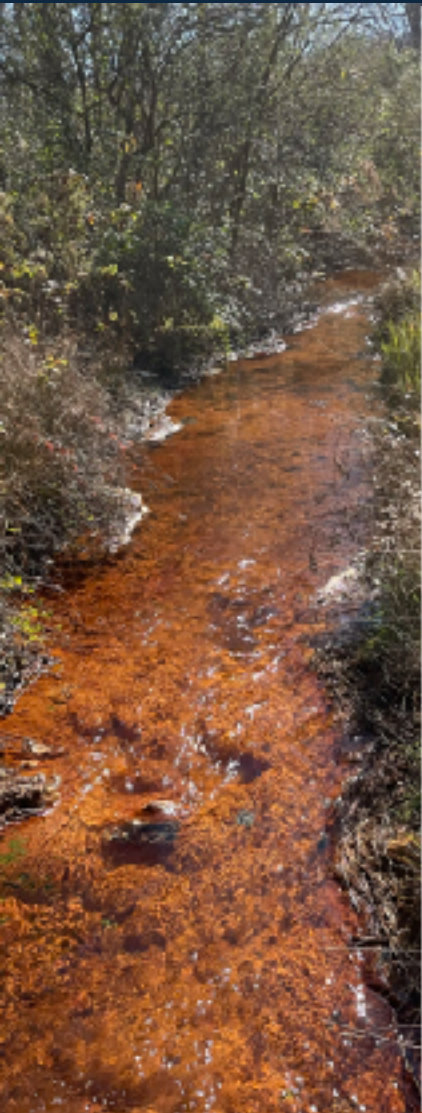
Pigment Recovery and Processing – Tale of Two Solids

Original (pH adjusted solids)

- Polymer selection known
- 99% yield
- Solids settle faster
- Difficult to dewater:
 - Increased filter areas needed
 - High water content in solids make drying expensive
- Less marketable color

Low-pH Solids

- Need to evaluate polymers for settling
- 50% yield
- Finer solids – slower settling rate
 - Increased clarifier size
- Improved filtration – faster filtering with thicker cake
- Color more consistent with commercial colors

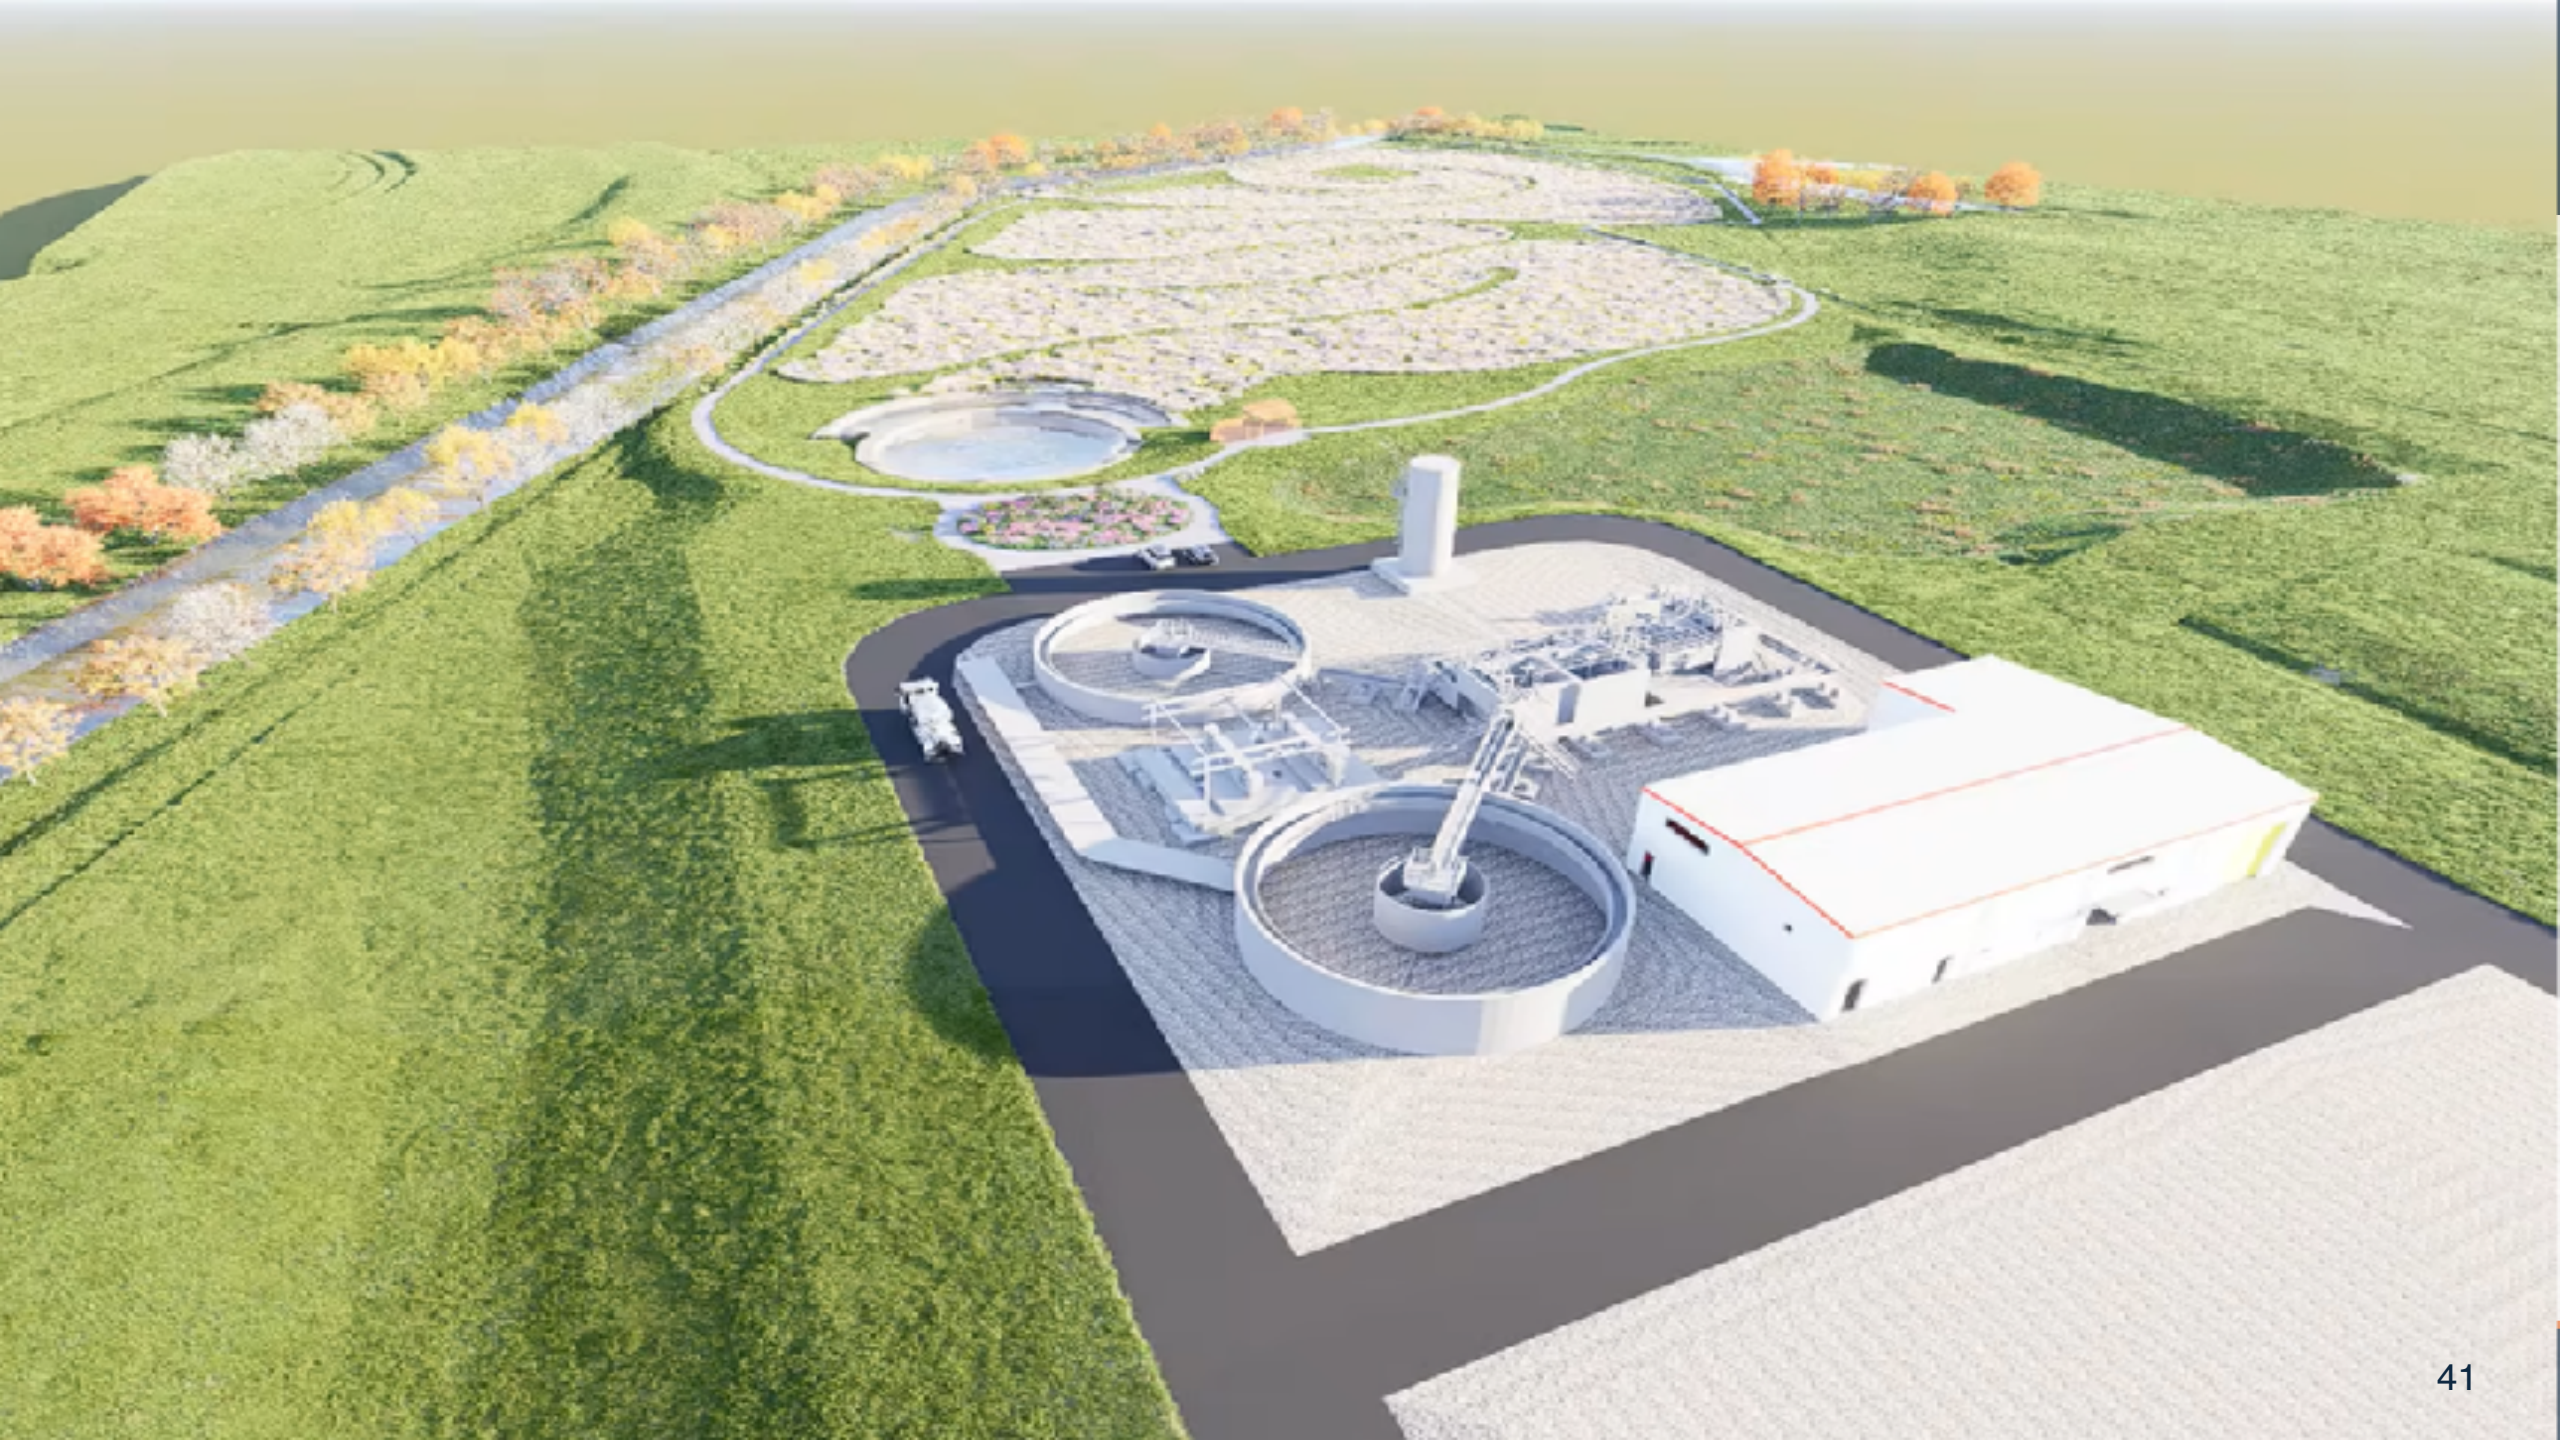
Current Design Concept

- IRRT treatment train still exists
 - Settling test were very dependent on polymer dosage but polymer impacts pigment quality
 - Due to the IRRT being in series, solids carryover is less critical
 - Low-pH solids are the preferred product for pigment
 - Caustic system was removed – only lime for pH adjustment
- Pigment testing to continue once facility is in service
 - Batch tank testing area in operations building
 - Ability to treat raw water or process sludge from clarifier
 - Plan to purchase small filter to develop design information on large scale pigment production
 - Once design information is better defined, expected to be a separate future project
