ALKALINE IRON STAINING **A TREATMENT ALTERNATIVE?**

By Tiff Hilton-Ben Faulkner-Jamie McPeck

Alkaline iron water is easily treated but can be expensive and a PITA depending upon the type of treatment used. Some of the current treatment alternatives are as follows.

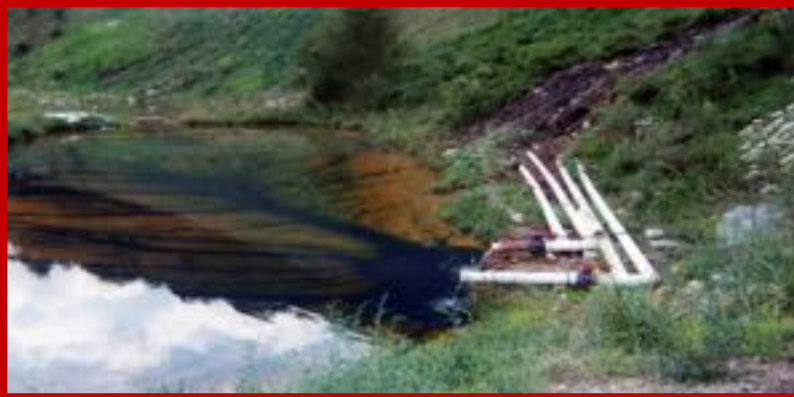
Sodium Hydroxide (Raising pH)

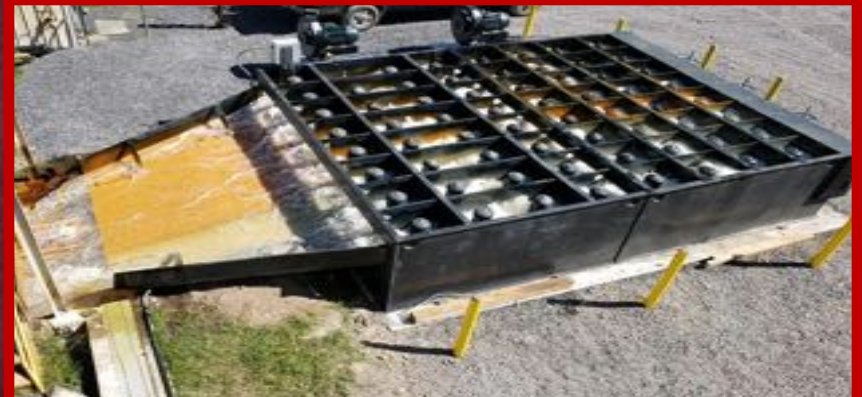
Malestrom Oxidizer (Physical Oxidation)

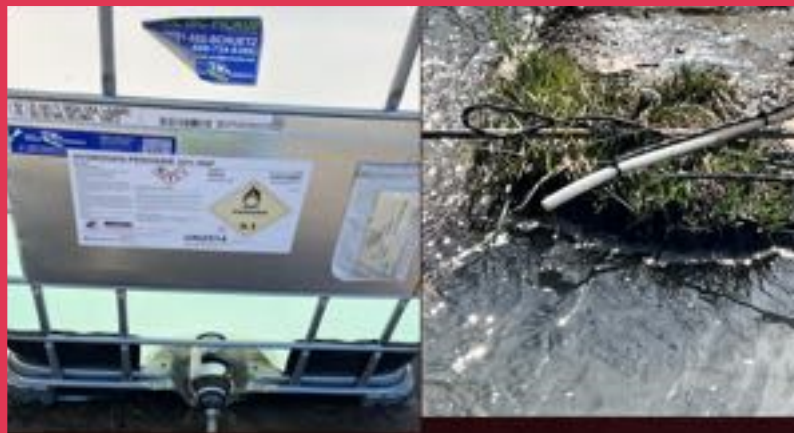
Hydrogen Peroxide (Chemical Oxidation)

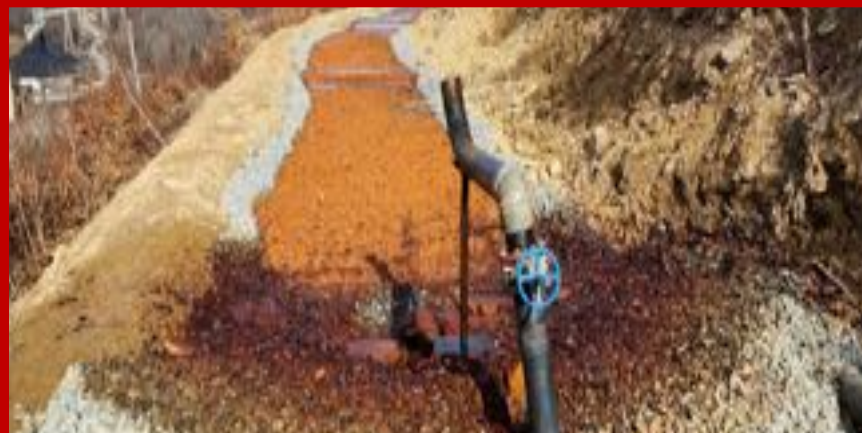
Staining (Transition of Fe+2 to Fe+3)

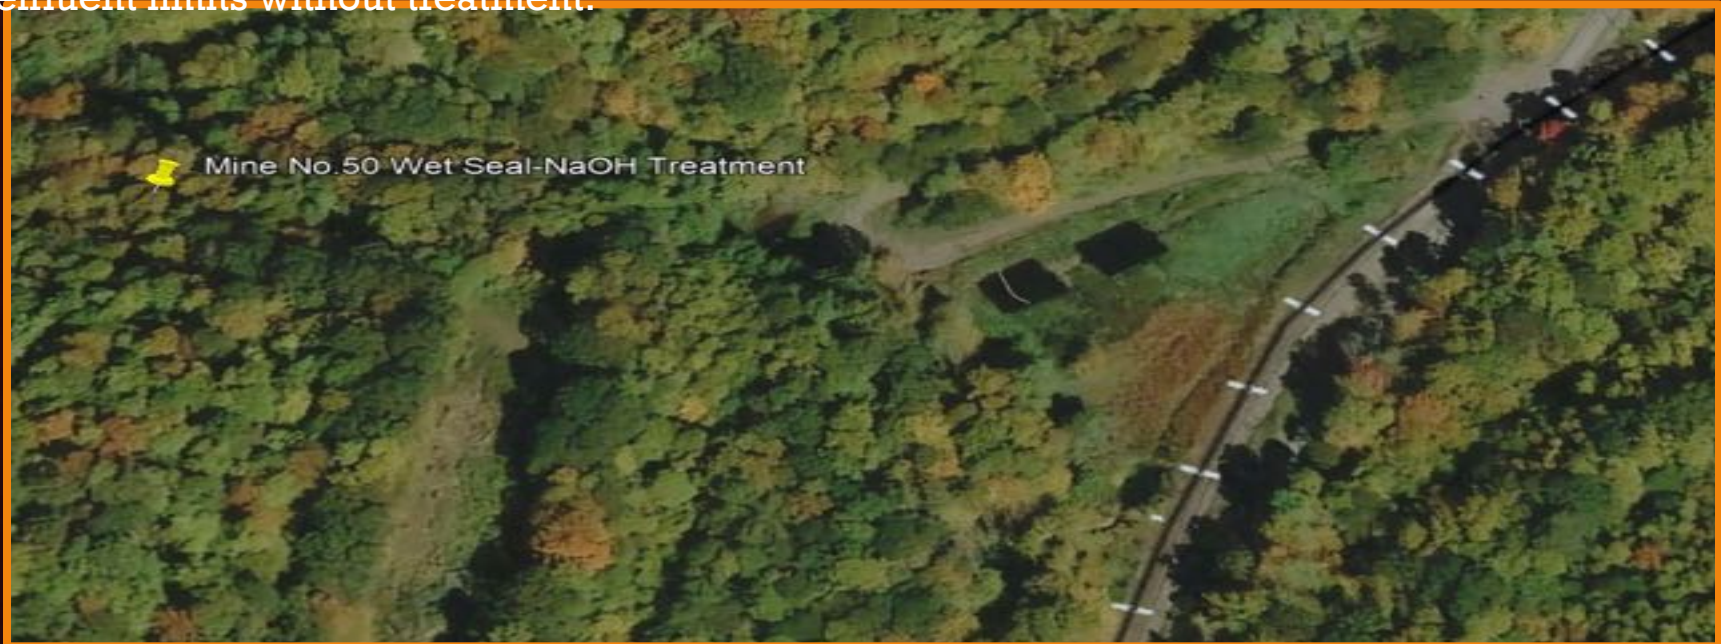
Mine No.50-Down Dip P6 Drift Mine

Special Reclamation Continued
“What the heck?” and constructed a grouted flume and two polishing ponds as illustrated below. The polishing ponds themselves testify to the success of staining (no orange color). This system worked for 15 years at which time the water met iron effluent limits without treatment.

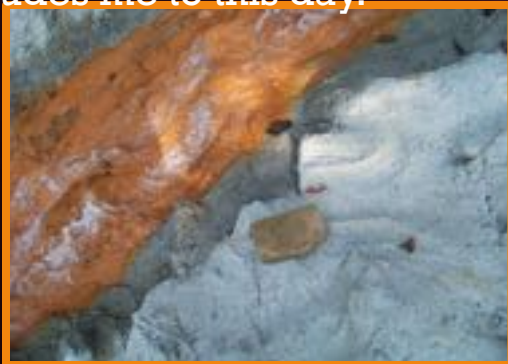
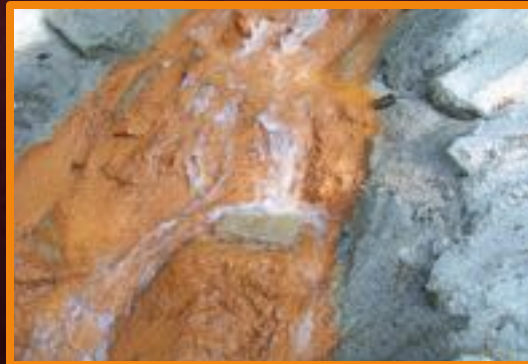
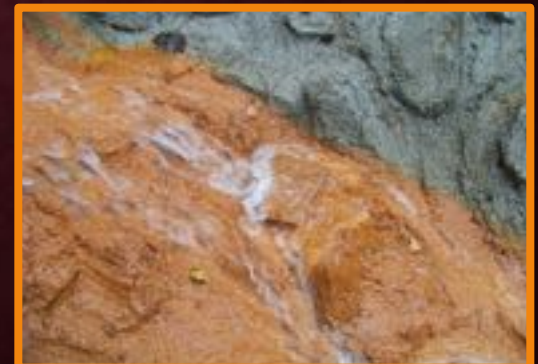
Mine No.50 is also the place where I began to understand that the staining occurs during the transition from Fe^{+2} to Fe^{+3} . Once totally oxidized the remaining solid Fe^{+3} would settle but not stain. To know how to control the rate of oxidation (Fe^{+2} to Fe^{+3}) for maximizing staining, eludes me to this day.

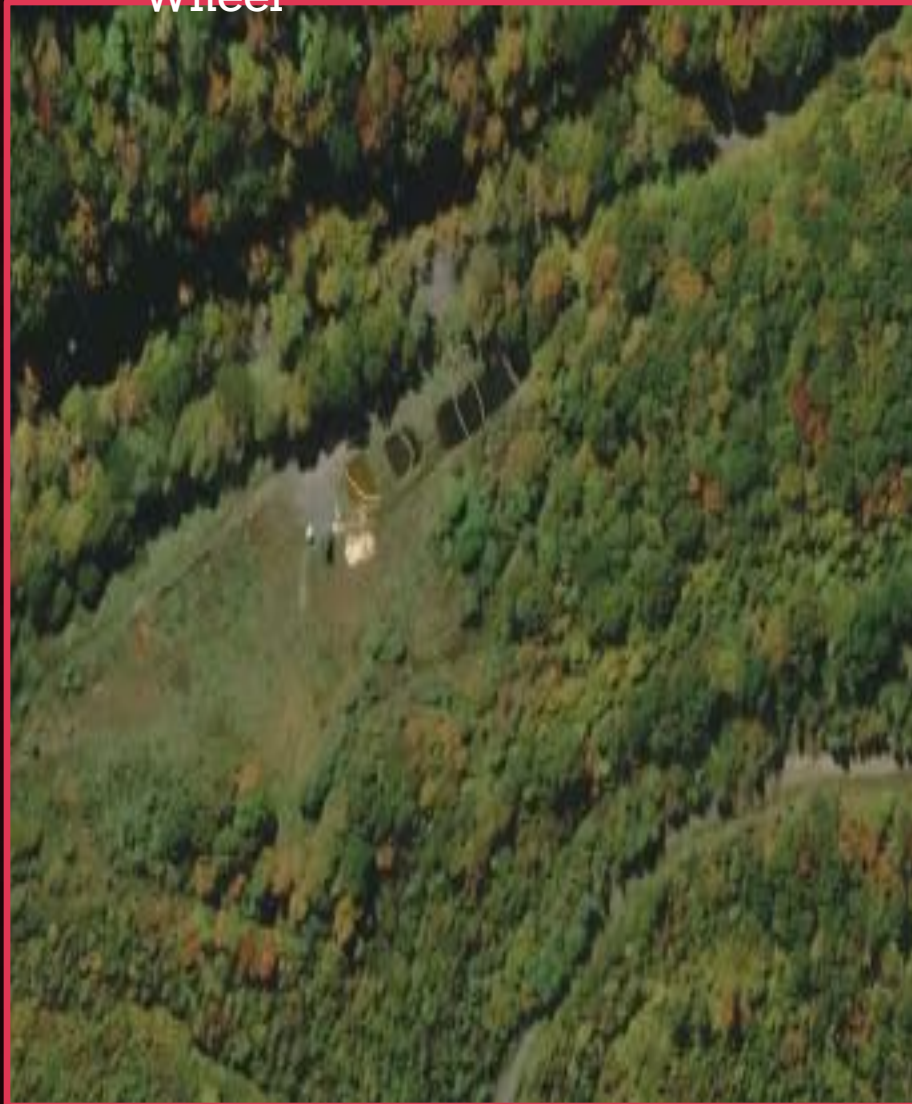
BEFORE: AquaFix Water
Wheel

As you already suspect, the mine filled back up with water and treatment was required. Leckie Smokeless was purchased in or around 1997 by Royal Scot Minerals and ultimately filed for bankruptcy a few years later. Special Reclamation assumed control of treatment and installed an AquaFix water wheel treatment system. Jumping ahead to present day, they decided to put in an iron staining bed along with a wetland and additional polishing ponds and the system is performing as expected.

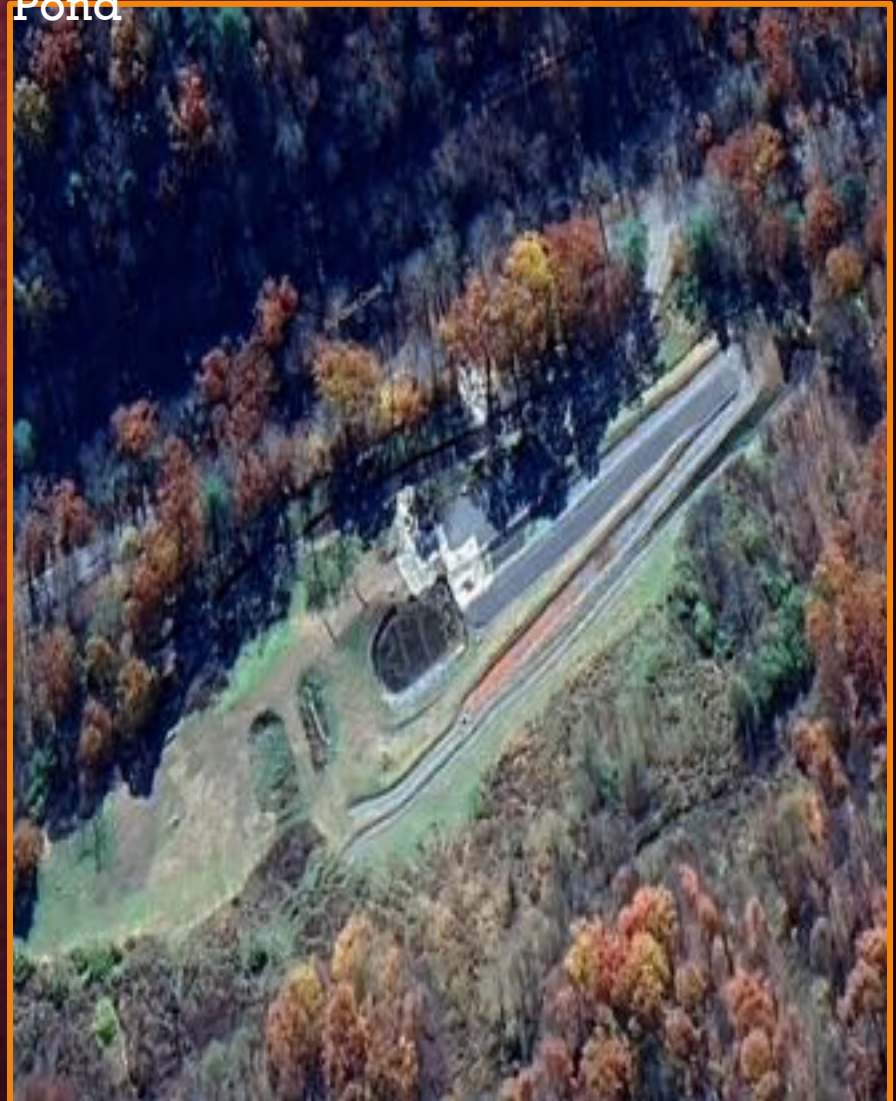
AFTER: Staining Bed/Wetland/Polishing
Pond

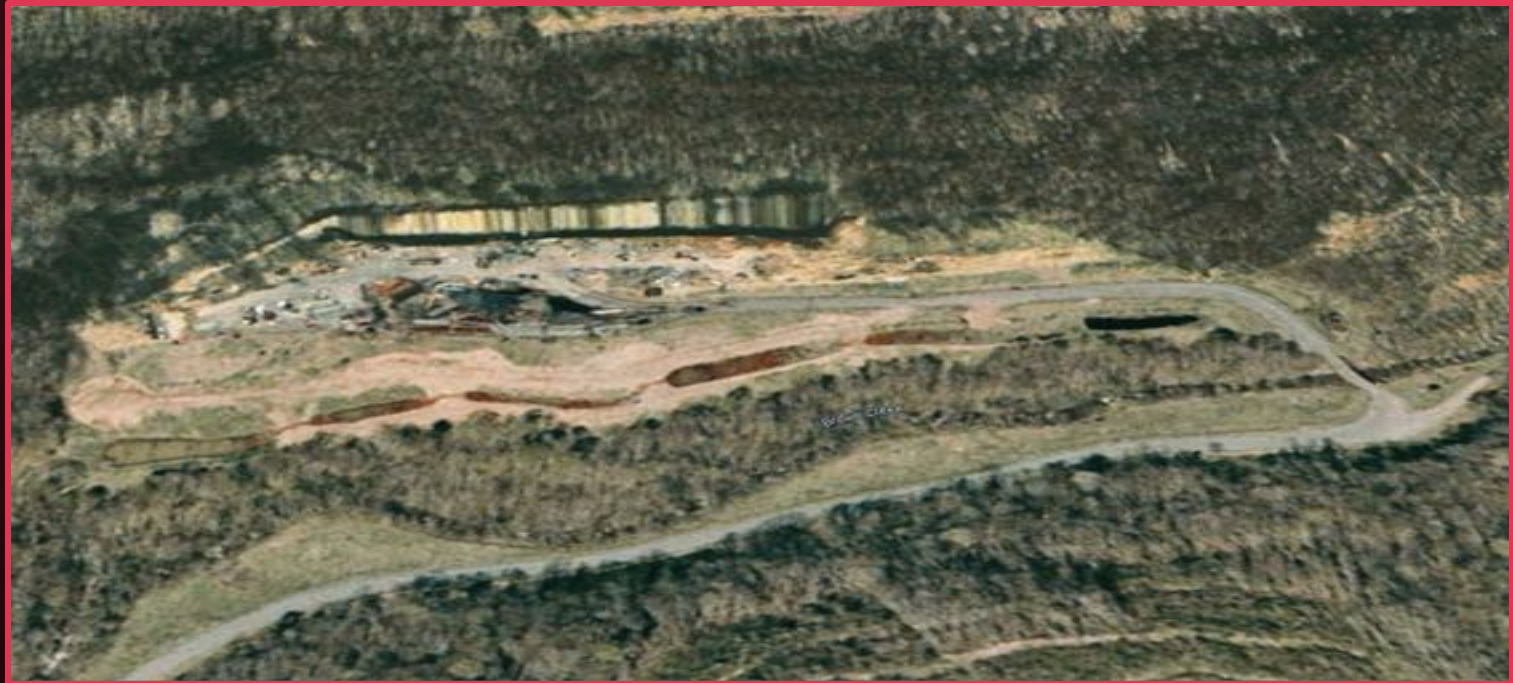
In 1985, we opened Mine No.62 in the Pocahontas No.6 seam about 2 miles up Brown Creek, a tributary of Big Clear Creek. As with the other 2 mines, water treatment began after operations were completed and wet seals were installed. After alkaline iron water began to discharge from the seals, chemical treatment was required or so I thought at the time. Consequently, I began treatment by raising the pH up with anhydrous ammonia and applying coagulant and flocculents to quickly settle out the iron. Below, you can see a series of sediment cells that collected the sludge after treatment. Another PITA relative to sludge disposal.

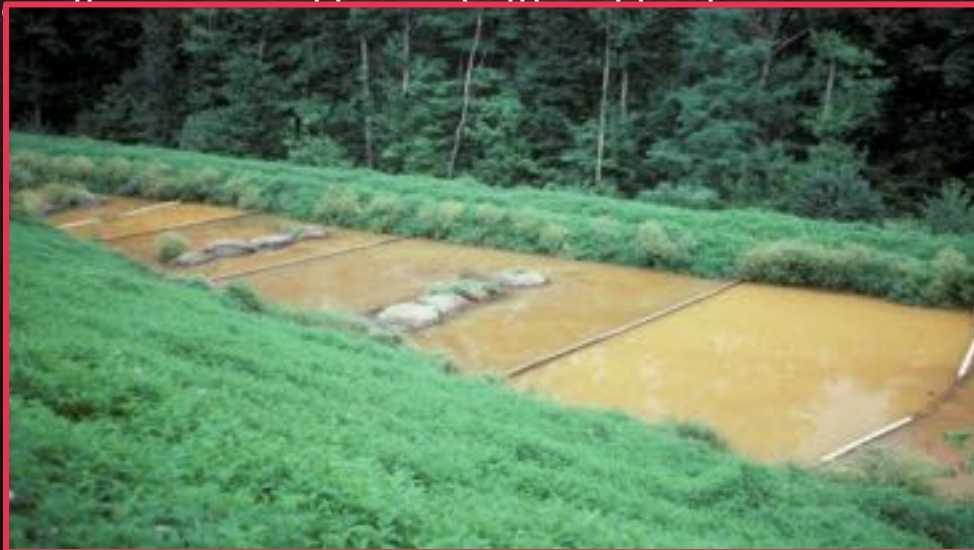
During this time of chemical treatment, I ran across a lady by the name of Jo Davison (The Bug Lady) who had some success at utilizing bacteria to remove iron from water. Getting to know her introduced me to new four letter words that I didn't even know existed. A very colorful individual to say the least but dedicated. She couldn't have been more than 5' tall and said she spent 25 year studying bacteria in the Okefenokee swamp in Florida. She gathered up 125 different bacteria that consisted of floaters swimmers, and sinkers. She even had a few prolific bacteria shipped in from Sweden for obvious reasons (LOL). However, before she would put the bacteria in the water, she had me ship in several tons of Zeolite from out West to eliminate residual ammonia from the ponds. That was my introduction to Zeolite as a Cation exchange material. Years later I would conduct research with Zeolite using Acid Mine Drainage (an amazing reusable material that takes out manganese, iron, aluminum, hydrogen ions (acid), and a number of other metals. I learned that chicken farmers spread it on the chicken coop floors to adsorb the ammonia to keep from scalding the chicken's feet. Why? Turns out that chicken feet are a big export item to China for consumption. So, I put the Zeolite in the sediment cells and removed the ammonia and she introduced the bacteria into the cells by using impregnated activated carbon. She then had me add some hay bales as a carbon source and install wooden baffles to force sub-surface flow. Needless to say, as seen below, results were 1

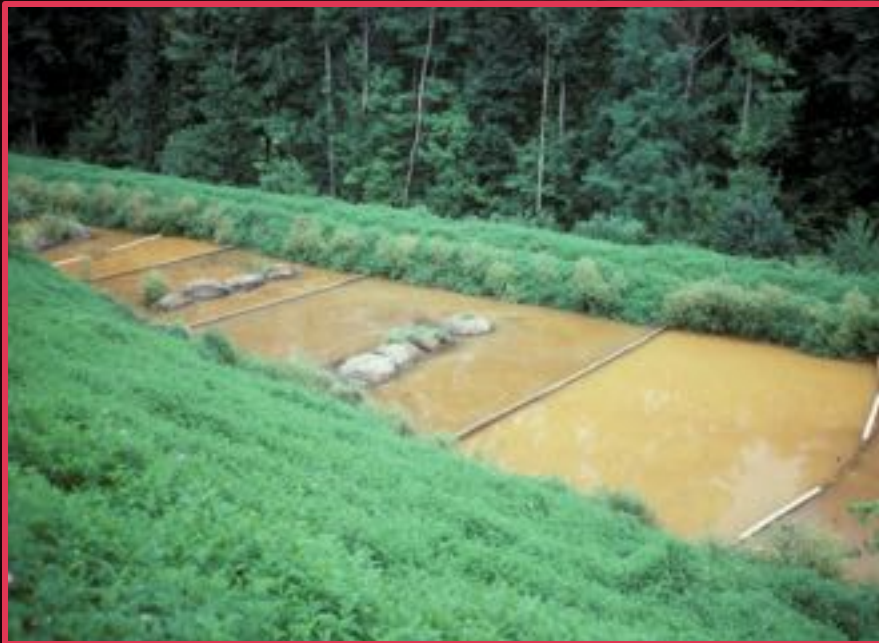
THIS

Sorry to get off topic, but sometimes there is a story within a story and this is it. Added to this story is Mike Daily. He helped me with the other 10 treatment sites across the property. He was self-taught (a genius) and spent his evenings reading Mother Earth News. Mike volunteered that the reason the process was not working the way it was supposed to was because the bugs were hungry. He said they needed phosphorous, potassium, and nitrogen (Mother Earth News). Well, where would you find this at a coal mine? He went to our hydroseeder and got two bags of fertilizer and poured them in the entrance channel of the first sediment cell. Within 24 hours, the water went from looking like

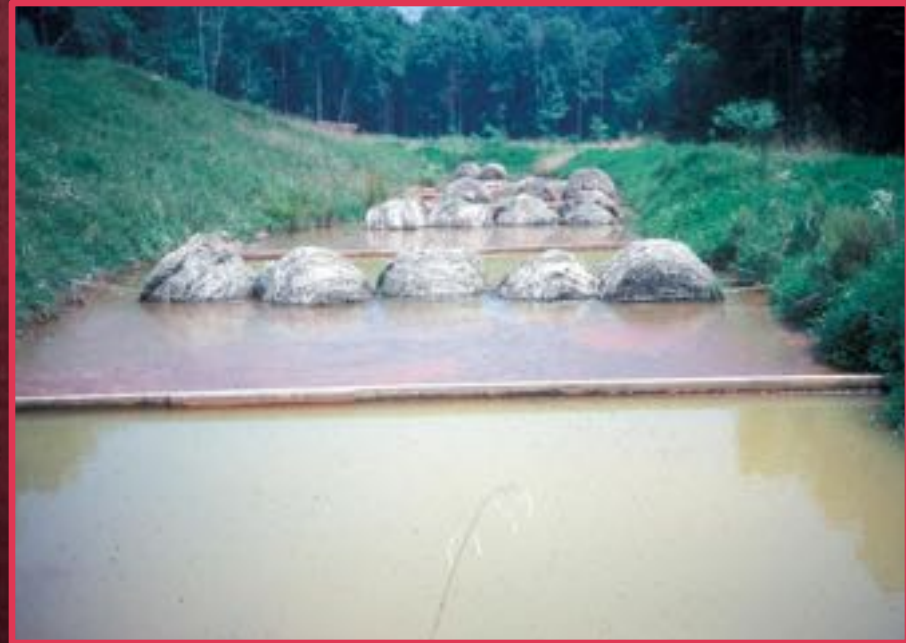
TO THIS

Effluent limits were met and treatment from that point on was two bags of fertilizer once a month. Like Mike said, “The Bugs were hungry”.

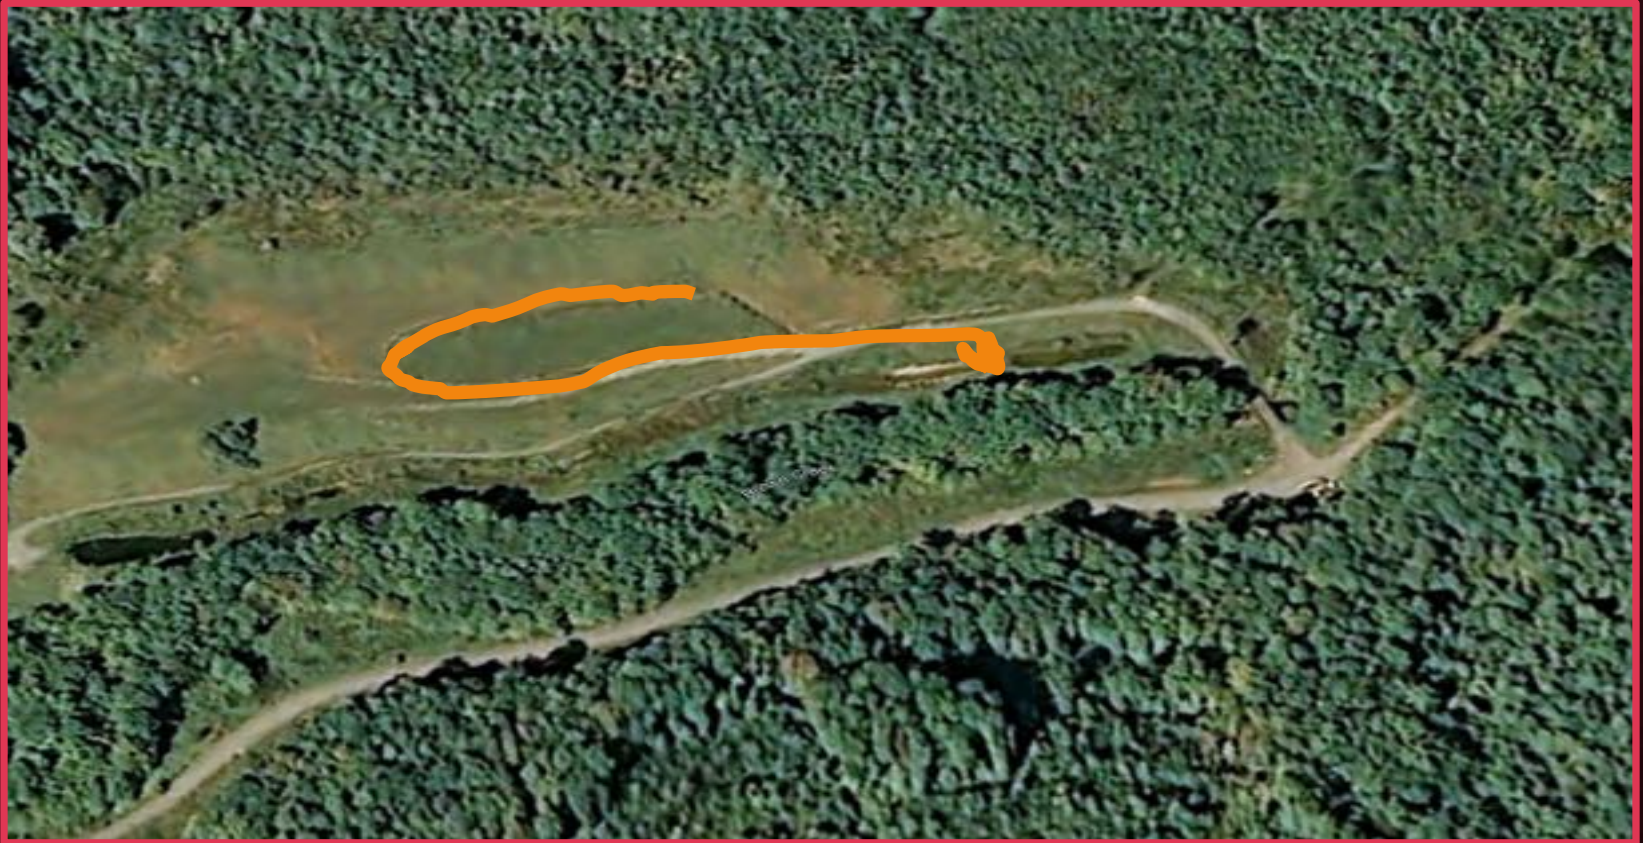
As Mine No.62 was part of the same bankruptcy as Mines No.50 and No.59, Special Reclamation reclaimed the site in 2004 and whoever did the design on the drainage system must have partially recognized the possible benefits from using staining to help treat the water.

You can see a very long ditch in the shape of a loop which the designer forced the water to flow through. The easiest way to get the water to the sediment cells was without the loop by taking it directly to the entrance channel to the cells. Staining must have played a role in his/her thoughts.

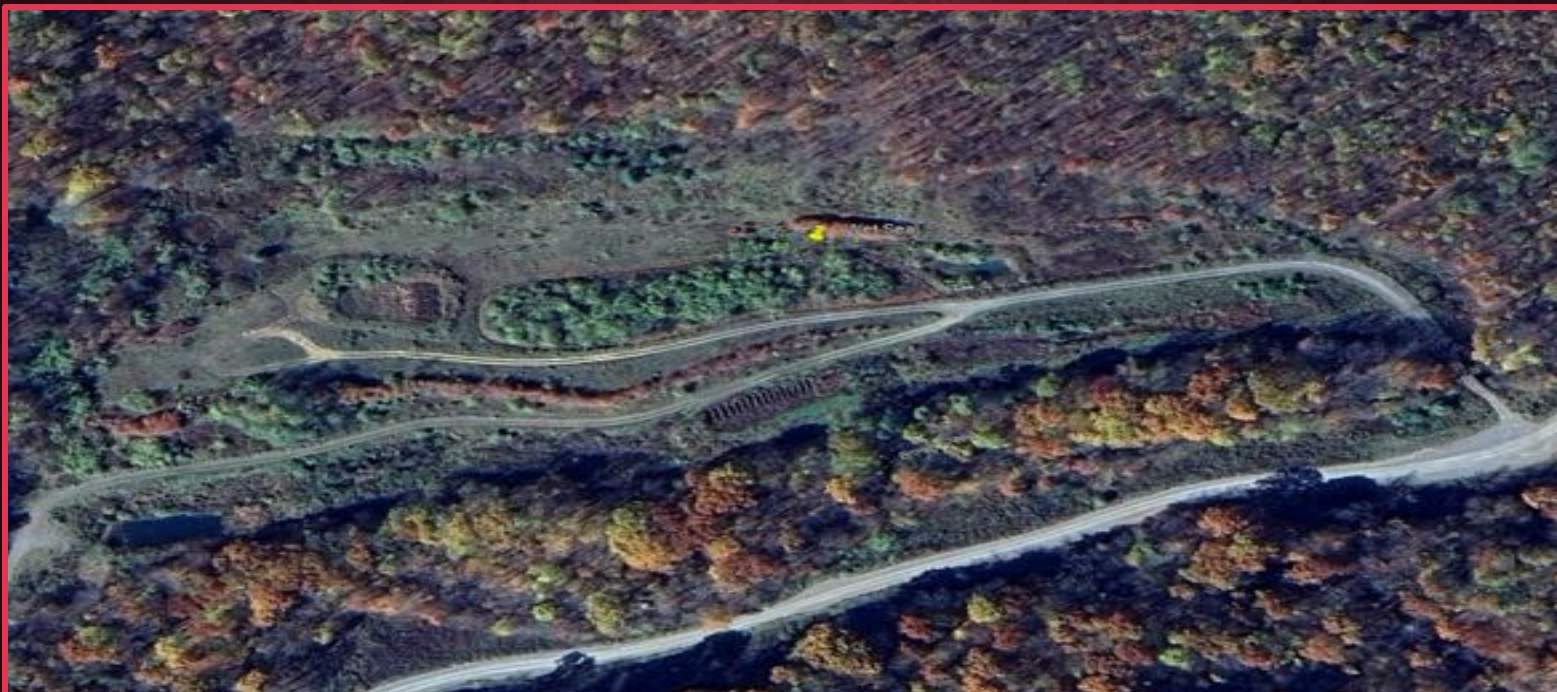
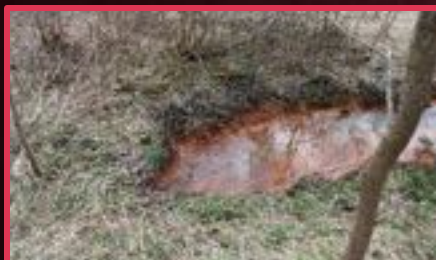
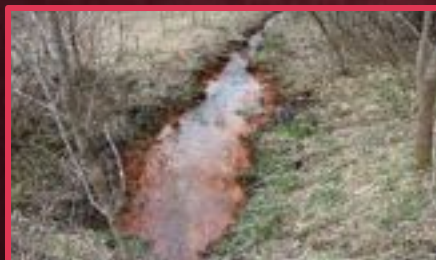
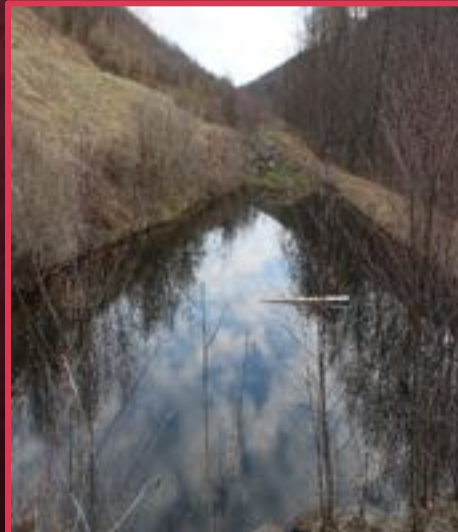
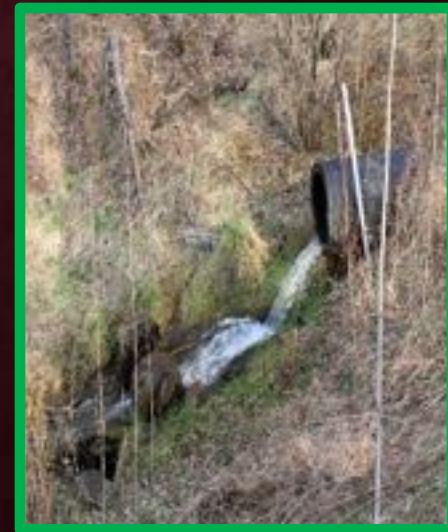
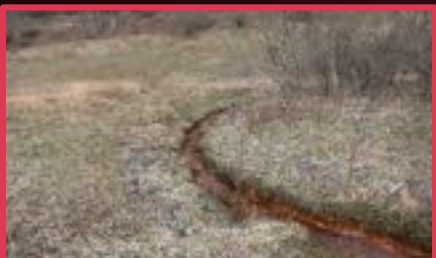
Staining continues to remove iron after 21 years. See below.

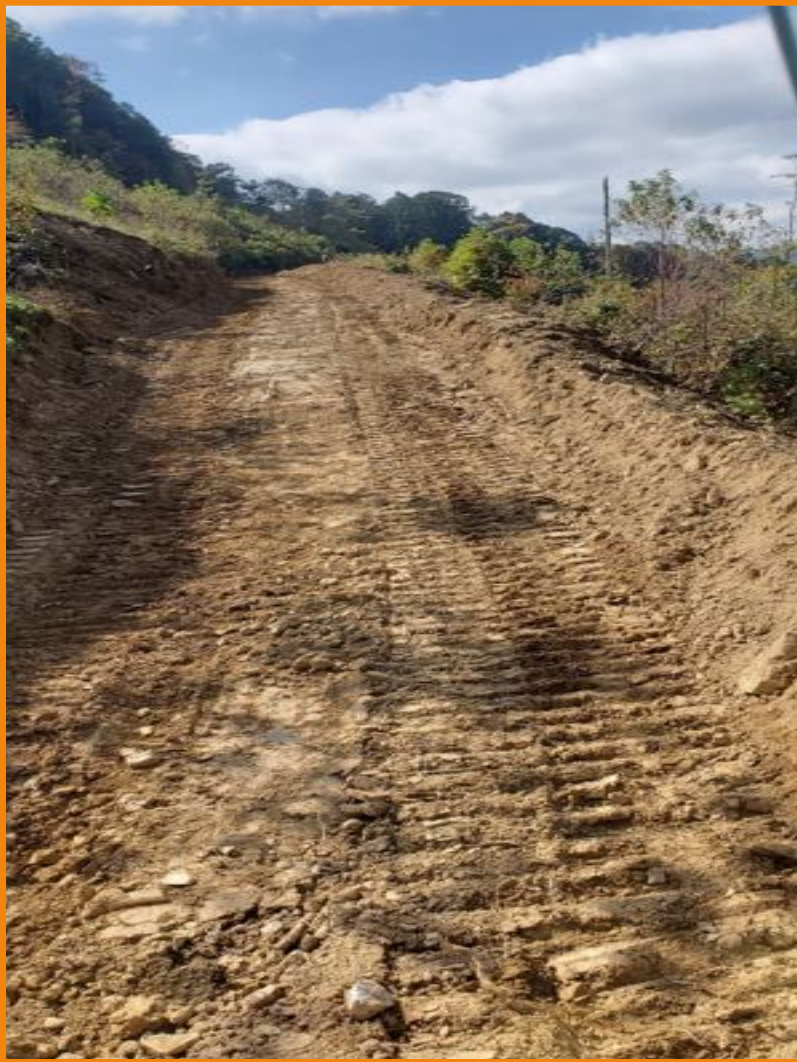
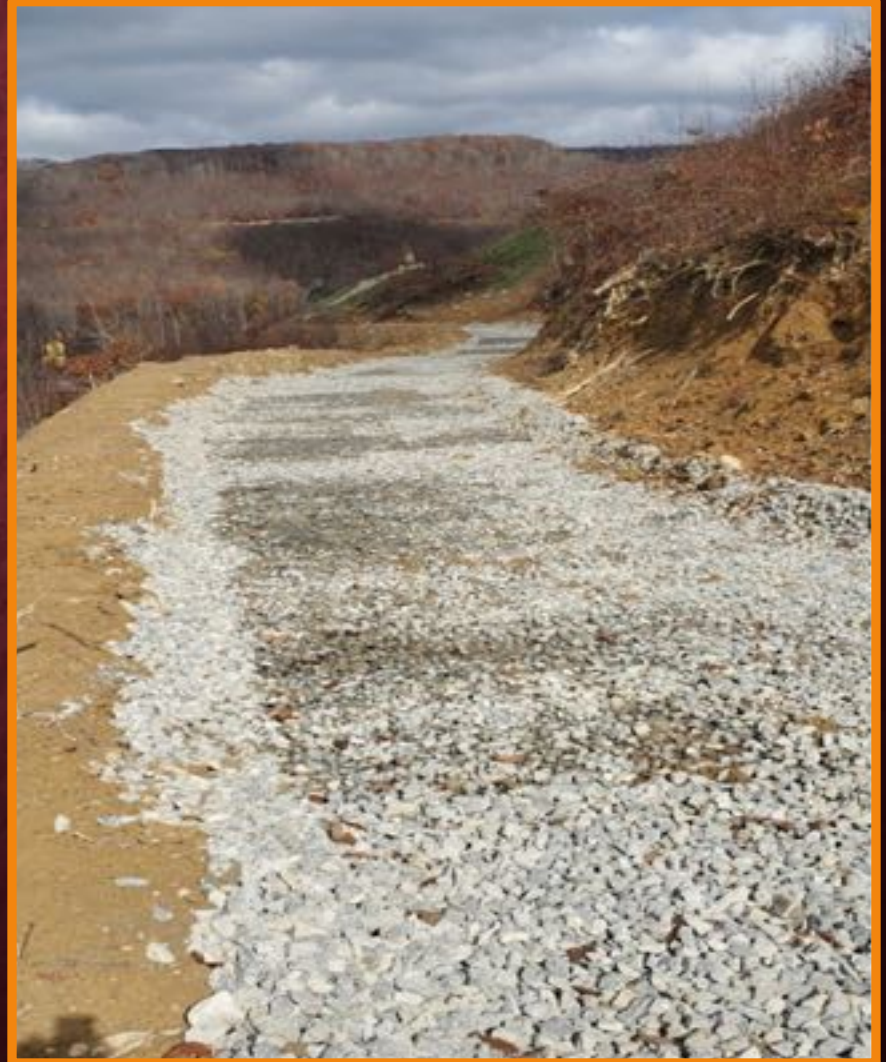
Pocahontas Mine-"The Revelation"

To minimize the surface disturbance for the Iron Staining Bed (ISB) construction, two existing skid roads previously used by timber operators were utilized. The two roads were then lined with 6" of stone and rock barriers 12" high were installed across the beds every 100'.

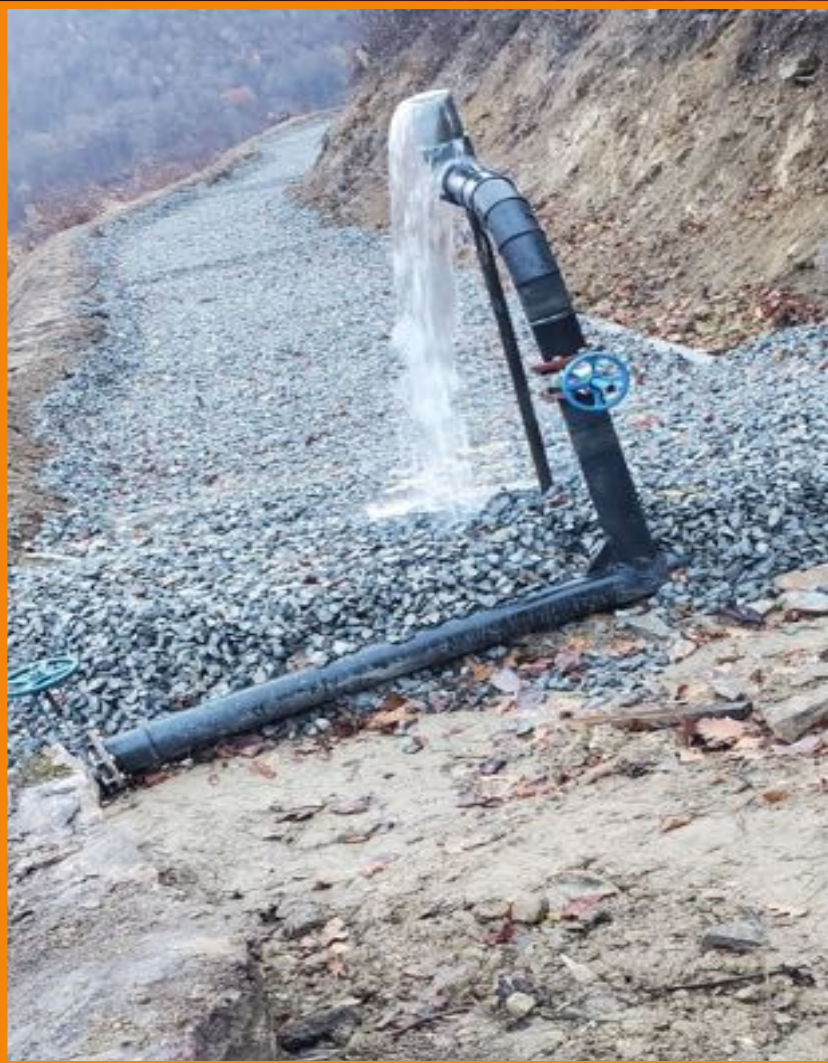
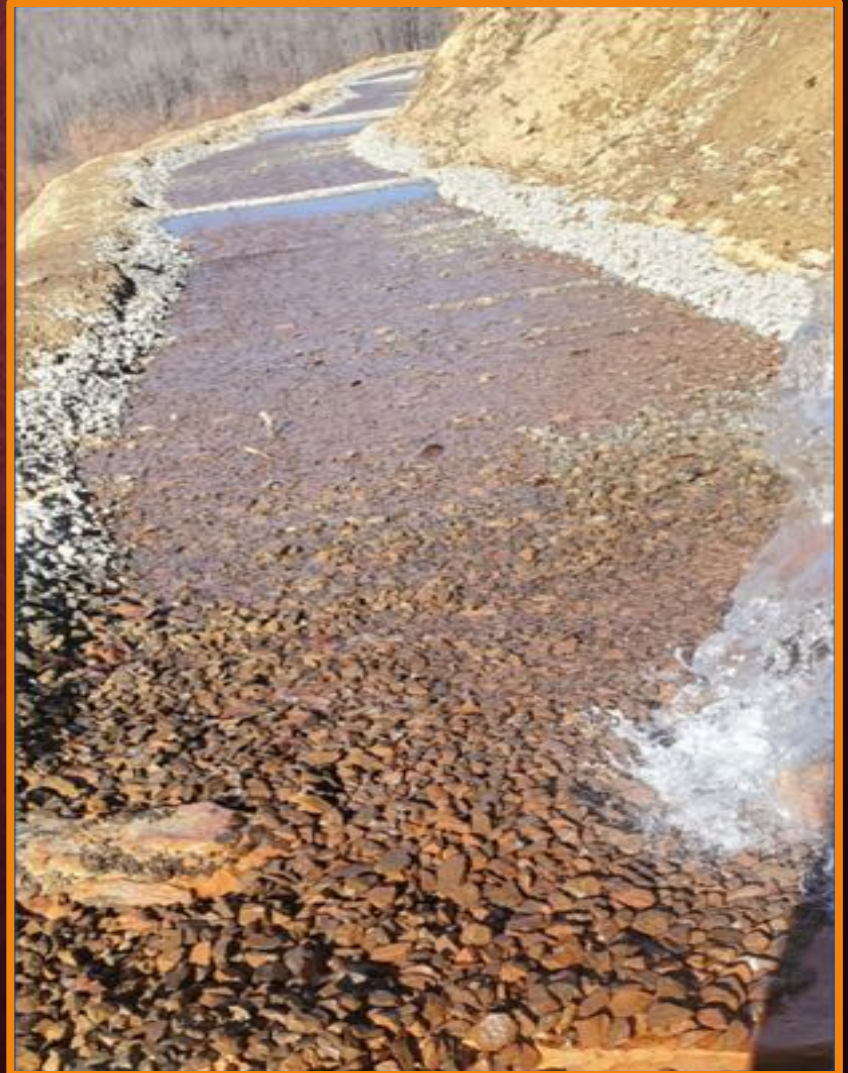
Pocahontas Mine-"The Revelation" Continued

The rock barriers were meant to help distribute the flow evenly across the beds to maximize contact time for staining to take place.

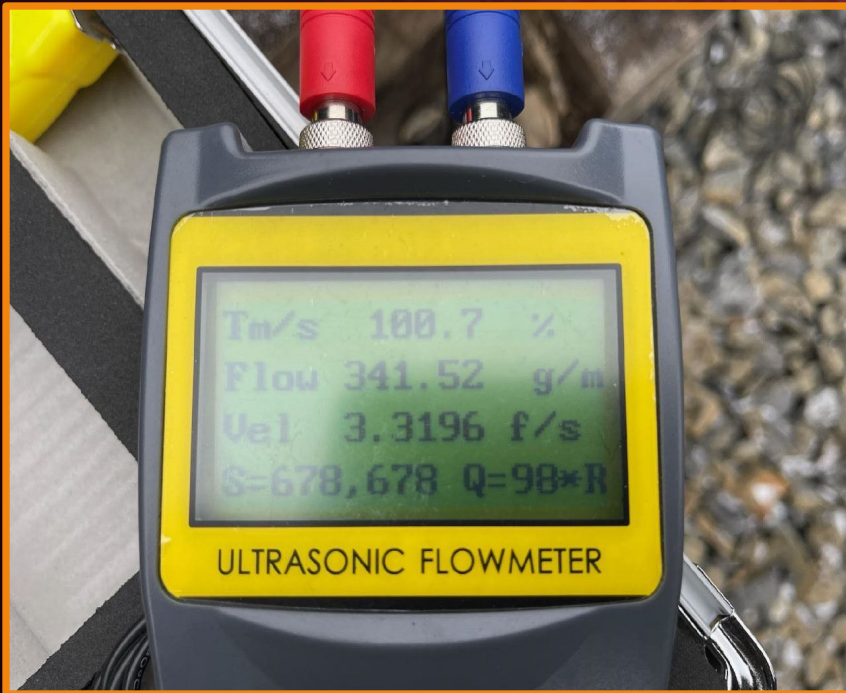
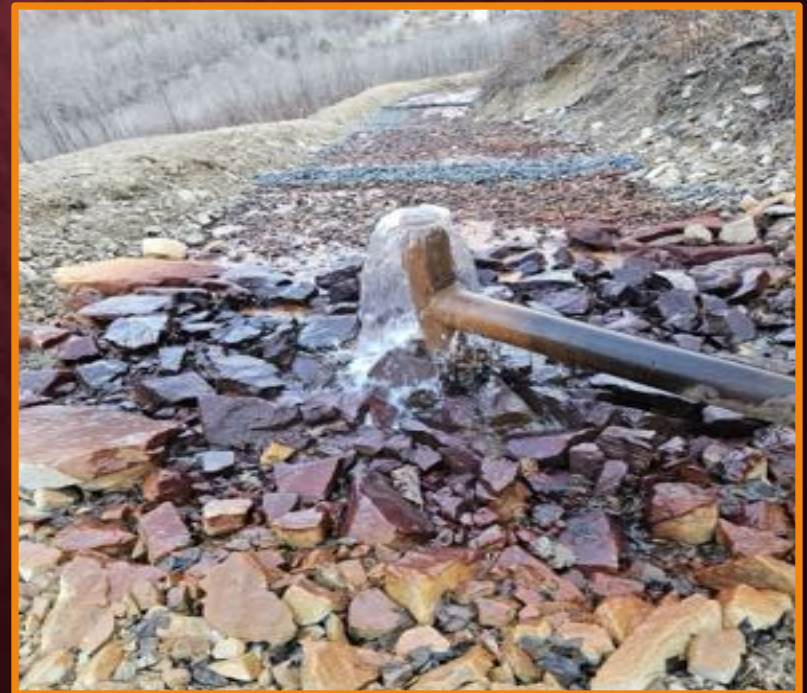
No.2 (Lower Staining Bed)

Concurrent with construction of the beds, pipes and valves were installed to carry the Alkaline Iron water from the Horizontal Drill hole to each bed. The water could be evenly split or one bed could be operated individually in case the other needed some maintenance or other related work. An ultrasonic flow meter measured 342 gallons per minute when the valves were opened for the first time on October 25, 2023. When water entered the beds, it took less than an hour to reach the other ends before proceeding to the polishing pond. The water entering the beds had a ferrous iron concentration of 9.7 mg/l. The permitted discharge limit is 0.93 mg/l. by the time the water reached the end of the beds, Bed No.1 had a Total Iron of 0.1 mg/l and a Dissolved Iron of 0.04 mg/l. Bed No.2 had a Total Iron of 0.08 mg/l and a Dissolved iron of 0.03 mg/l. Needless to say, the beds far exceeded our expectations as iron removal was near instantaneous and complete from the very first time the flow reached the end of the beds to the last day the beds were in use. All in all, over 60,000,000 gallons of water was processed through the beds. As a matter of general interest, we intermittently ran the entire flow through each bed alone and got the same results.

The No.2 Iron Staining Bed averaged discharging a Total Iron of 0.059 mg/l & Dissolved Iron of 0.023 mg/l

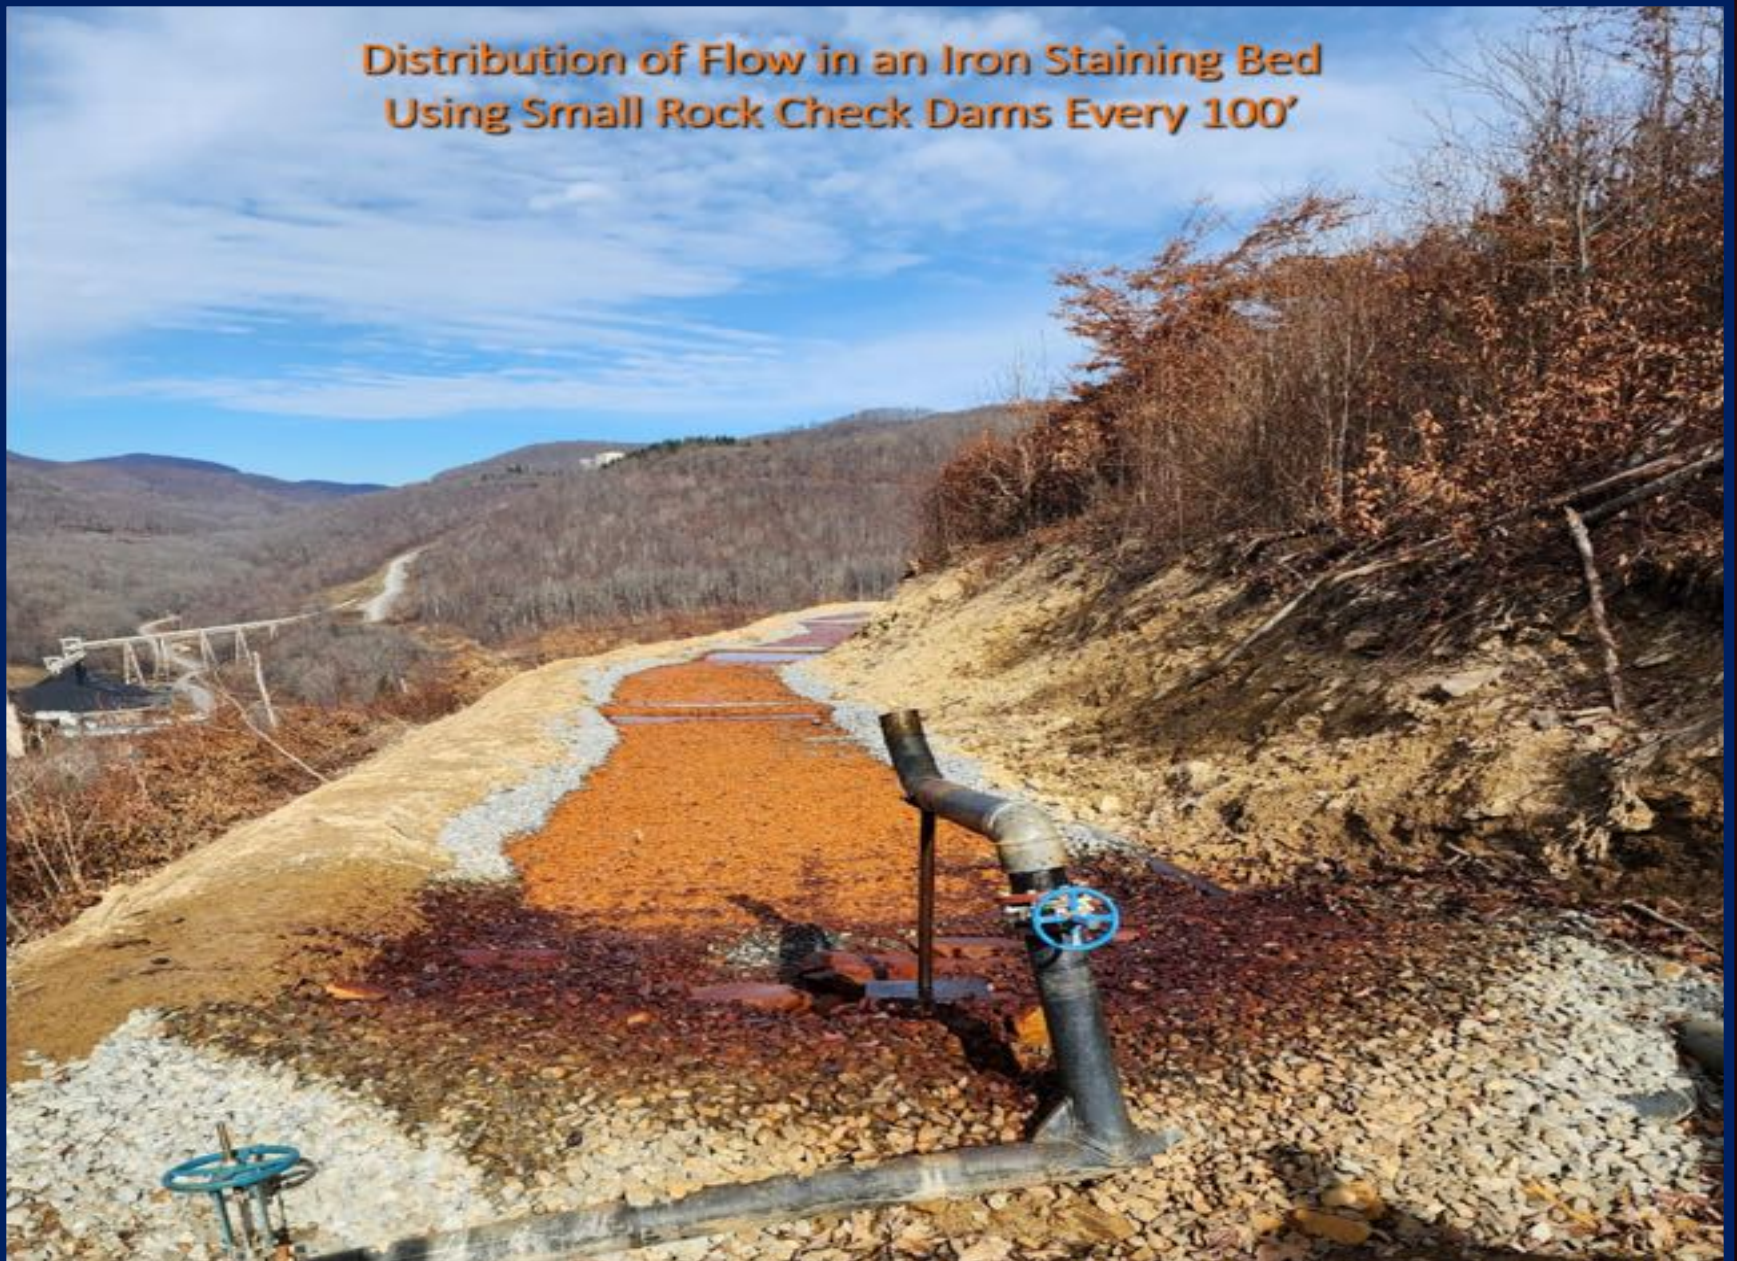
No.1 (Upper Staining Bed)

Distribution of Flow in an Iron Staining Bed
Using Small Rock Check Dams Every 100'

The No.1 Iron Staining Bed averaged discharging a Total Iron of 0.11 mg/l & Dissolved Iron of 0.038 mg/l

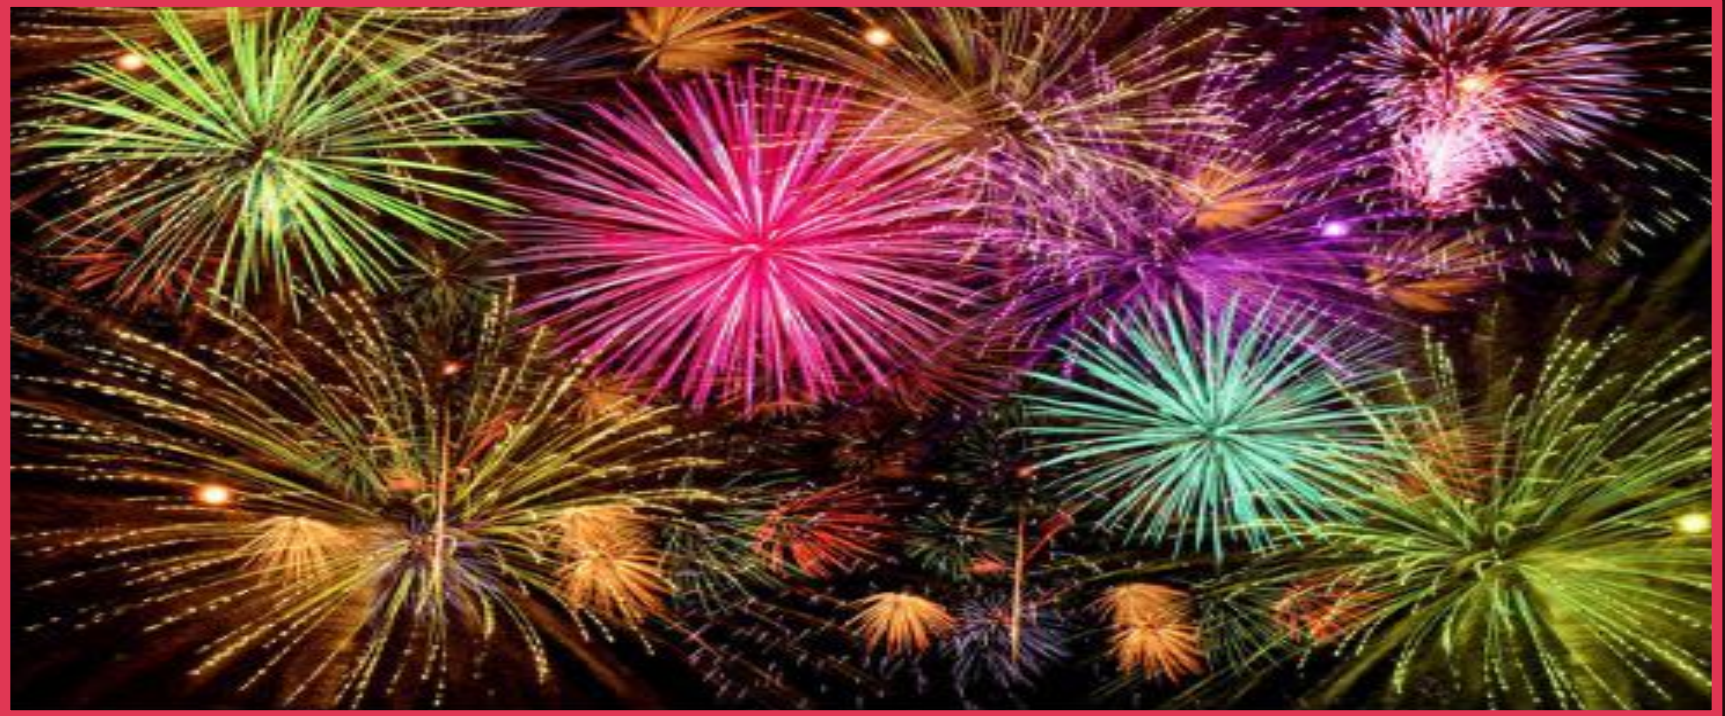
Pocahontas Mine-FINALLY- "The Revelation"

Impounded water in the western part of the Pocahontas Mine was **“9.70 mg/l”**
Upon draining the impounded water, free flowing water since 6/2024 **“0.31 mg/l”**

- Fluctuation in flow is monitored by rain gauge data to try and determine the lag time between precipitation and infiltration.
- As stated previously, the Iron concentration of the water draining through the horizontal drill hole is now between 0.25 mg/l and 0.35 mg/l.
